GoldEye Home Inspection Ltd

Home Inspection Report

RE: Report No. SAMPLE
Guelph, ON

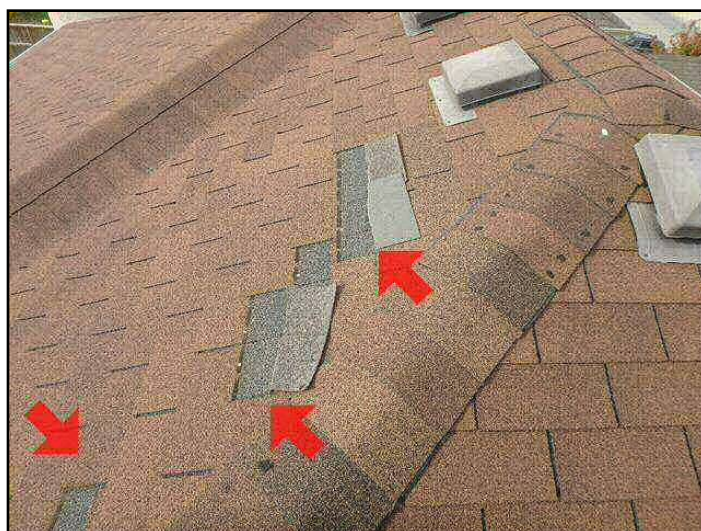
Condition: • [Missing, loose or torn](#)

Implication(s): Chance of water damage to contents, finishes and/or structure

Location: Rear Roof

Missing, loose or torn

Task: Repair or replace

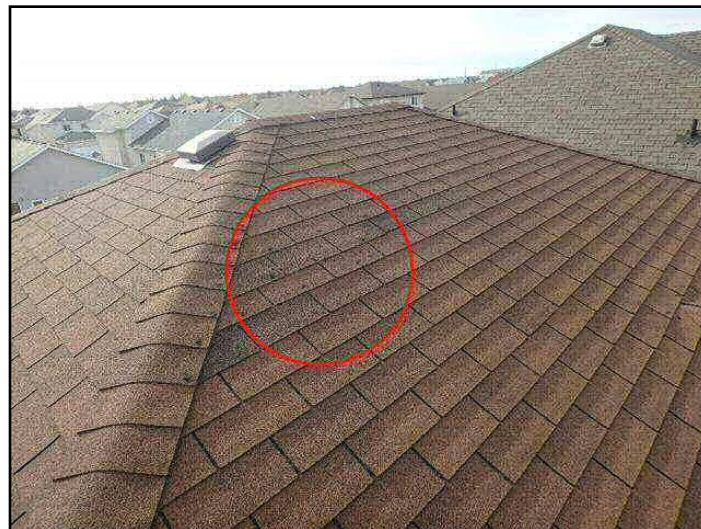
Condition: • [Patched](#)

Location: Front Roof

Patched

Task: Monitor

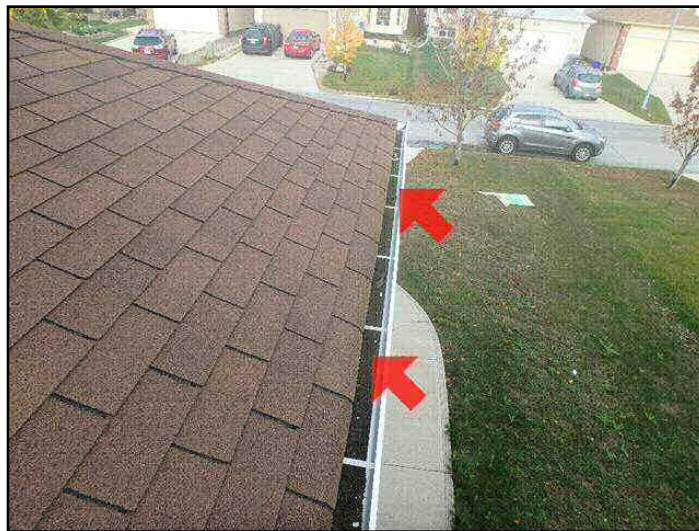
Condition: • [Clogged](#)

Location: Garage Roof

Clogged

Task: Clean

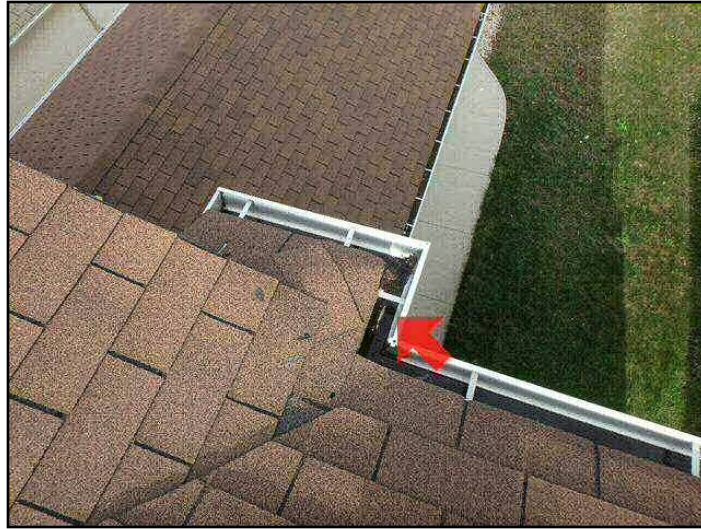
Condition: • [Improper slope, ponding](#)

Location: Front

Improper slope, ponding

Task: Improve

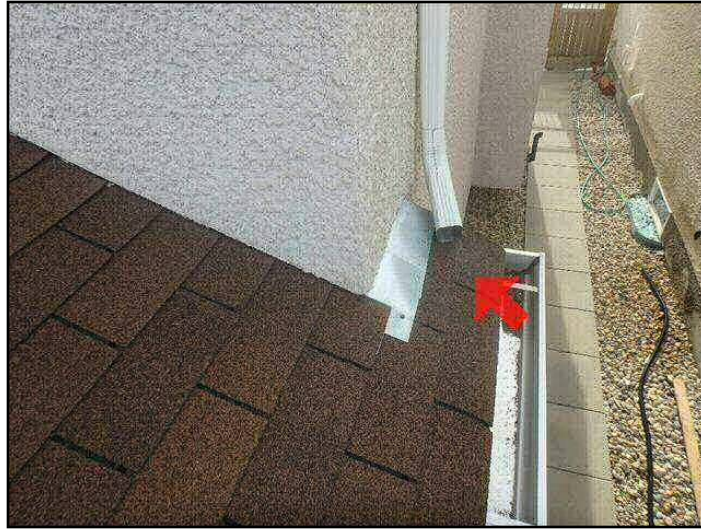
Condition: • [Downspouts discharging onto roofs](#)

Location: Roof

Downspouts discharging onto roofs

Task: Improve

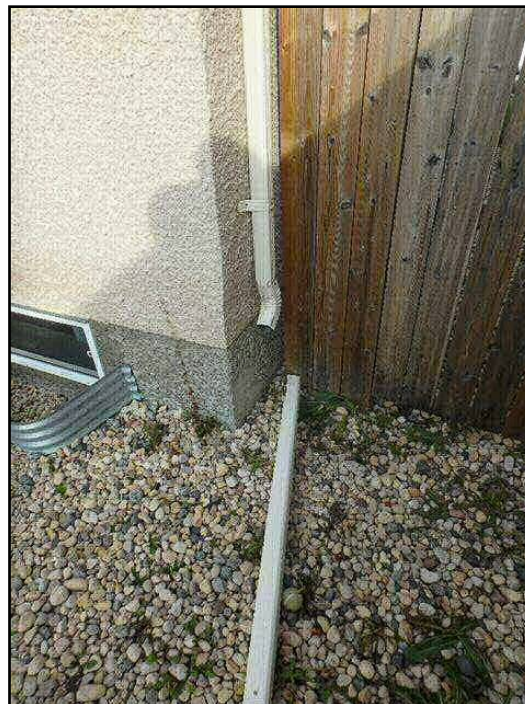
Condition: • [Should discharge 6 feet from building](#)

Location: Various Exterior Wall

Should discharge 6 feet from building

Task: Repair or replace

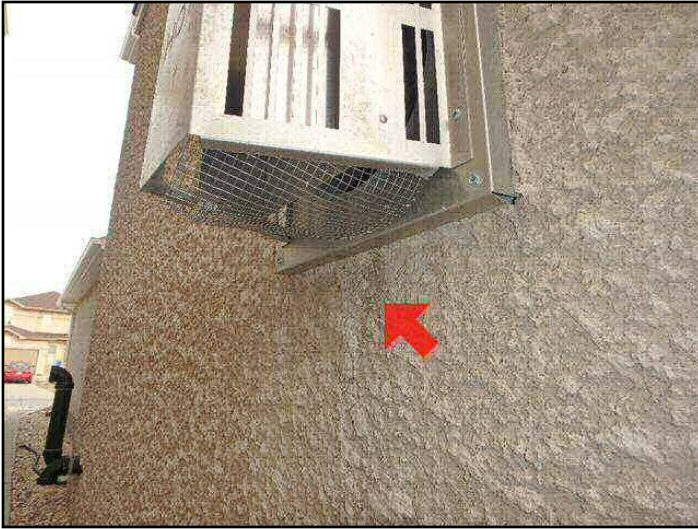
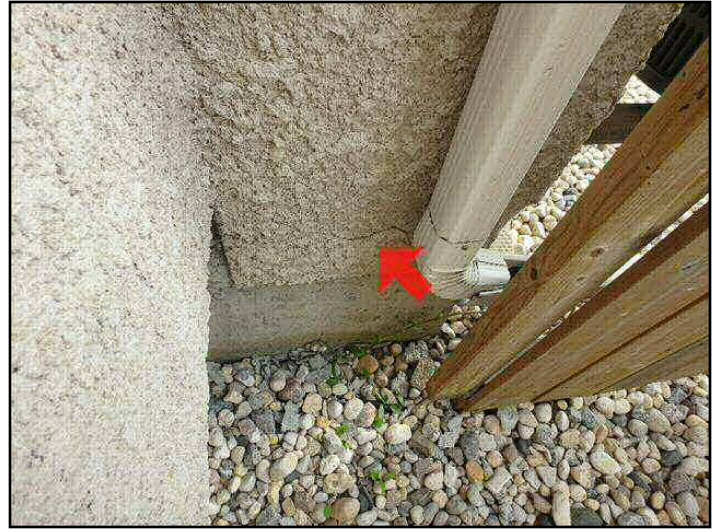
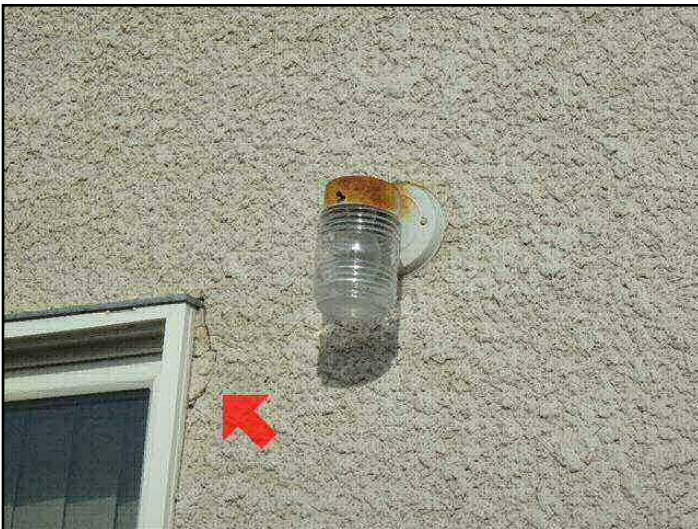
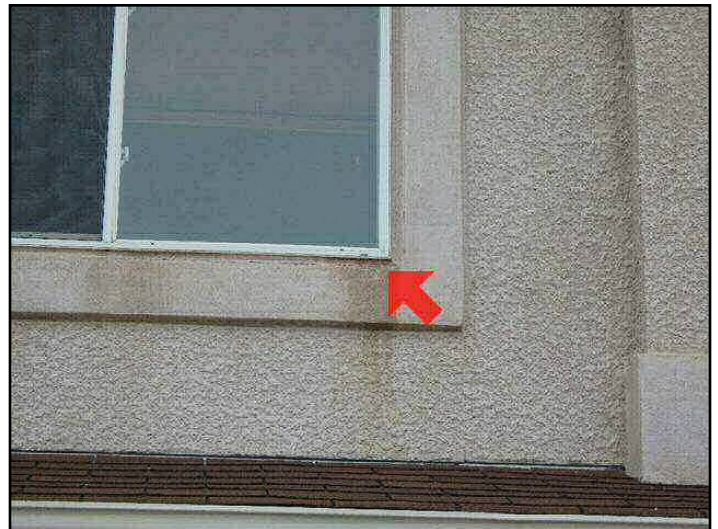
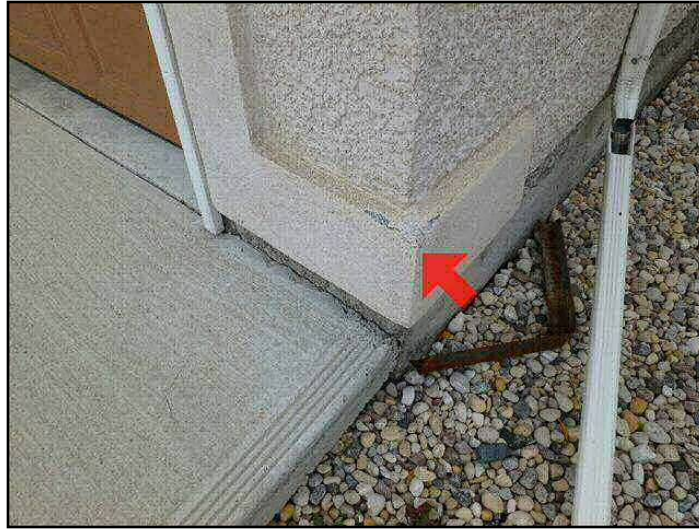
Condition: • [Crumbling](#)

Minor cracking/crumbling of stucco is typical for house of this age. Monitor and repair to reduce chance of water damage

to structure and interior finishes and contents.

Crumbling

Task: Repair Monitor

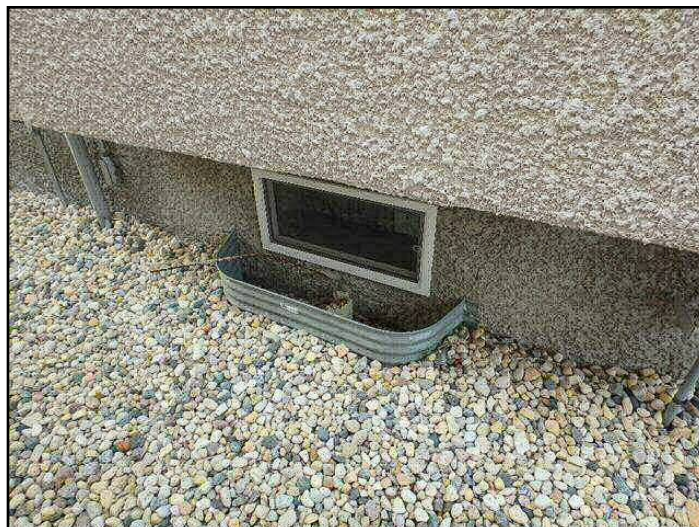
Condition: • Rebar stuck in window well drain.

Implication(s): If drain is functioning, this is not a problem. It may be an indication tha the drain was not functioning and the homeowner attempted to clear it. If the drain is not functioning it is important to prevent water from pooling against the wall and potentially leaking into the house by clearing the drain or by installing a window well cover. The implications would be damage to the strucutre and interior finishes and contents.

Task: Monitor

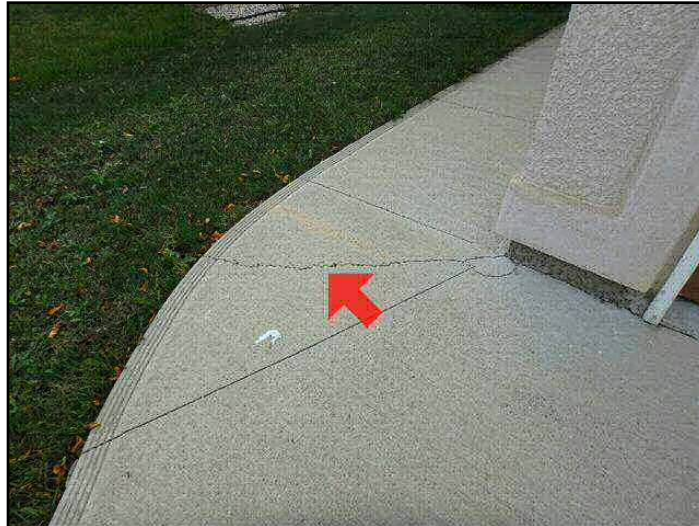
Condition: • [Cracked or damaged surfaces](#)

Implication(s): Trip or fall hazard

Cracked or damaged surfaces

Task: Monitor to ensure that repairs are made before it becomes a tripping hazard.

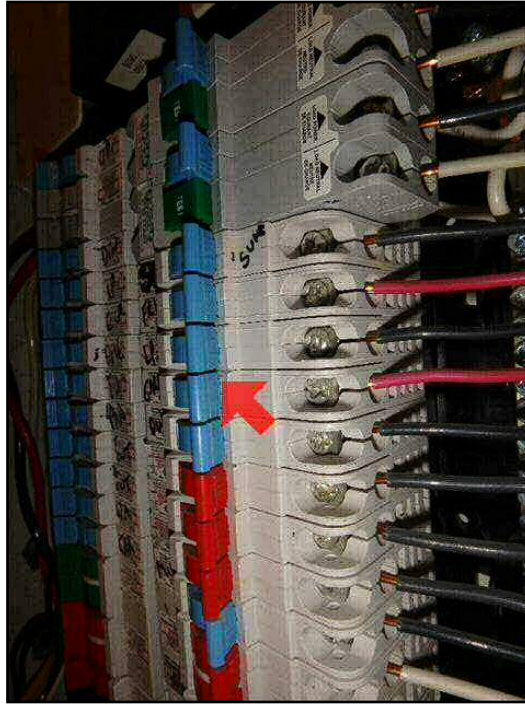
Condition: • [No links for multi-wire circuits](#)

Several pairs of black and red have breakers that are unlinked (no bridges so that both breakers will trip if one does). They should be evaluated to determine if they serve the same circuits.

Implication(s): Electric shock

No links for multi-wire circuits

Task: Provide

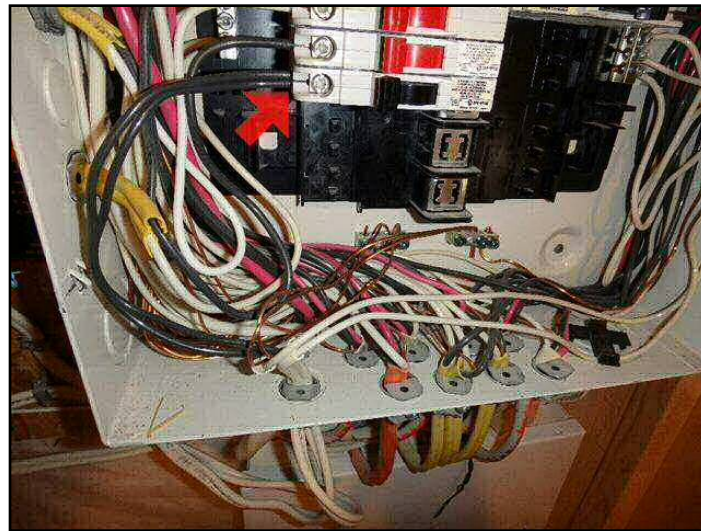
Condition: • [Double taps](#)

Implication(s): Fire hazard

*Double taps*

Task: Correct

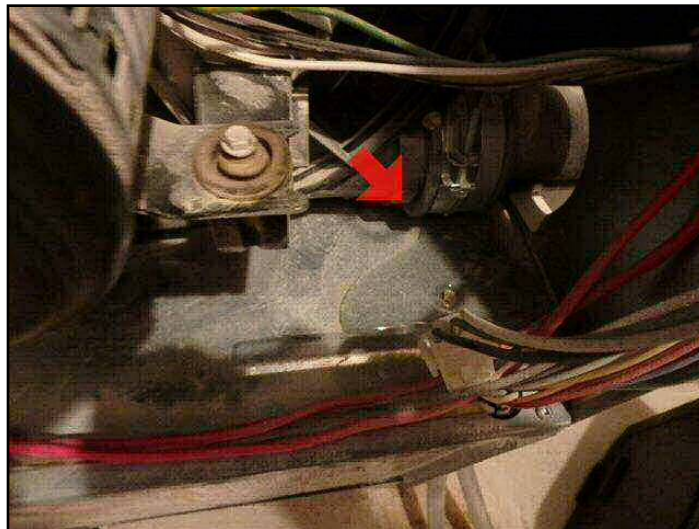
Condition: • [Condensate problems](#)

Implication(s): Chance of water damage to contents, finishes and/or structure | Reduced system life expectancy

Condensate problems

Recommend servicing furnace by qualified HVAC (Heating Ventilation Air Conditioning) technician prior to winter. Ensure leak is repaired.

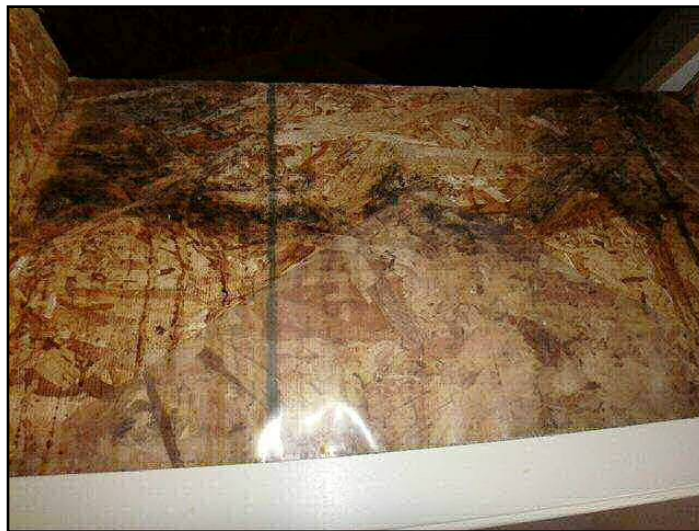
Condition: • [Not weatherstripped](#)

Black stains on wood are possibly mold. Warm air leaking past hatch door can condense on the wood when attic is cold. Weatherstripping should be provided to reduce chance of further moisture damage.

Implication(s): Chance of condensation damage to finishes and/or structure | Increased heating and cooling costs

Not weatherstripped

Task: Repair or replace

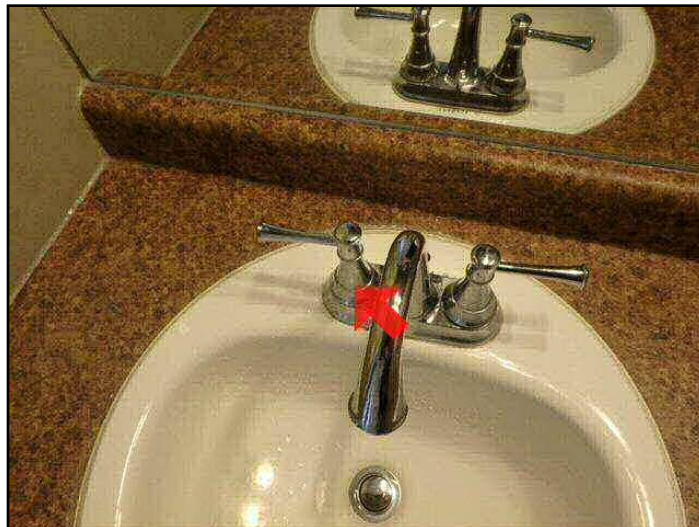
Condition: • [Loose](#)

Implication(s): Equipment failure

Loose

Task: Repair or replace

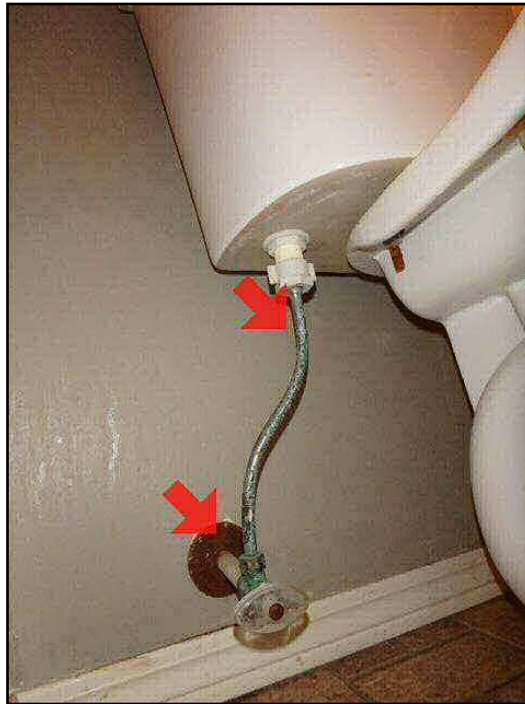
Condition: • [Leak](#)

Possible leak

Implication(s): Chance of water damage to contents, finishes and/or structure

Leak

Task: Further evaluation

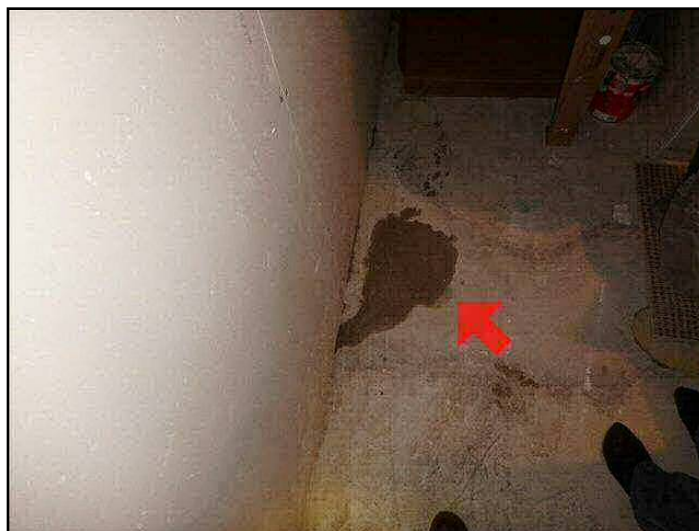
Condition: • [Leak](#)

Leak from shower unit detected on floor in furnace room.

Implication(s): Chance of water damage to contents, finishes and/or structure

Leak

Task: Repair or replace

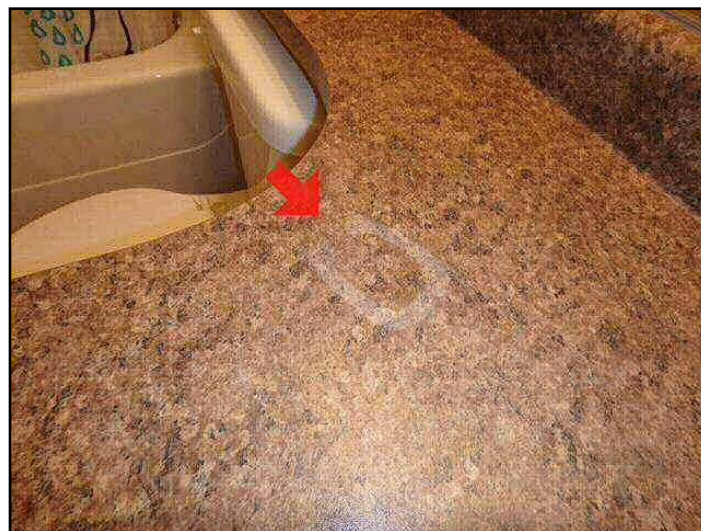
Condition: • [Damage, stained](#)

Implication(s): Cosmetic defects | Hygiene issue

Damage, stained

Task: Correct

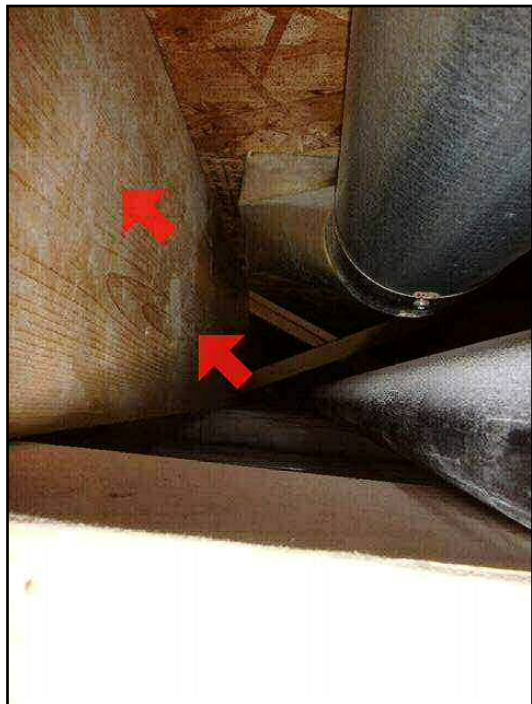
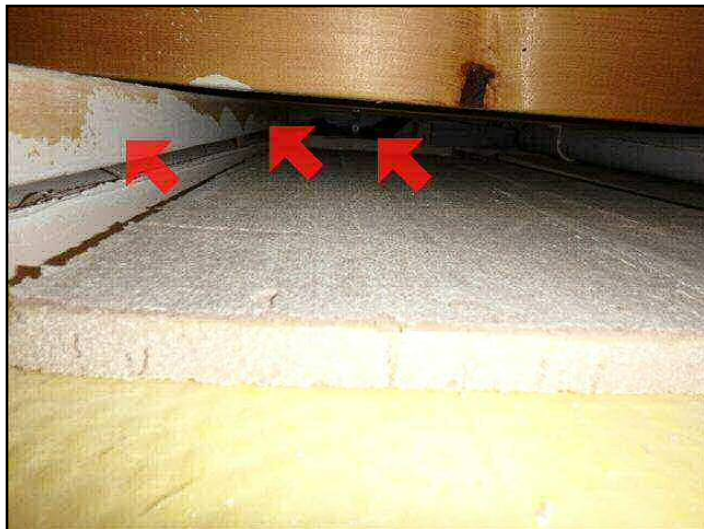
Condition: • [Stains](#)

Staining on the floor joists above the basement bathroom indicates an ongoing problem with humidity in this area. It could be related to the residents using the shower without the primary fan unit operating. Operating the primary fan frequently or continuously can help to remove moisture from the house and reduce the chance of mildew or mold growth in these areas.

Implication(s): Cosmetic defects | Chance of water damage to contents, finishes and/or structure

Stains

Task: Monitor
