# Confidential Inspection Report

LOCATED AT:  
777 Luck Ln  
Happyville Utah

Inspector, Heath Madsen  
J-Pro Inspects

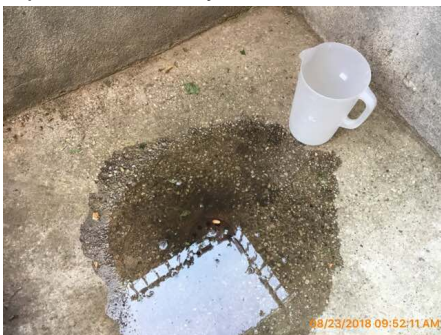
**RM s-32:** - The basement stairwell drain drained slowly. Recommend clearing drain and/or that a qualified plumber repair if necessary.

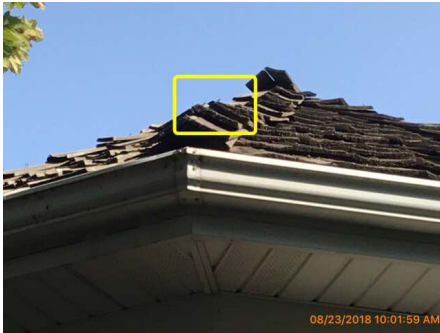
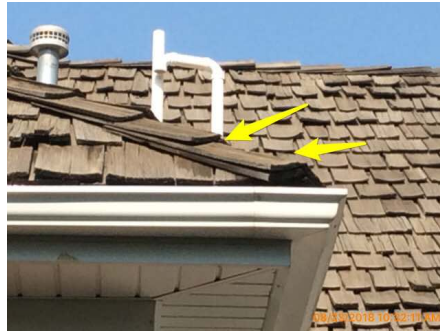
**RR s-49:** - Some wood shakes or shingles were loose and warped. Leaks can occur as a result. Recommend that a qualified contractor repair as necessary. For example, by replacing or fastening shakes or shingles, or installing flashing.

Fasteners loose

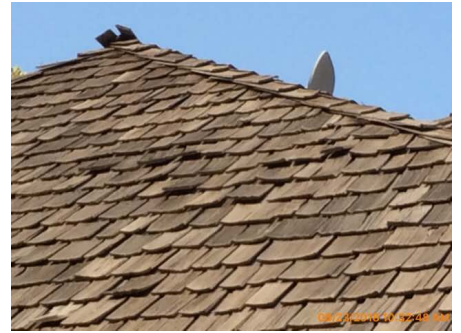
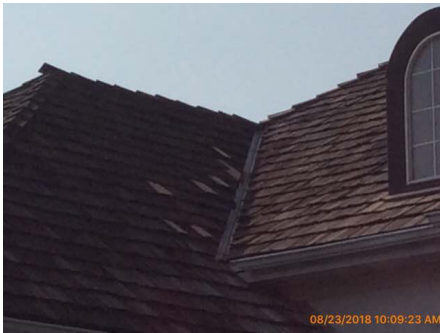
**RR s-50:** - The wooden roof surface (shakes or shingles) appeared to have been recently repaired. Shakes can deteriorate prematurely if not maintained. Recommend that a qualified contractor clean the roof surface and apply a preservative per standard building practices. For wooden roof surfaces, this should be done approximately once every three to five years.

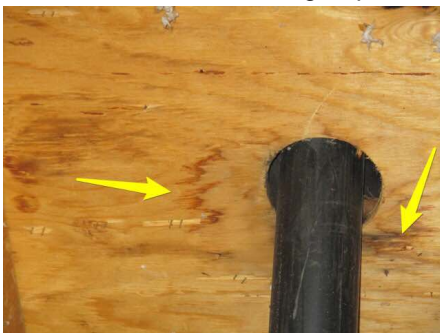
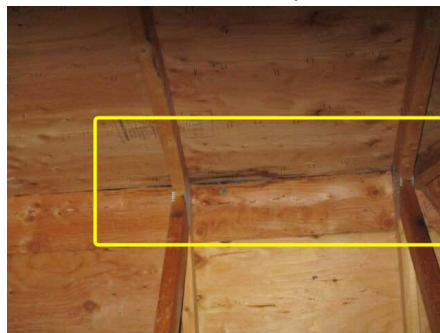
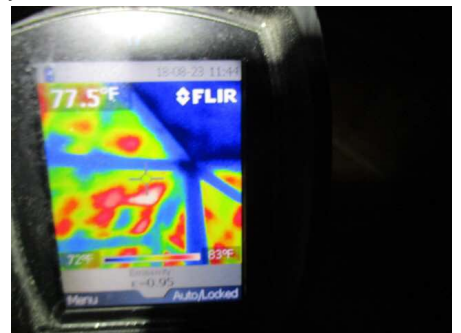
**s-57:** - Stains were found in one or more areas on the underside of the roof. The inspector was unable to determine if an active leak exists (inaccessible height). Recommend asking the property owner about this, monitoring the stains in the future, and/or having a qualified contractor evaluate and repair if necessary.

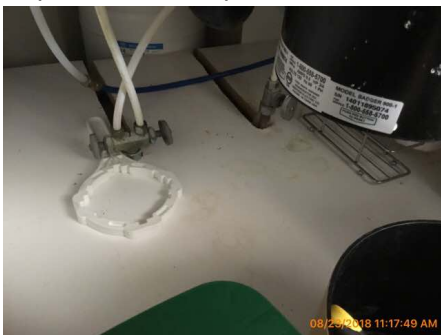
**Mo 12:** - Stains were found in shelving or cabinets below the kitchen sink. No leaks were found at the time of the inspection. The inspector is unable to determine the condition of underlying materials.

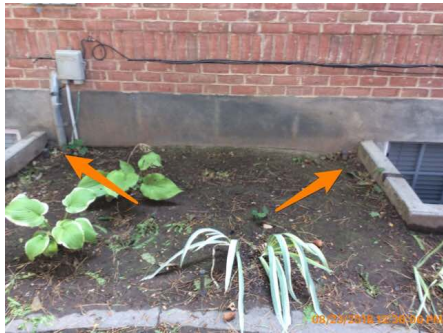
**RM Mo 22:** - The soil or grading sloped towards building(s). This can result in water accumulating around/under the foundation and in basements. Recommend grading soil so it slopes away from the structure. The recommended slope is at least 1 inch per horizontal foot for every 6 feet out from buildings.

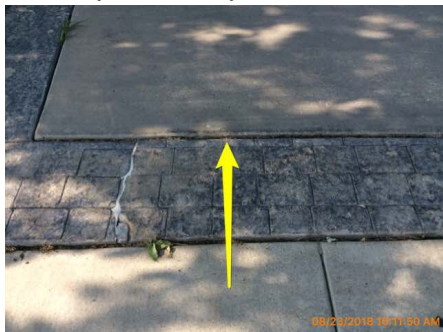
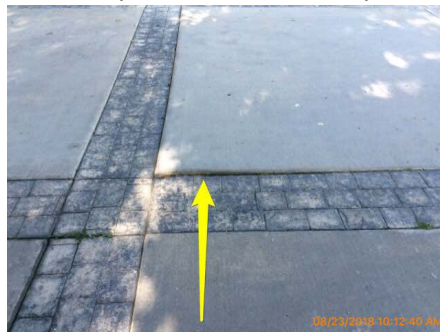
**Safe RR 24:** - Cracks, holes, settlement, heaving and/or deterioration resulting in trip hazards were found in the driveway. For safety reasons, recommend that a qualified contractor repair as necessary.

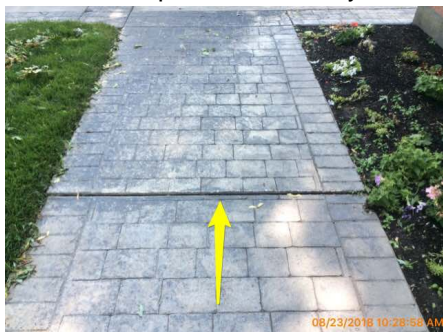
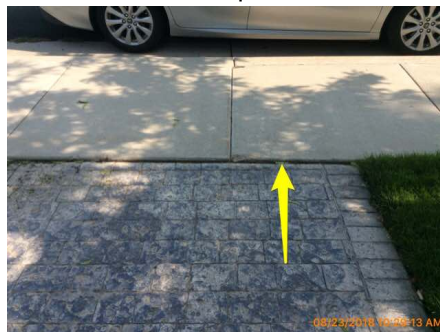
**Safe RM 26:** - Cracks, holes, settlement, heaving and/or deterioration resulting in trip hazards were found in the sidewalks or patios. For safety reasons, recommend that a qualified contractor repair as necessary.

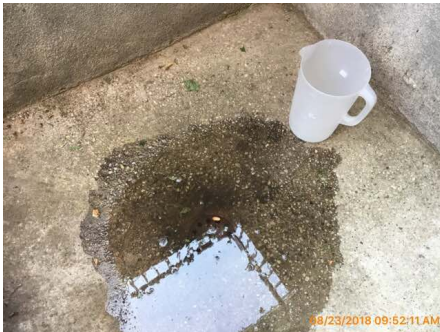
**RM** 32: - The basement stairwell drain drained slowly. Recommend clearing drain and/or that a qualified plumber repair if necessary.

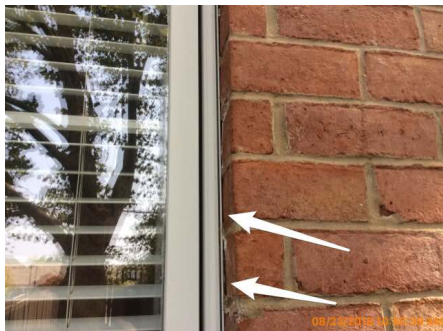
**RR RM 40:** - Caulk was missing and substandard in some areas. For example, around windows. Recommend that a qualified person renew or install caulk as necessary. Where gaps are wider than 1/4 inch, an appropriate material other than caulk should be used.

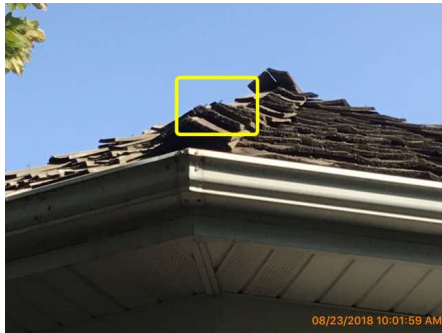
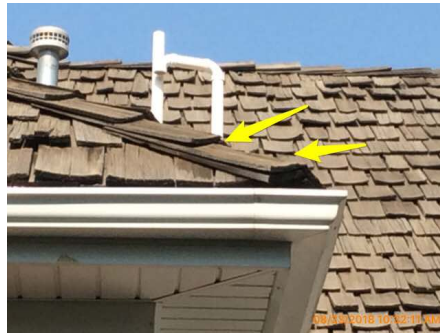
**RR 49:** - Some wood shakes or shingles were loose and warped. Leaks can occur as a result. Recommend that a qualified contractor repair as necessary. For example, by replacing or fastening shakes or shingles, or installing flashing.

Fasteners loose

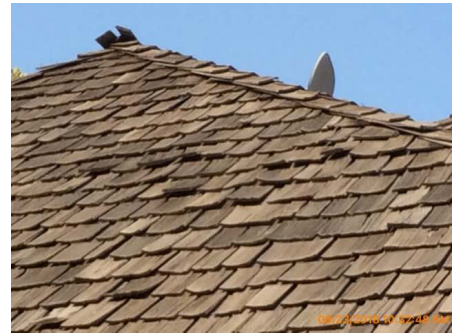
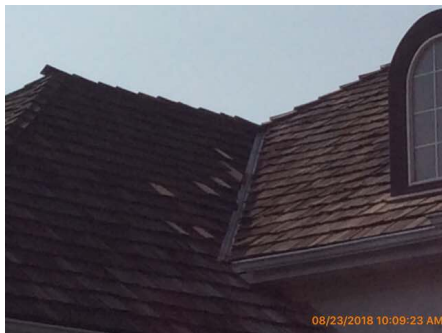
**RR 50:** - The wooden roof surface (shakes or shingles) appeared to have been recently repaired. Shakes can deteriorate prematurely if not maintained. Recommend that a qualified contractor clean the roof surface and apply a preservative per standard building practices. For wooden roof surfaces, this should be done approximately once every three to five years.

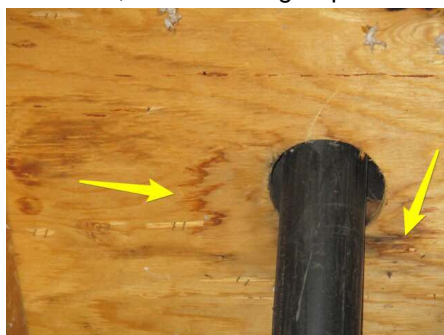
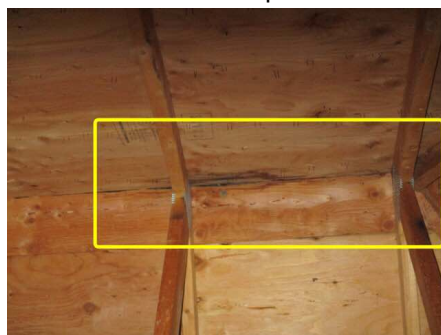
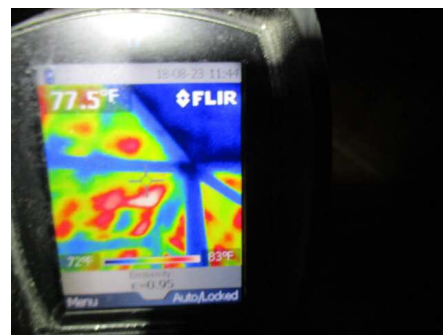
**57:** - Stains were found in one or more areas on the underside of the roof. The inspector was unable to determine if an active leak exists (inaccessible height). Recommend asking the property owner about this, monitoring the stains in the future, and/or having a qualified contractor evaluate and repair if necessary.

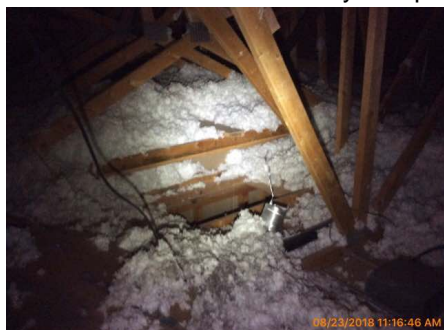
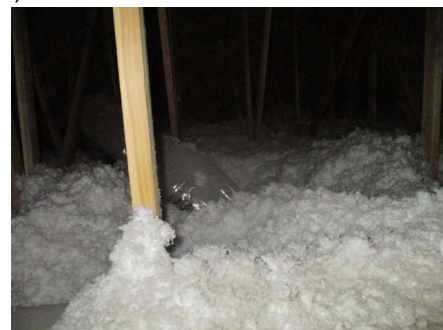
**61:** - The ceiling insulation in one or more areas of the attic was compacted or uneven and missing. Heating and cooling costs may be higher due to reduced energy efficiency. Recommend that a qualified person repair, replace or install insulation as necessary and per standard building practices (typically R-38).

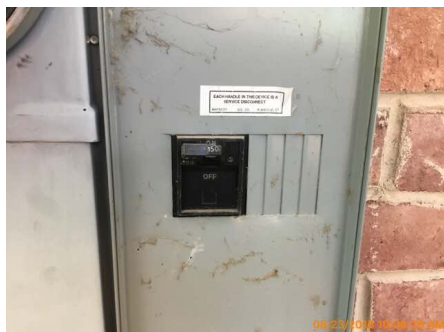
88: - The main disconnect breaker was damaged. Recommend replacing the breaker.

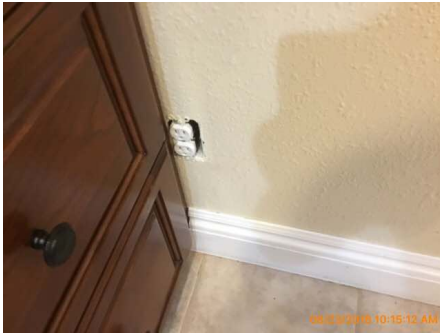
Basement south east wall

**Safe** **RR** 91: - Cover plates for switches, receptacles (outlets) or junction boxes were missing or broken. These plates are intended to contain fire and prevent electric shock from occurring due to exposed wires. Recommend that a qualified person install cover plates where necessary.

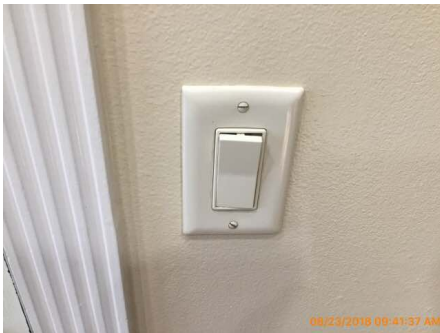
Kitchen

**Safe RR 95:** - One or more wall switches were broken or damaged. Recommend that a qualified electrician replace wall switches.

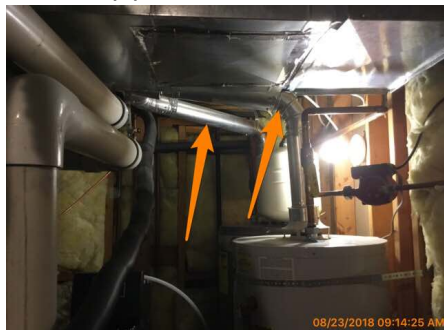
**Safe** **RR** 122: - The flues were undersized for the units. Units with a BTU rating 38,000 or greater should have a four inch flue pipe installed. Recommend having a plumber replace the 3 inch flue pipe with a 4 inch flue.

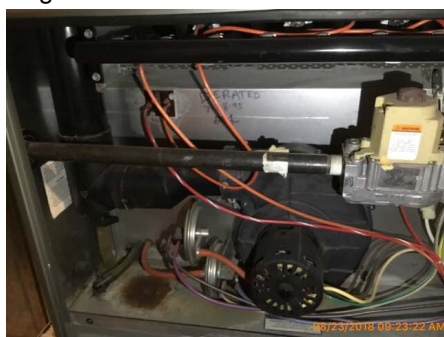
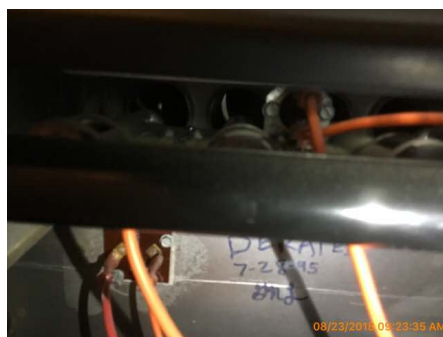
**Safe E** 133: - Because of the age of and condition of the forced air furnace, recommend that a qualified HVAC contractor inspect the heat exchanger and perform a carbon monoxide test when it's serviced. Note that these tests are beyond the scope of a standard home inspection. Recommend having this service completed prior to the due diligence date.

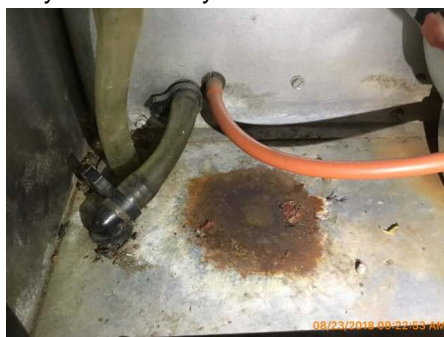
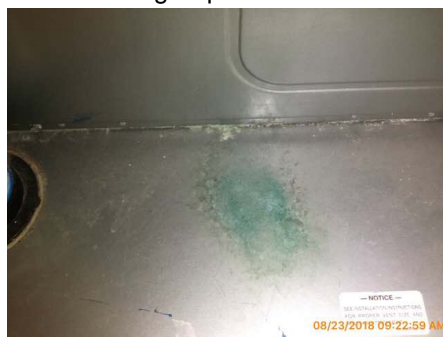
**E** 134: - Corrosion was present inside the furnace. No leaks were present at the time of the inspection. The issue may have already been resolved. Recommend having a qualified HVAC contractor evaluate and repair if necessary.

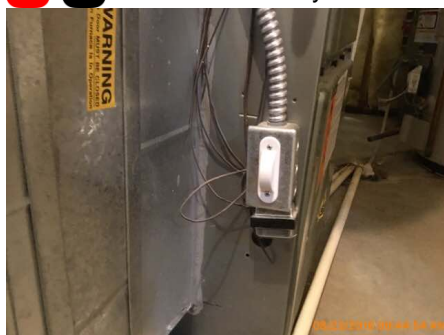
**Safe C** 135: - The safety switch for the furnace was covered and not readily accessible.

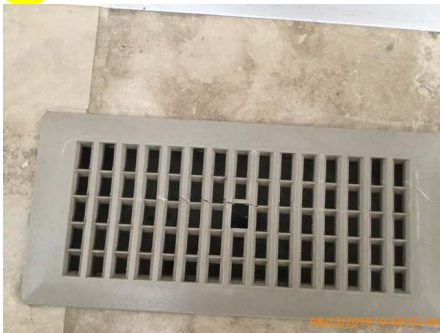
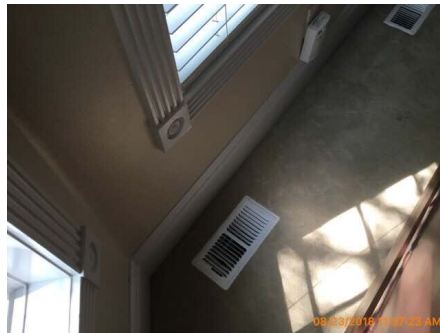
**RR 139:** - Some air supply registers were damaged. Recommend replacing where necessary.

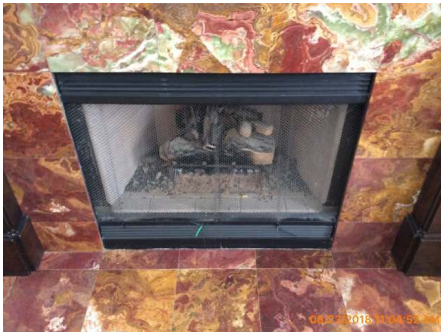
**Safe** **RR** **151:** - A wood burning fireplace has been converted to use gas logs, and no glass doors were installed on the fireplace. For gas conversions like this, the fireplace damper should be modified so it is permanently open to prevent combustion gases from the pilot light and main burners accumulating in living spaces. Since the damper is always open, unconditioned air from outside can enter living spaces through the chimney, and conditioned air from inside can exit through the chimney. This can result in higher heating and cooling costs. Recommend that a qualified person install glass doors on the fireplace per standard building practices.

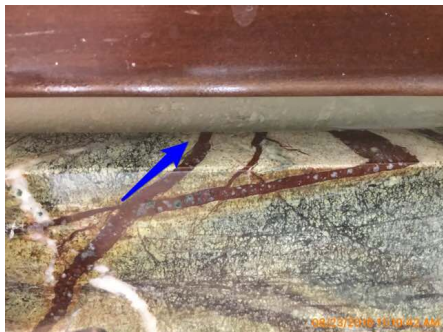
Master bathroom

**155:** - Gaps, no caulk, or substandard caulking were found between the backsplash and the wall in the master bathroom. Water can penetrate these areas and cause damage. Recommend that a qualified person repair as necessary. For example, by installing or replacing caulk.

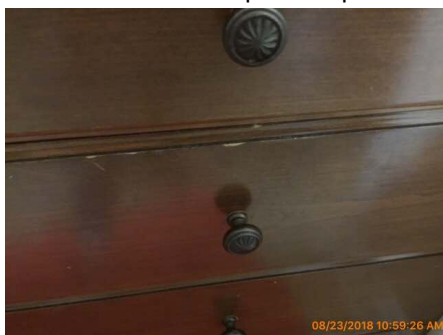
**156:** - One or more drawers and cabinet doors in the basement bathroom were damaged or deteriorated. Recommend that a qualified person repair or replace as necessary.

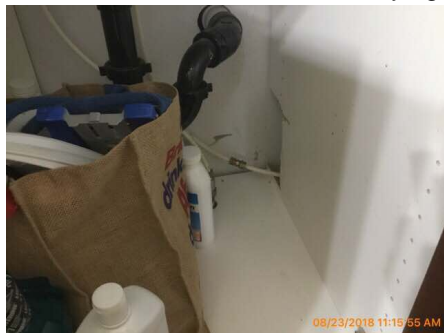
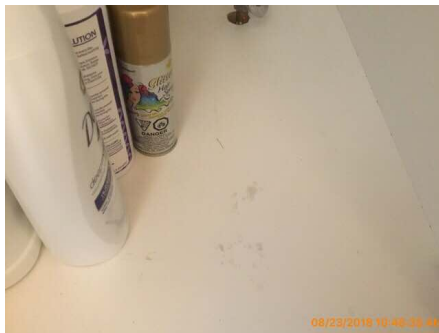
**Mo 158:** - Stains were found in shelving or cabinet components below one or more sinks in the upstairs hallway bathroom and master bathroom. No leaks were found at the time of the inspection. The inspector is unable to determine the condition of underlying materials.

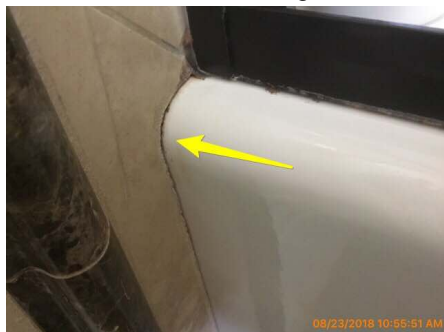
**RM 160:** - Gaps, no caulk, or substandard caulking were found between the bathtub and the surround in the basement bathroom. Water may penetrate these areas and cause damage. Recommend that a qualified person re-caulk or install caulking as necessary.

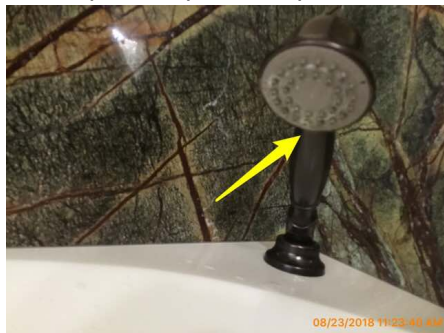
**RM 162:** - The shower head in the master bathroom bathtub dripped when the shower was turned on. Recommend that a qualified person repair as necessary.

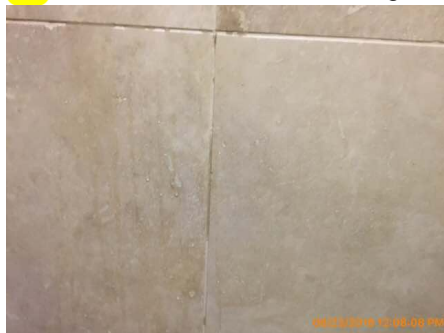
**RM 165:** - Recommend cleaning and sealing the grout in wet areas such as showers and bathtub surrounds.

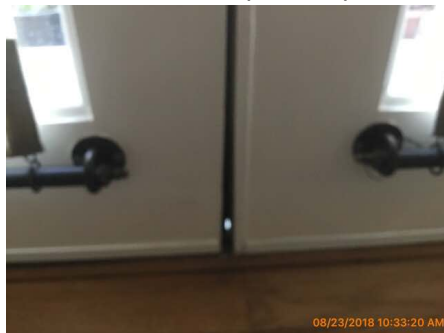
**RR 168:** - Weatherstripping around front door was substandard. Energy efficiency may be reduced as a result. Recommend that a qualified person repair or replace weatherstripping as necessary.

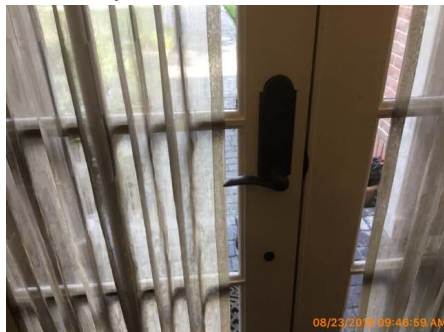
Front door

**169:** - The deadbolt lock for the front door was difficult to operate. Recommend that a qualified person repair as necessary.

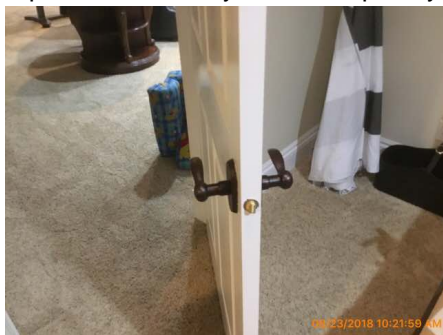
Basement play room.

**RM 171:** - One or more interior doors wouldn't latch or were difficult to latch. Recommend that a qualified person repair as necessary. For example, by adjusting latch plates or locksets.

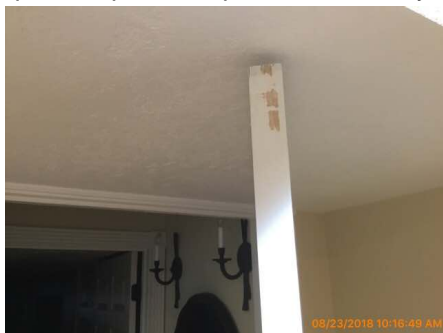
Basement hall east door

**RM 172:** - One or more interior doors were sticking in the door jamb and were difficult to operate. Recommend that a qualified person repair as necessary. For example, by trimming doors.

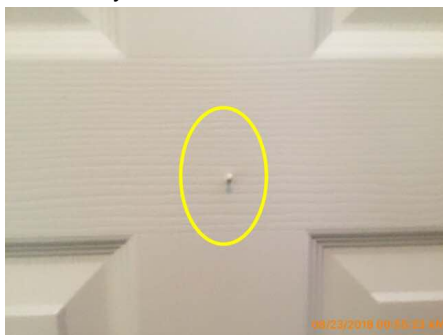
North bedroom

**173:** - One or more interior doors were damaged. Recommend that a qualified person replace or repair doors as necessary.

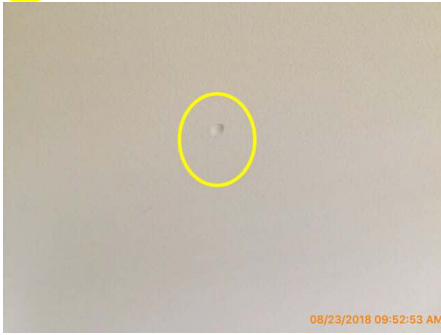
North bedroom

**RR 174:** - One or more doorstops were missing. Wall damage had occurred as a result.

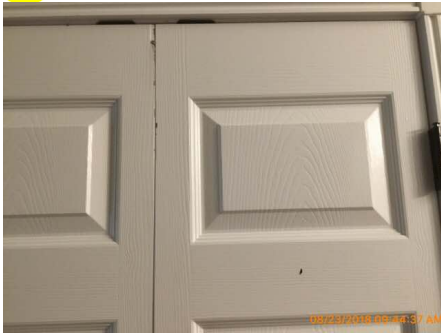
Upstairs Hallway

**RR 175:** - One or more closet doors were damaged.

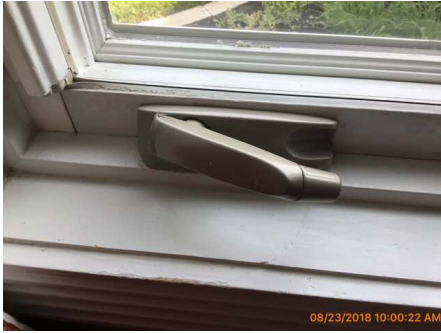
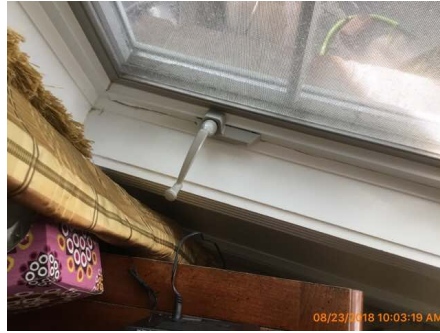
**RR 177:** - Crank handles at some windows were difficult to operate and damaged. Recommend that a qualified person replace handles or make repairs as necessary.

Master bedroom the new crank has been ordered.

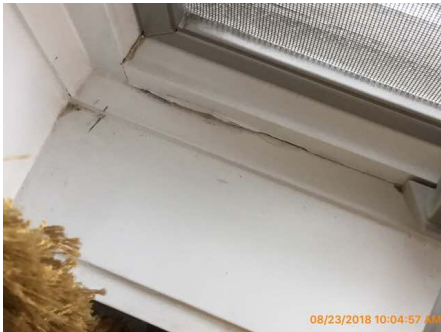
Basement bedroom

**178:** - Evidence of past water intrusion was found in one or more window sills. No elevated levels of moisture were found at the time of the inspection. The inspector is unable to determine the condition of underlying materials. Recommend monitoring these areas in the future especially during times of heavy and/or prolonged rain. If moisture is found in the future recommend a qualified person make repairs.

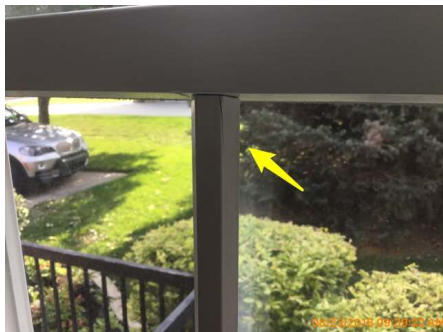
Kitchen

**180:** - One or more windows were damaged.

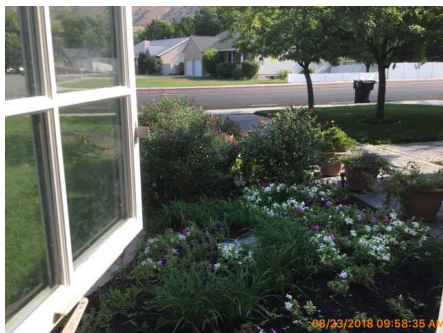
North bedroom

**RR 181:** - One or more window screens were missing. These window(s) may not provide ventilation during months when insects are active. Recommend replacing window screens as necessary.

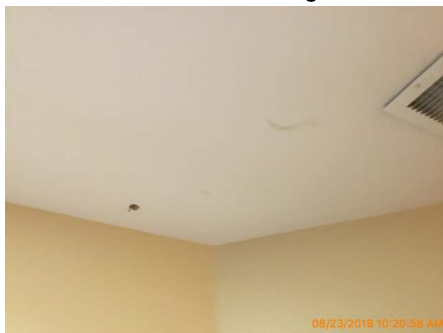
Basement play room.

**184:** - One or more ceilings and walls were damaged.
