INSPECTION REPORT

For the Property at:
123 MAIN STREET
SYKESVILLE, MD 21784

Prepared for: JOHN SMITH
Inspection Date: Friday, December 20, 2019
Prepared by: Christopher Gotsch, CPI

RE: Report No. 1589, v.2
123 Main Street
SYKESVILLE, MD
21784

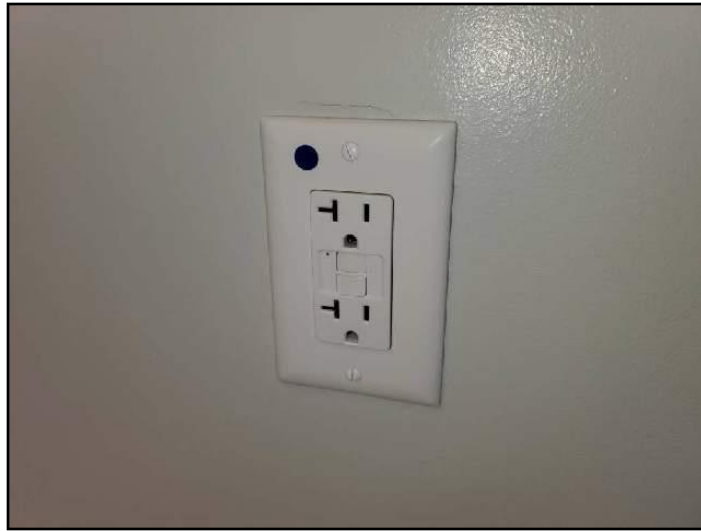
2. **Condition:** • [Loose](#)

Implication(s): Electric shock | Fire hazard

Location: Hallway Bathroom

1. Loose

Task: Repair

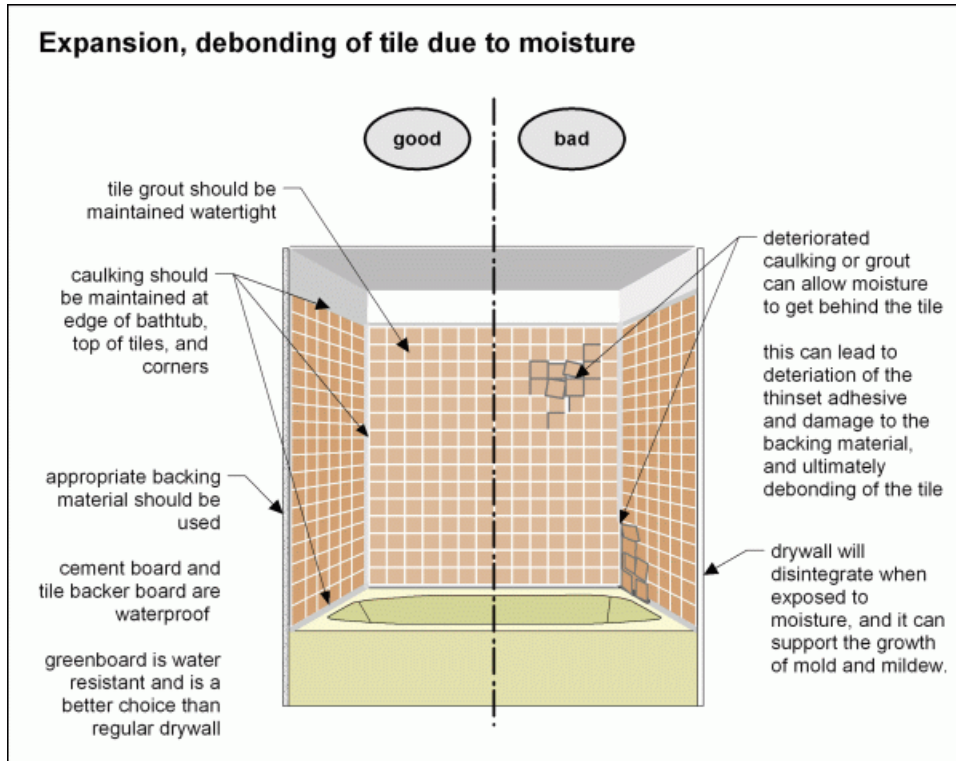
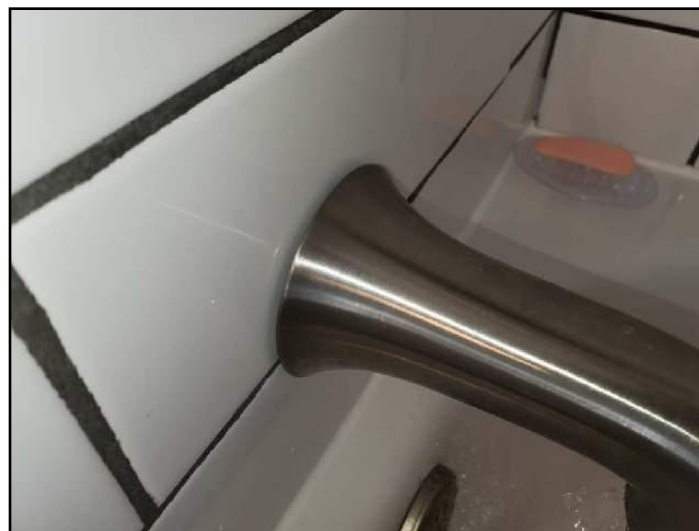
4. Condition: • [Caulking loose, missing or deteriorated](#)

Around tub spout

Implication(s): Chance of water damage to contents, finishes and/or structure

Location: Hallway Bathroom

2. *Caulking loose, missing or deteriorated*

Task: Improve

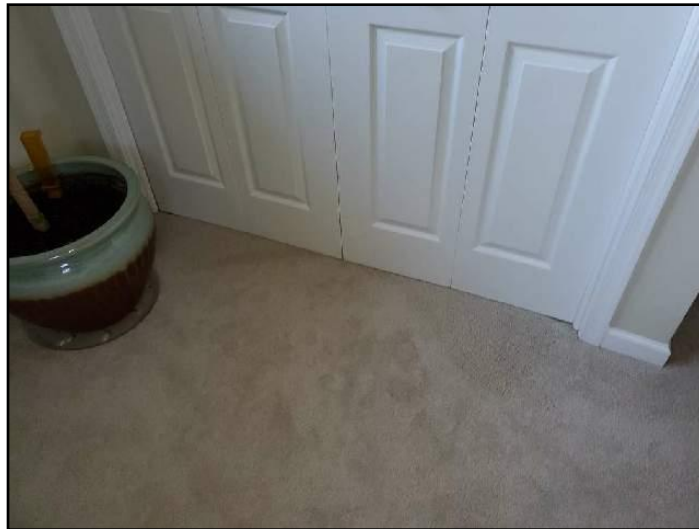
5. Condition: • Interior door is rubbing on the carpet.

Location: Basement Bedroom

3. Interior door is rubbing on the carpet.

Task: Improve

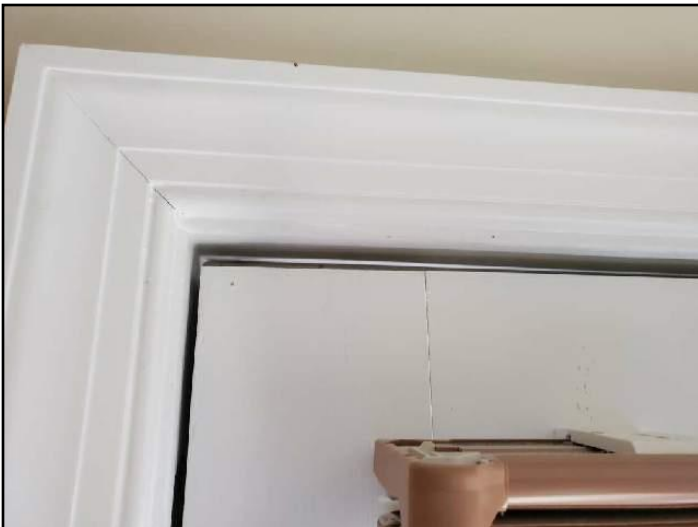
6. Condition: • [Weatherstripping missing or ineffective](#)

Implication(s): Chance of water entering building | Increased heating and cooling costs | Reduced comfort

Location: Front door and door to deck

4. Weatherstripping missing or ineffective

Task: Improve

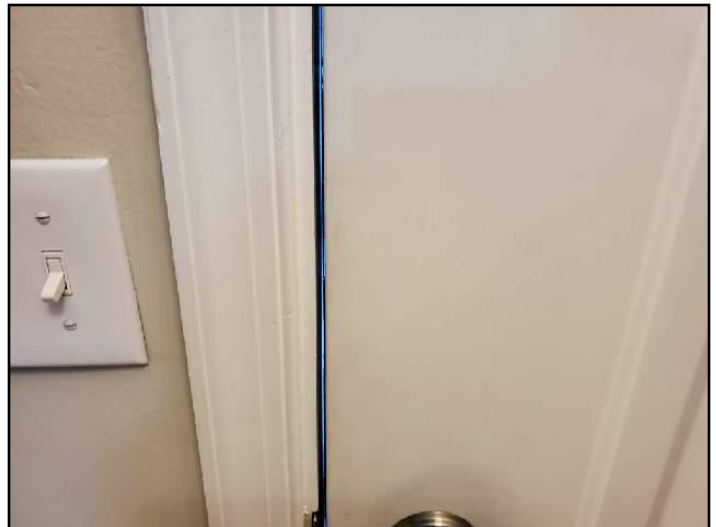
5. Weatherstripping missing or ineffective

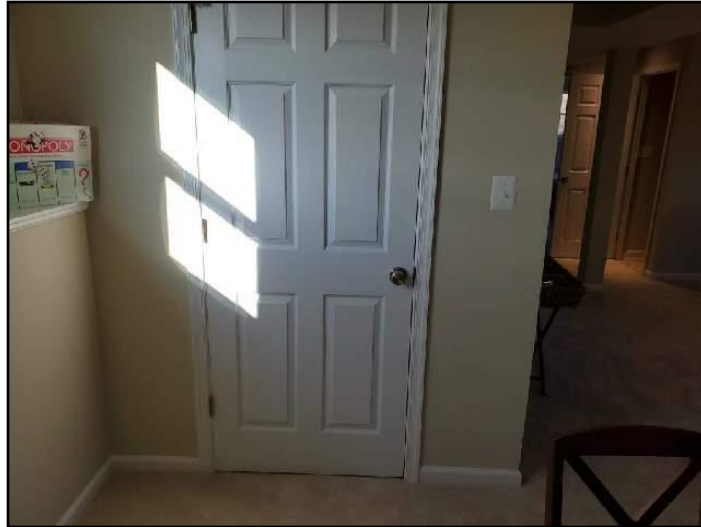
7. Condition: • Does not latch properly

Implication(s): System inoperative or difficult to operate

Location: Basement Closet

6. Does not latch properly

Task: Repair

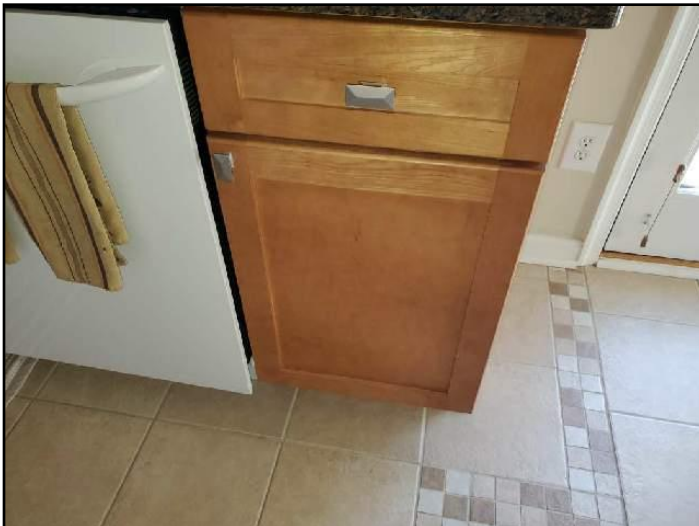
8. Condition: • [Doors or drawers missing or loose](#)

Implication(s): Nuisance | Damage or physical injury due to falling materials

Location: Kitchen

7. Doors or drawers missing or loose

Task: Repair

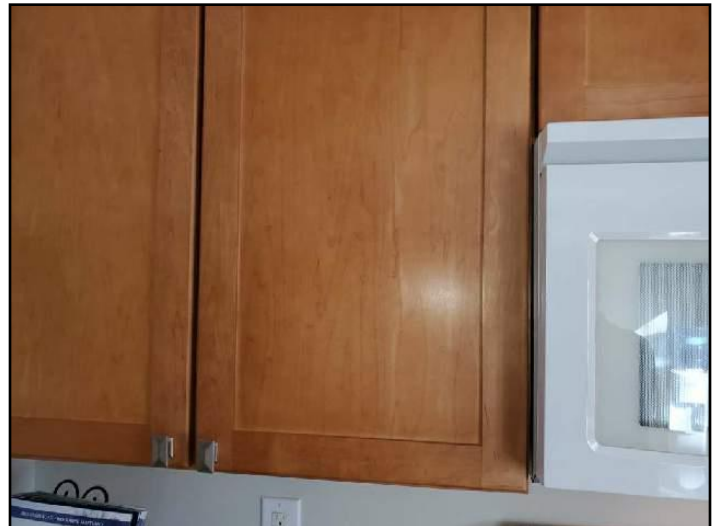
8. Doors or drawers missing or loose

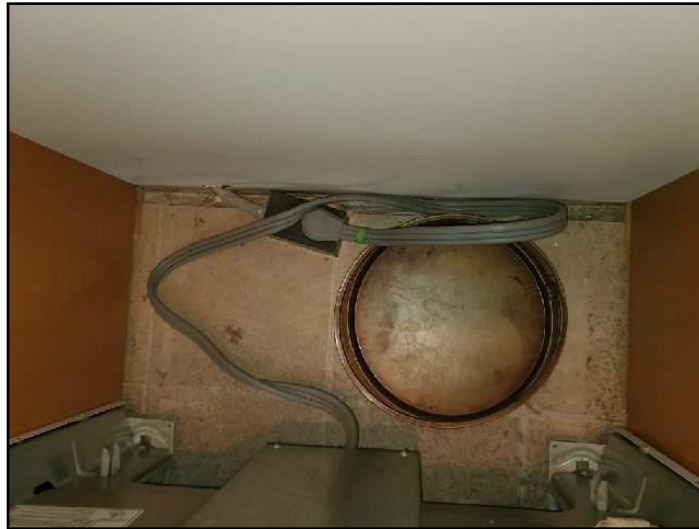
10. Condition: • Anti-tip device missing

Implication(s): Physical injury

Location: Kitchen

9. *Anti-tip device missing*

Task: Replace
