INSPECTION REPORT

For the Property at:
1535 CATALONIA AVENUE
CORAL GABLES, FL 33134

Prepared for: HARRY JORDAN
Inspection Date: Saturday, November 2, 2013
Prepared by: Rick Poston

Report No. 1012, v.0

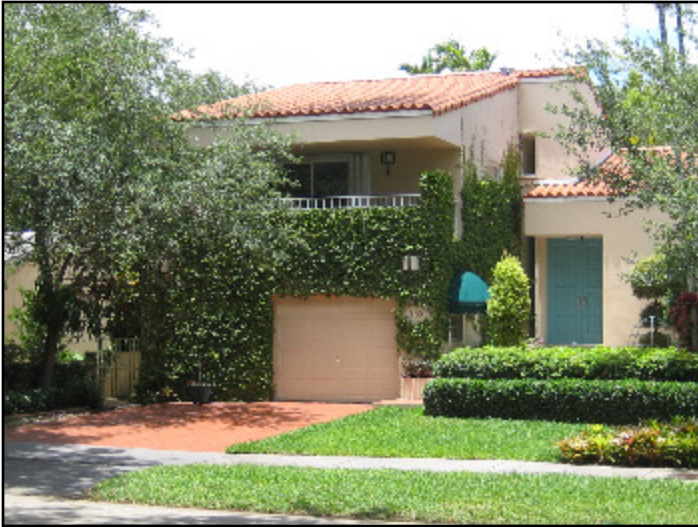
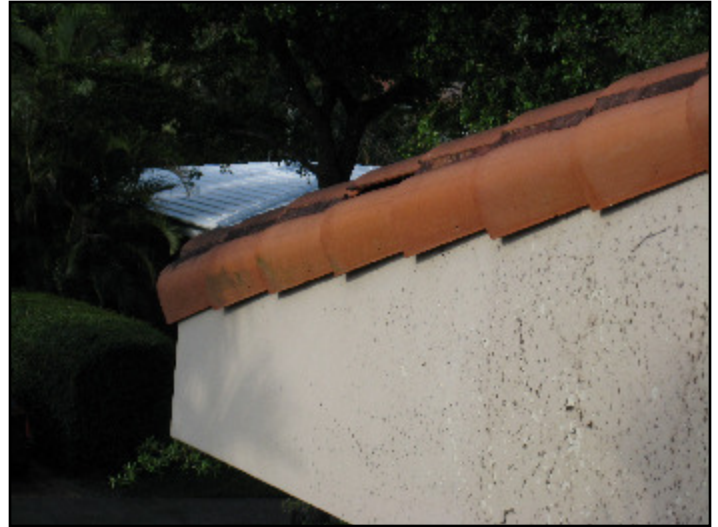
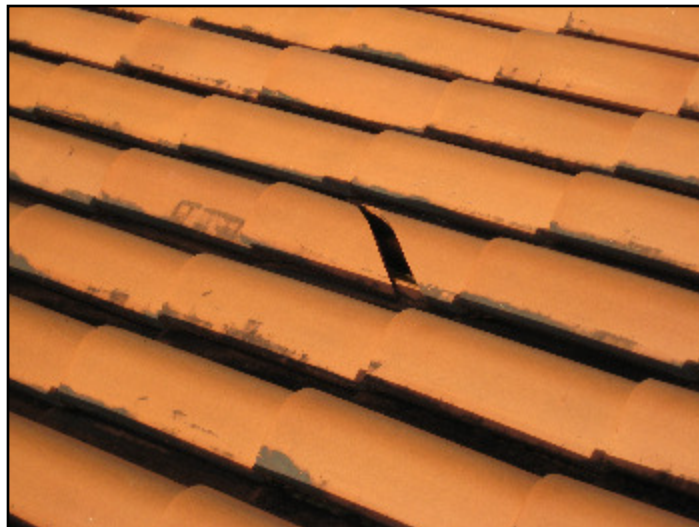
One field tile is cracked and separated. One eave tile on the East elevation has lifted and separated from the bond mortar. In a wind born event, both could eventually lift out of place. A repair is recommended as possible in the future.

Implication(s): Chance of water damage to contents, finishes and/or structure | Damage or physical injury due to falling materials

1. Missing, loose or broken pieces

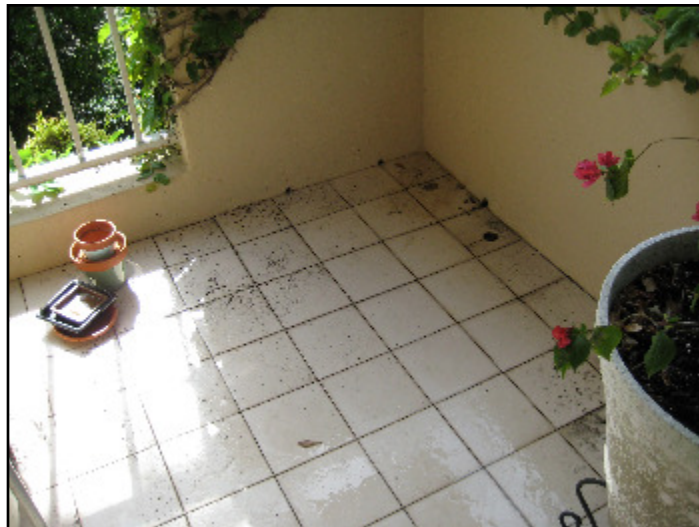
4.

Balcony: • Several small diameter holes are drilled into the floor of the South upper balcony because there does not appear to be any obvious pitch to the tiled floor. In heavy downpours, these are not adequate and water collects. It is possible to install at least one larger drain hole with drain to alleviate this problem as an alternative.

2. • It is recommended that gutters and downspouts be installed on the front and rear elevation roof to divert rain water to the sides of the house and particularly in the back lessen the accumulation of mildew build up on the exterior walls and eliminate a large percentage of the water that accumulates on the floor of the upper front balcony.

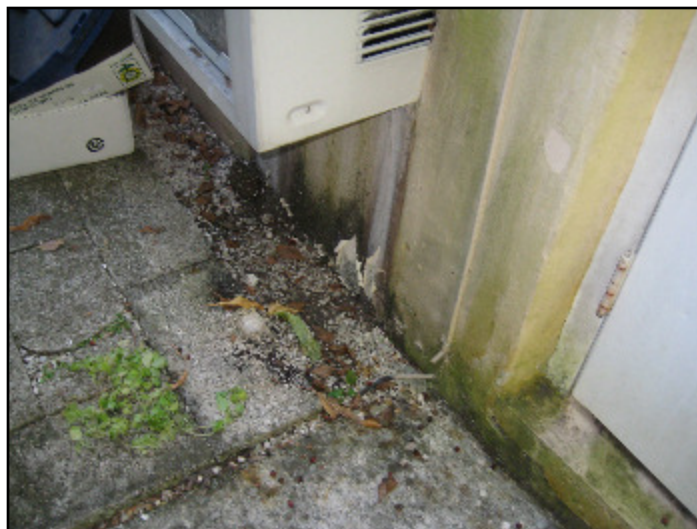
6.

3. Condition: • The wall mounted A/C/ unit on the West side exterior appears to be draining down the wall and deteriorating the paint and eventually the stucco. This could be corrected with a drain hose that could be installed and inset into the ground below the unit.

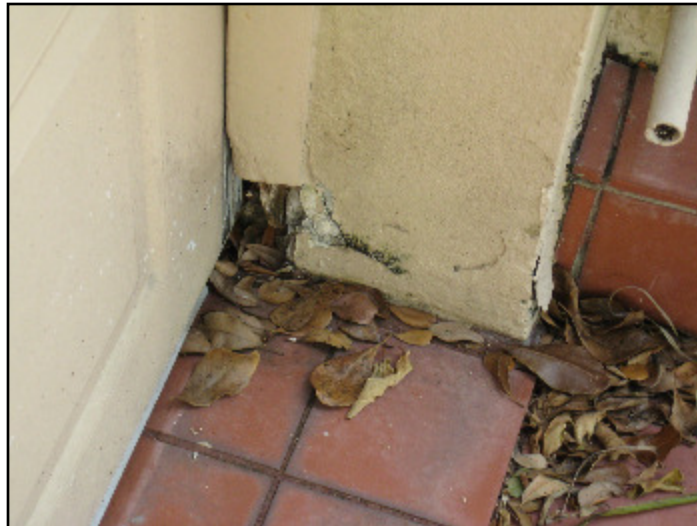
4. Condition: • A small area adjacent the East side of the exterior garage door is collecting water in the drive from perhaps a combination of reasons namely rain run off and condensate from an adjacent A/C drain line. To repair a couple of holes could be drilled in the area and the condensate drain redirected to the front planter area on the opposite side of the walkway and stair. The wood trim section could then be replaced and sealed and protected from further rot. An estimate to cost would be from \$100.00 to \$200.00.

7. Moisture penetration

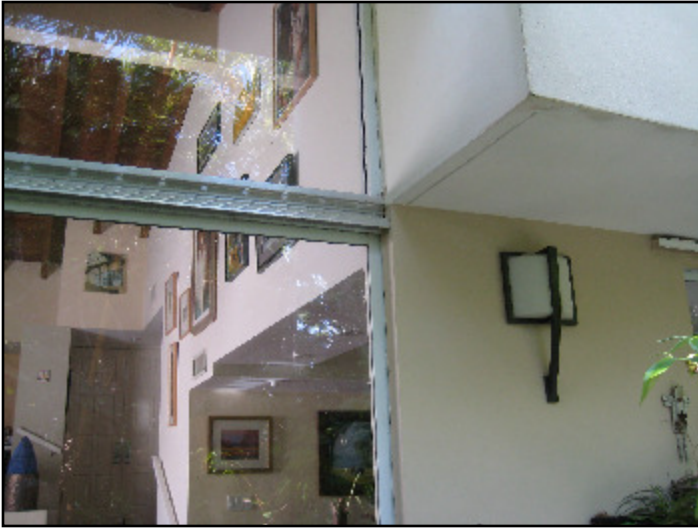
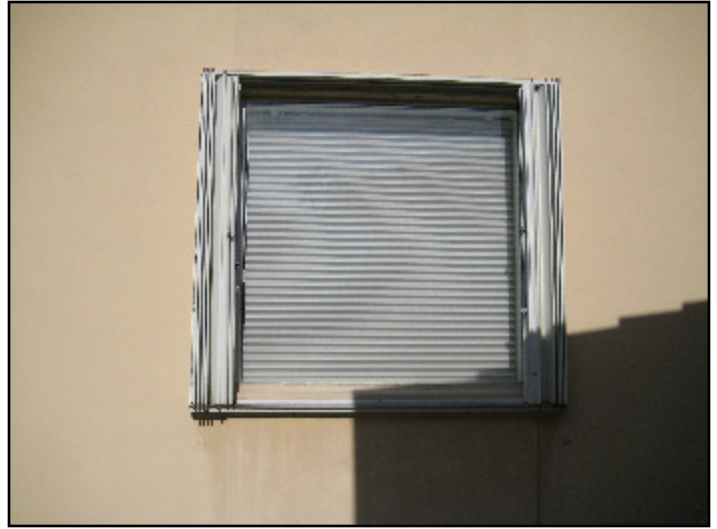
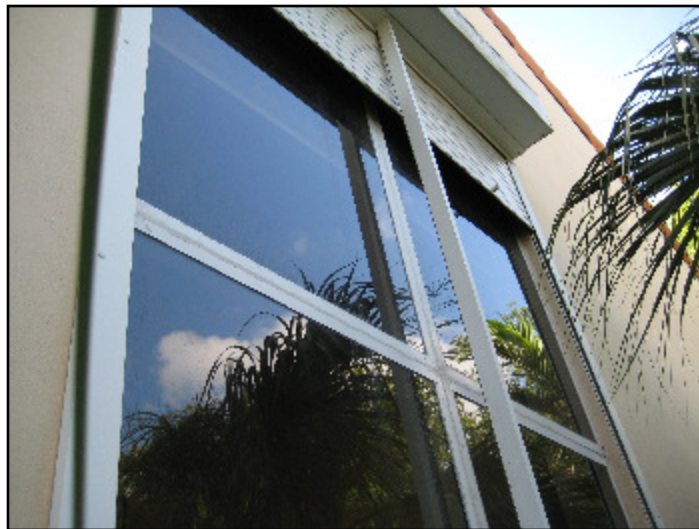
5. Condition: • The glazed openings are provided with a variety of hurricane shutters yet all are not covered for mitigation purposes. The types are illustrated and the large plate windows at the rear of the property have panels cut, stored and provisions for attachment. The plate window adjacent the front entry would need protection as well as the upper bath window on the East elevation of the house to derive a better mitigation value.

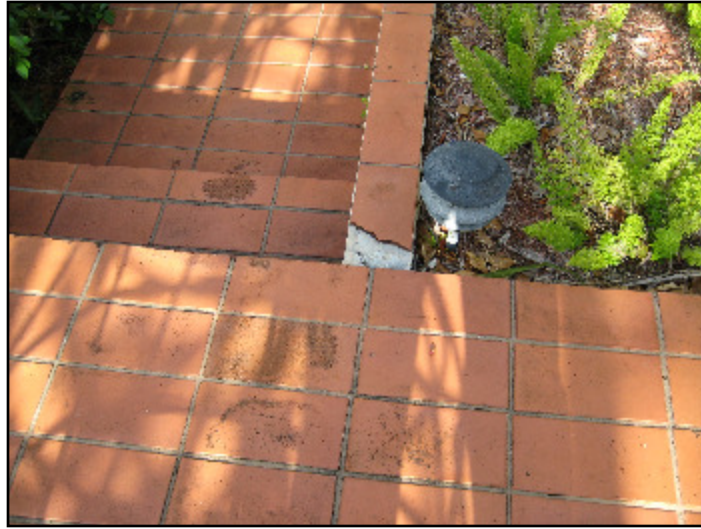
11.

6. Condition: • This tile/paver could simply be replaced in that the color and style are typically readily available. This does not pose a hazard as such.

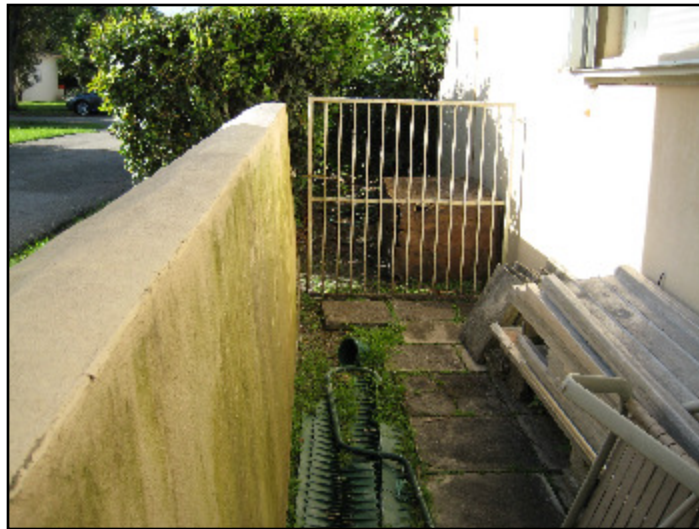
Exterior wall construction: • A standing block and stucco perimeter wall on the East side of the property adjoining a neighbor's property is leaning over toward the neighbor's property but clearly a part of and on the client property. It is recommended that contact be made with your insurance company to discuss a claim for replacing the wall or at the very least demolition of the wall. Replacement cost would be estimated at between 3 and 5 thousand dollars.

12. Leaning

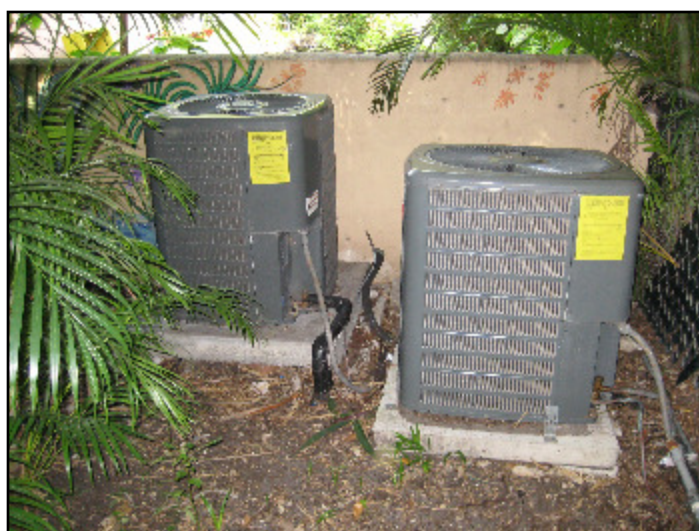
One of the A/C/ outside units at the rear of the yard is out of level and should be corrected to allow an adequate flow of oil to the compressor. This could probably just be corrected by elevating and shimming the low side of the concrete support pad.

Implication(s): Reduced system life expectancy | Damage to equipment

18. Out of level

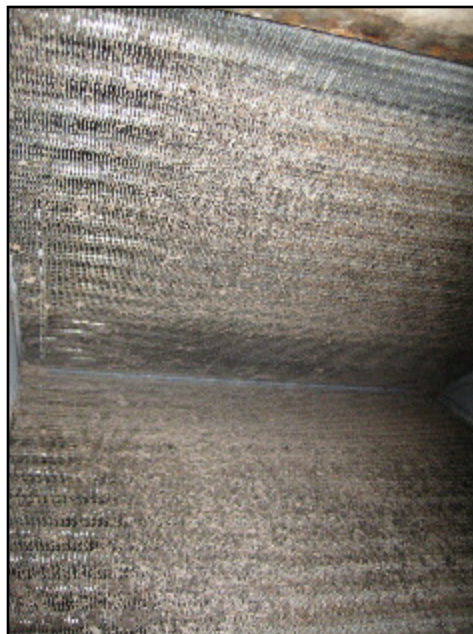
Implication(s): Increased cooling costs | Reduced comfort

19. Dirty

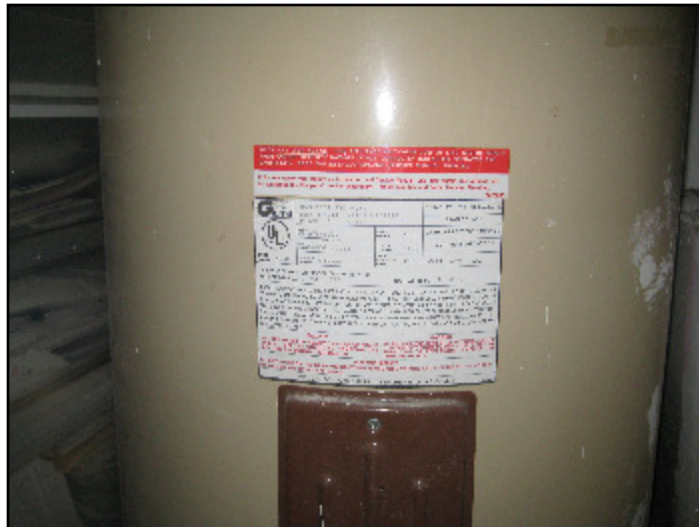
The water heater is a Pur-O-Matic, 52 gallon and was manufactured in 1981. There does not appear to be any obvious exterior deterioration.

The water heater is passed its normal service life of 15 years and consideration should be to replace it as able or at the very least have it drained and refilled.

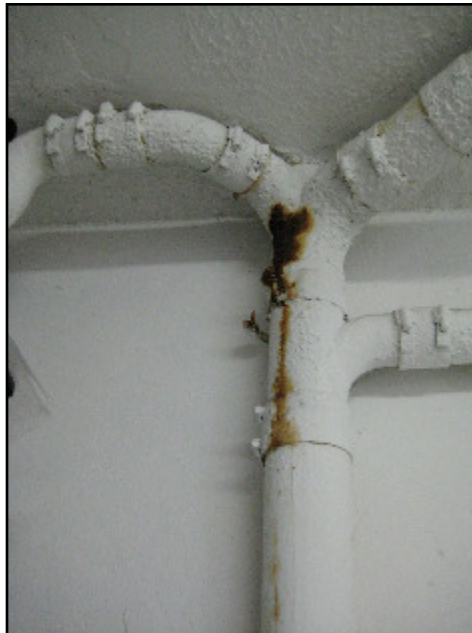
22.

12. Condition: • A "Y" connector at a waste vent pipe adjacent the laundry is corroded and has a slow leak which will eventually develop into a problem if it is not replaced.

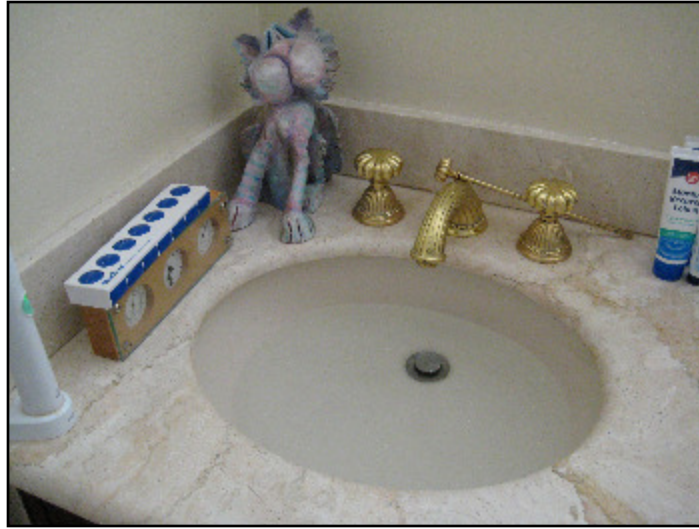
13. Condition: • [Slow drains](#)

23. *Slow drains*

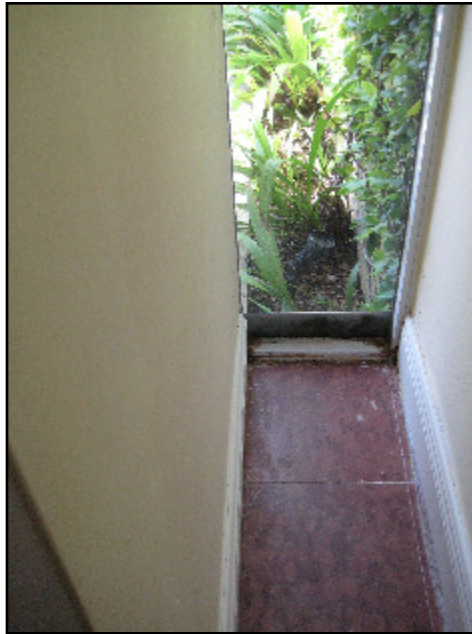
All wall finishes appear to be in good condition generally. There appears to be some water intrusion around or beneath the long fixed glass window adjacent the front door which should be investigated and perhaps resealed.

24. *Plaster/drywall*

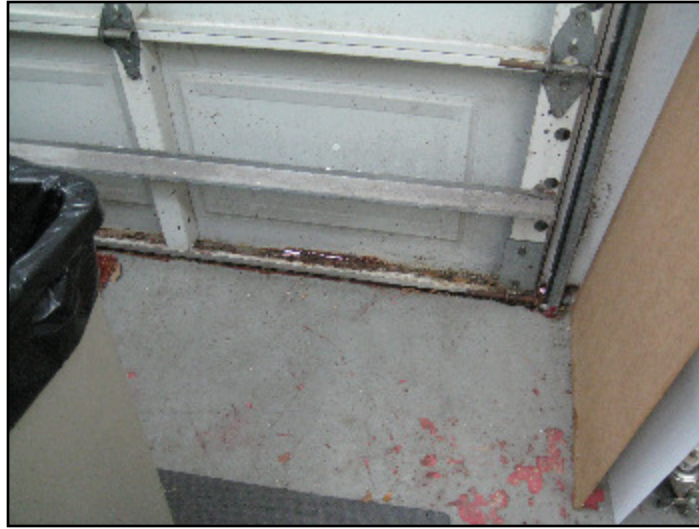
26.

15. Condition: • [Rusted or dented](#)

Implication(s): Material deterioration

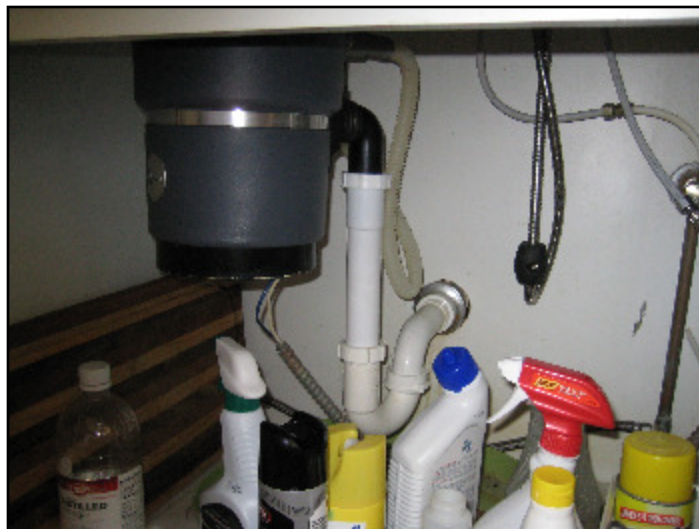
The electrical cable to the disposal needs to be reconnected properly to the clamp at the bottom of the unit. This is a safety hazard.

29. *Loose/ Missing wire clamp*

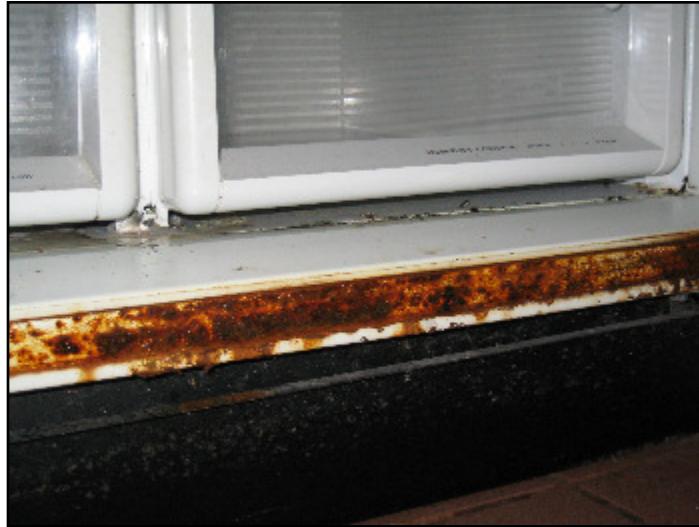
The Sub Zero refrigerator is original to the house and shows signs of failure and deterioration particularly at the base where there is evident rust and some accumulated mold. The unit should be serviced with options recommended.

30. High failure probability
