Home Inspection Report

Sample , Greenwich , CT 06830

Sunday, August 16, 2020

1st Selection Home Inspection

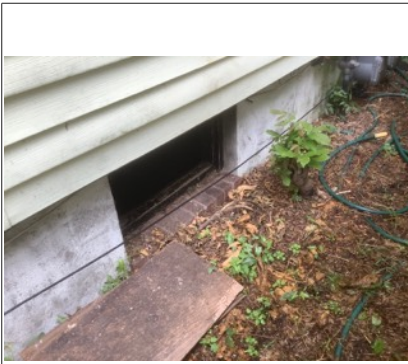
Improve crawl spaces access

Crawl spaces Repair: Both (2) crawl space windows should be replaced. A quality window with heavy gauge screen to prevent vermin entry is recommended. Improving the ventilation in the crawl space is the goal. Improve: By replacing both crawl space windows we can achieve a cross ventilation of the crawl space.

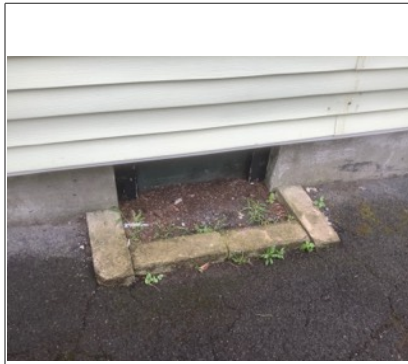
Crawl space windows require replacement

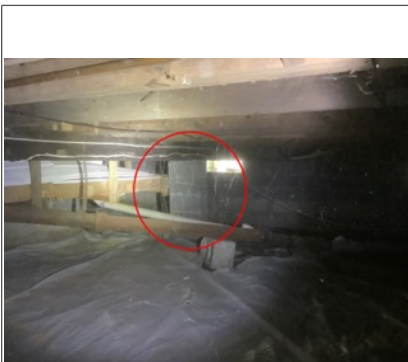
Repair: The support column is out of plumb suggesting settlement. Consult a licensed professional for further evaluation and repairs.

Repairs to support columns are recommended

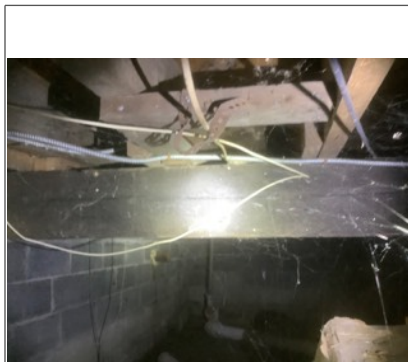
Repair: A beam is cracked. Further cracking or movement risks serious structural movement and damage. Re-supporting this beam is recommended.

Beam cracks

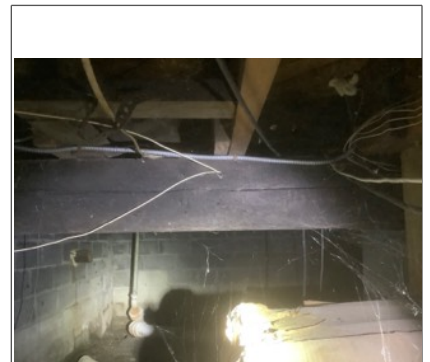
Beam cracked

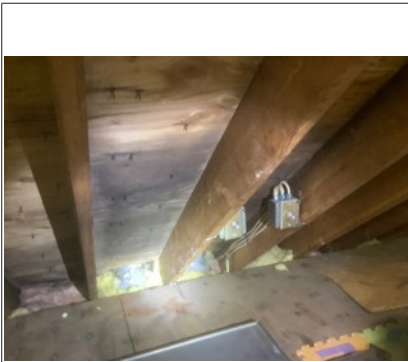
Repair: A mold like substance was observed on the roof sheathing/ plywood. Consult a licensed mold professional for further evaluation and repairs.

Mold like substance observed on roof sheathing

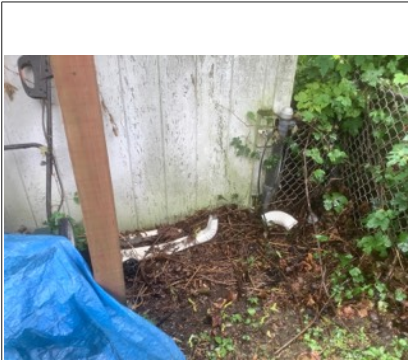
Wood to soil contact observed

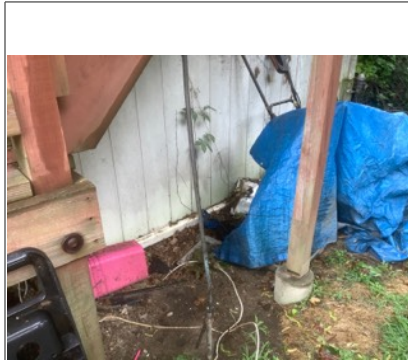
Wood to soil contact observed

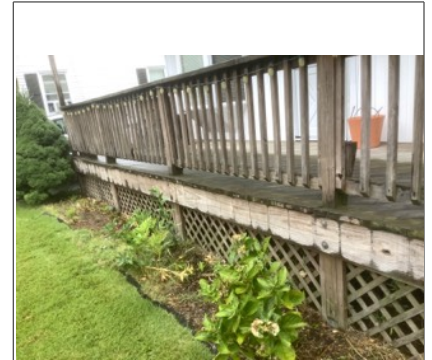
Wood to soil contact contact

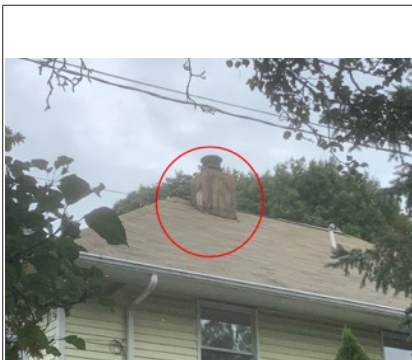
Masonry and flashing repairs should be anticipated

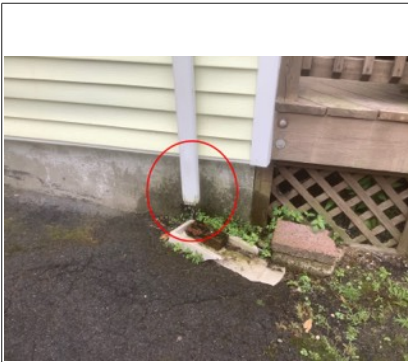
Repair: The downspout(s) should discharge water at least five (5) feet from the house. Storm water should be encouraged to flow away from the building at the point of discharge.

Downspouts discharging close to home

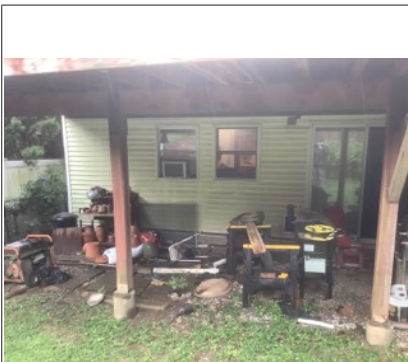
Power washing vinyl is recommended

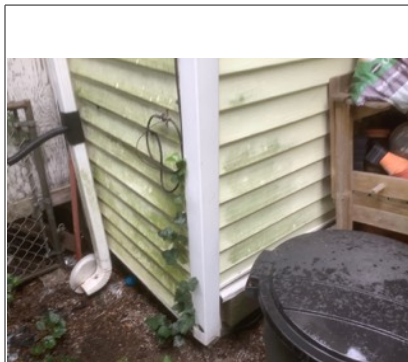
Moss build up on vinyl

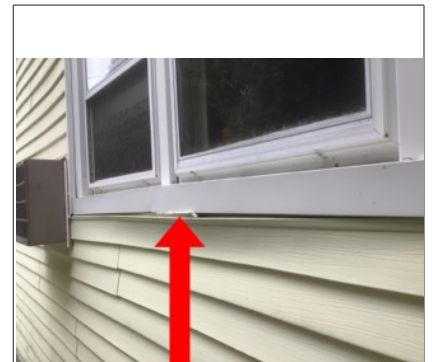
Caulking and siding repairs

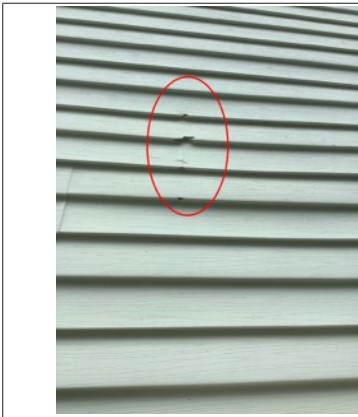
Holes in siding

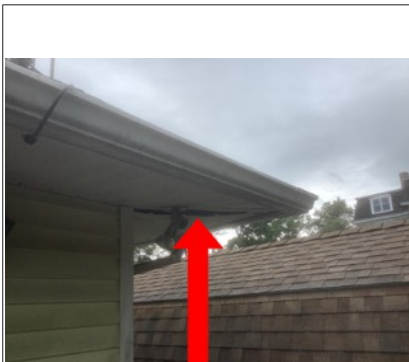
Repair: Openings in the soffit have become vermin entry points. Soffit requires repairs. Consult a licensed pest technician for pest control and maintenance.

Vermin entry points

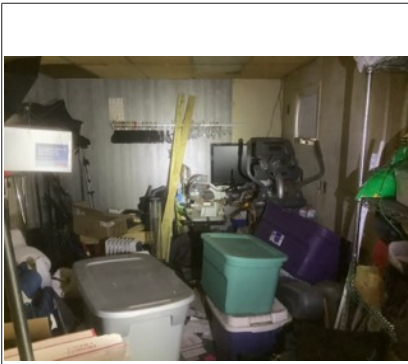
Significant clutter and debris

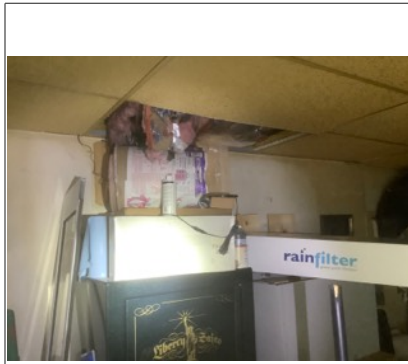
Repair: Water damage was observed at the interior finishes of the detached garage. This condition suggests prior leaks.

Water damage

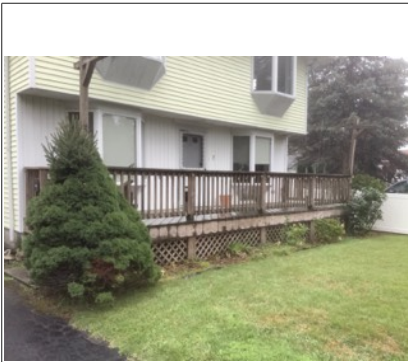
Wood to soil contact

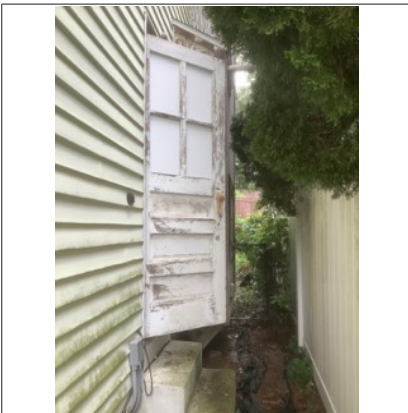
Repair: The exterior staircase to the boiler room requires railings.

No railings

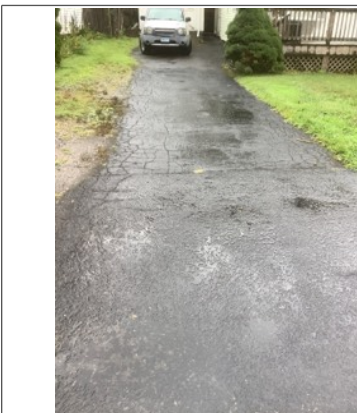
Repair/Monitor: Typical cracks and deterioration was observed at the driveway. The best long-term approach is resurfacing the driveway. The driveway should be sealed annually to prevent further deterioration.

Typical cracks and deterioration observed

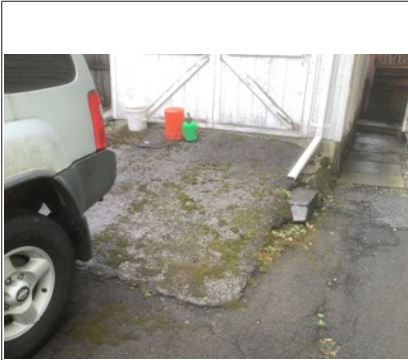
Cracks and deterioration observed

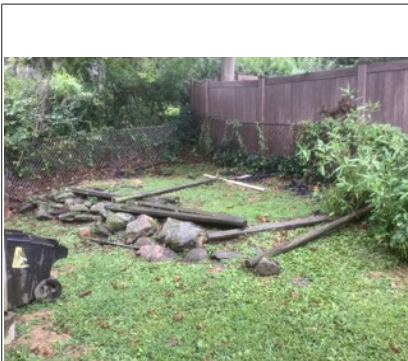
Retaining wall Repair/ improve: The retaining wall requires rebuilding.

Rebuilding required

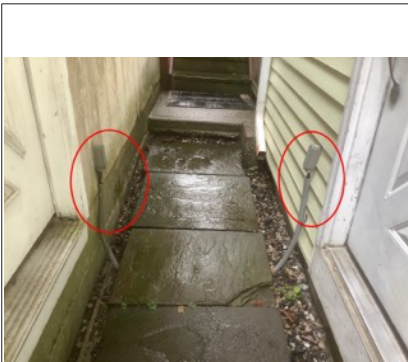
Distribution wires Repair: Abandoned wiring should be removed or appropriately terminated with a box and cover.
 Safety Issue: All junction boxes should be fitted with cover plates, in order to protect the wire connections.

Open conduit / moisture penetration

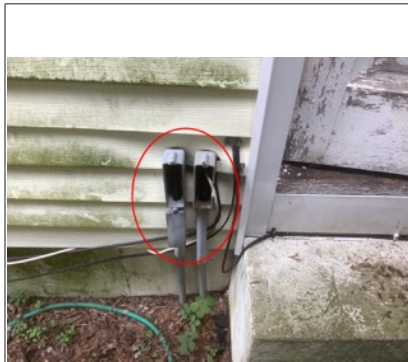
Abandoned manifold

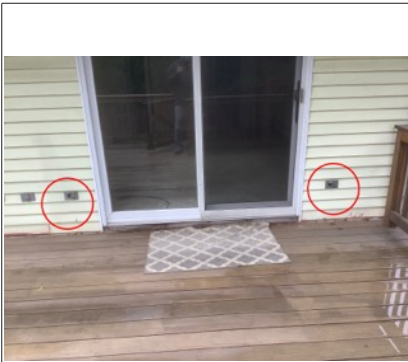
Repair/Safety Issue: The installation of a ground fault circuit interrupter (GFCI) is recommended. A GFCI offers increased protection from shock or electrocution.
 Repair: An outlet is damaged. It should be replaced.

Not Gfci protected

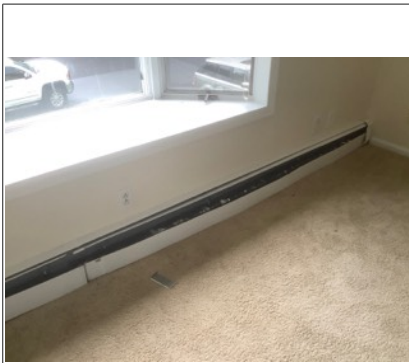
Baseboard heater Repair: Damaged baseboard heaters require replacement.

Damaged baseboard heater

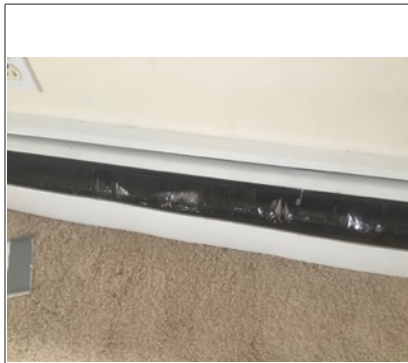
Damaged baseboard heater

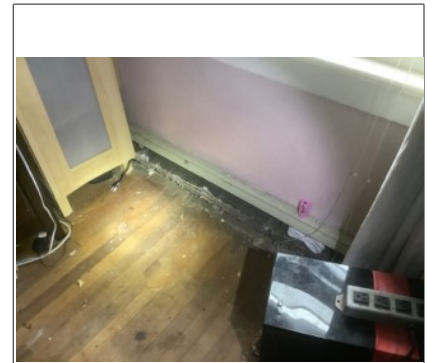
Damaged baseboard heater

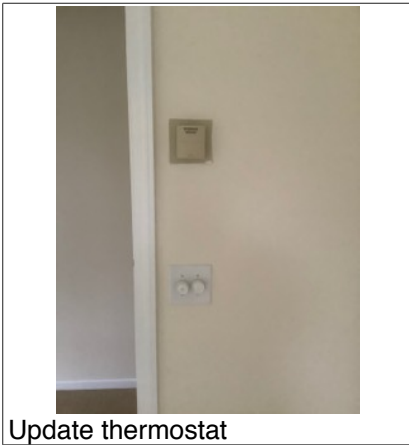
Thermostat Monitor: The thermostat is old and may be temperamental. Consider NEST thermostat.

Update thermostat

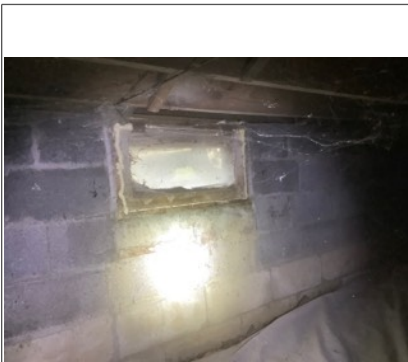
Replace windows

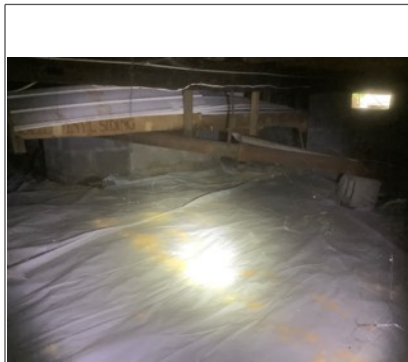
Vapor barrier adjustments

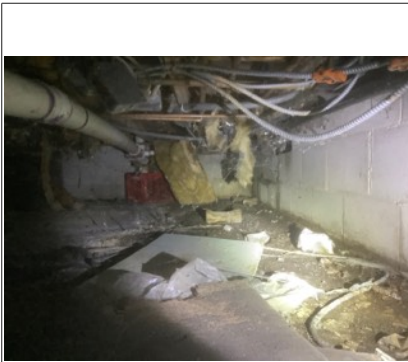
Loose and damaged insulation

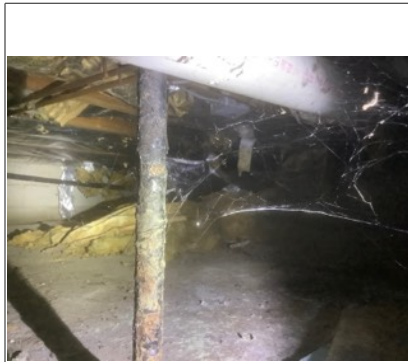
Loose and damaged insulation

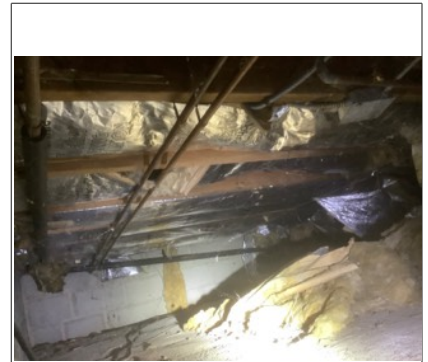
Insulation in floor above crawl space is installed upside down

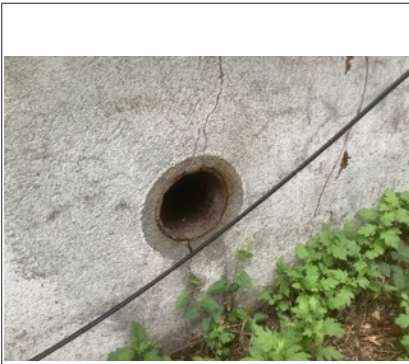
Waste pipe vent / no grill cover

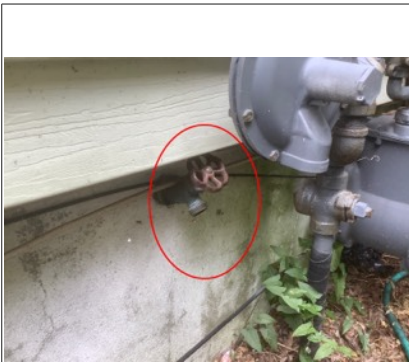
Repair: It is recommended that an anti-siphon device be added to the hose bib(s). The anti-siphon device serves to prevent chemicals from getting into the house water supply when mixing chemicals for exterior landscaping.

Update hose bibs

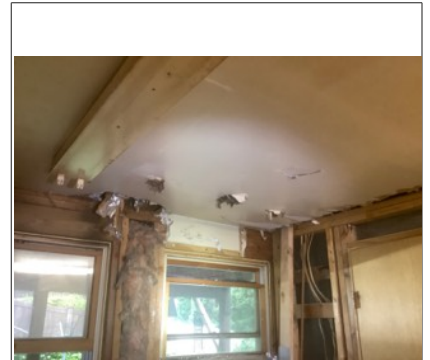
Wall / ceiling finishes Repair/Monitor: The first floor unit is in significant disrepair. Major repairs and renovations to the interior walls, ceilings and floors will be required to bring the homes interior to a livable standard. Expect a complete "Gut" renovation of the first floor unit!

Damaged Sheetrock

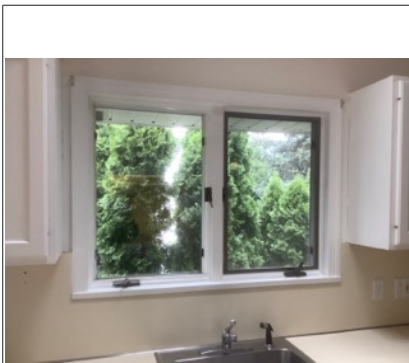
Repair: The windows are in mild disrepair. This is a common condition that does not necessitate immediate major repair. Trimming and adjustment, hardware improvements and glazing repairs would be logical long term improvements. In practice, improvements are usually made on an as needed basis only. The most important factor is that the window exteriors are well-maintained to avoid rot or water infiltration.

Damaged window hardware
missing window screens

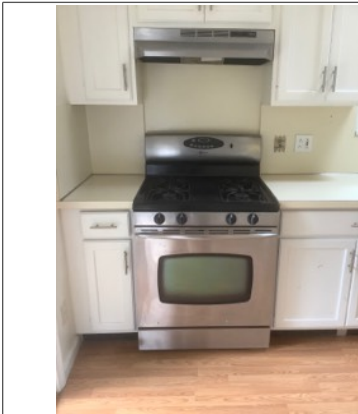
Gas range unit Monitor: The gas range is an old unit. While replacement is not needed right away, it would be wise to budget for a new range. In the interim, a higher level of maintenance can be expected.

Gas range old

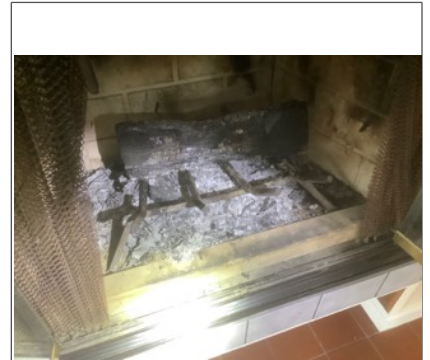
Fireplace Repair: The fireplace chimney should be inspected and cleaned prior to operation.

Cleaning required
