Inspection Report

Robbins Services, Inc.

Property Address

1007 USA Drive, Shield City, FL 34685

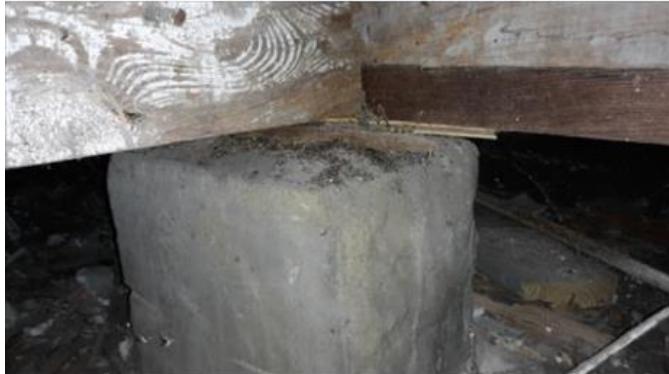
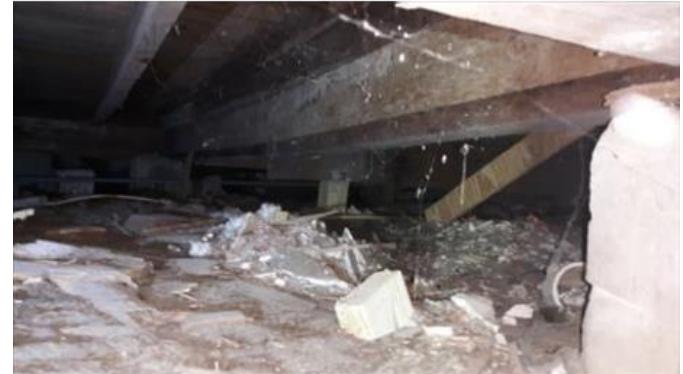
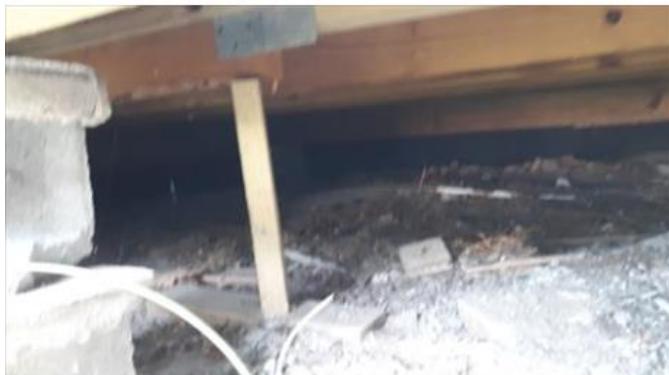
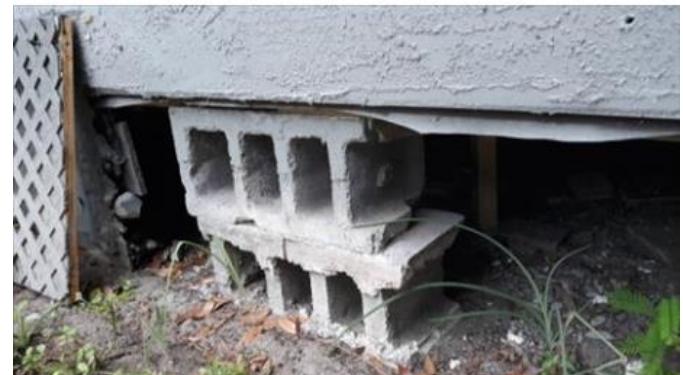
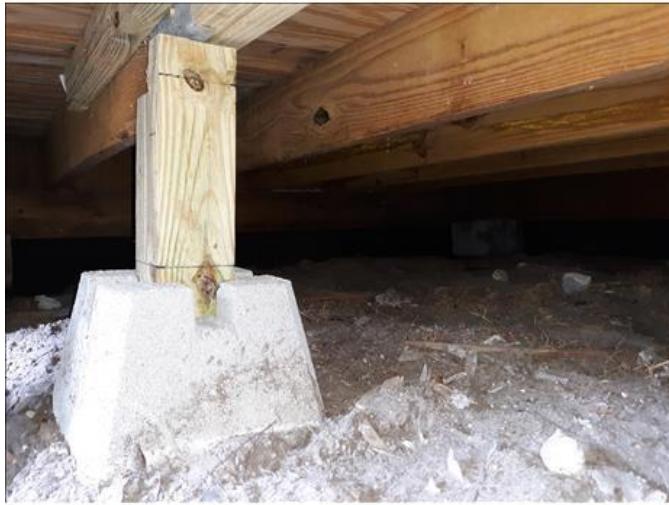
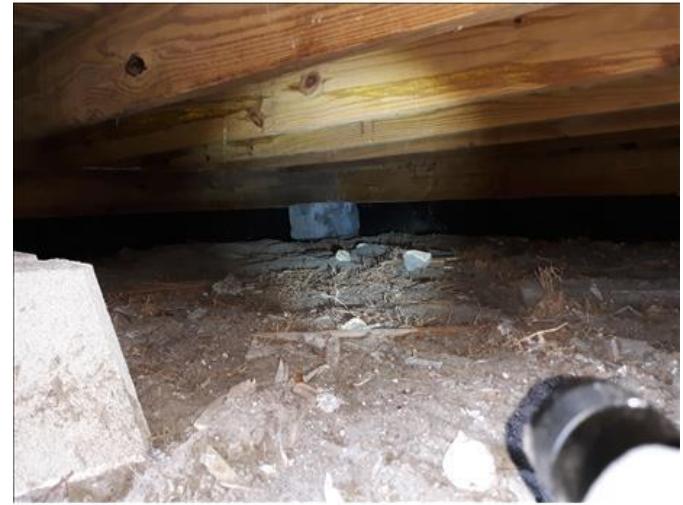
Unprofessional / temporary support was observed at center beam and kitchen. Floor joists and / or beams were supported by wood simply propped under them. Although no immediate concern was observed, client should contact a qualified contractor for further information and / or evaluation.

Re-inspection 10/2/19 - New supports have been added at the center beam and kitchen. Loose concrete blocks have been added for added support and are still in use at the rear bedroom, these piers generally require proper footers to support the excessive weight of the home. Deck post supports and loose blocks are generally not considered structurally sound for use in home foundations. The ground did not appear to have been disturbed as expected for footers to have been added, however the inspector is unable to comment on whether pier footers were added or repaired since they are underground and generally concealed from view. Generally, the contractor would add a vapor barrier once foundation work is completed to help avoid future issues. If the work was performed by a contractor familiar with crawlspace foundations and conditions; I recommend you obtain a warranty from the contractor in writing guaranteeing the work and that the improvements were made per approved construction standards.

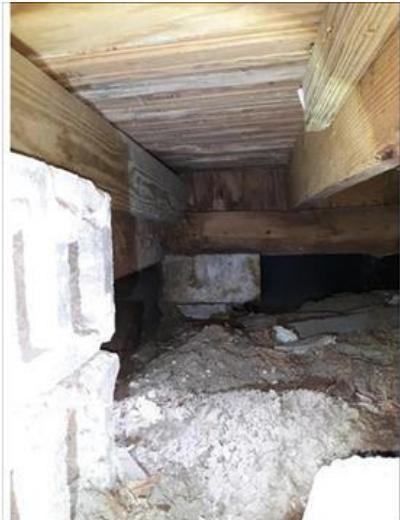
Re-inspection 10/2/19 - Concrete Blocks, Rear Bedroom

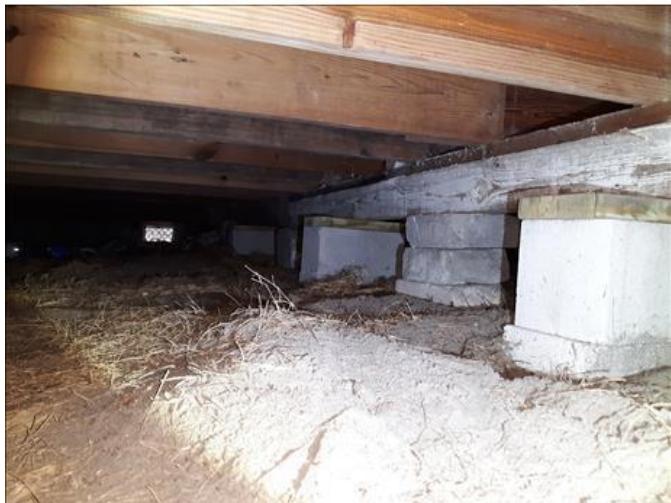
Sagging framing components were observed at numerous areas. Recommend further evaluation and repair as needed by a qualified / licensed contractor.

Re-inspection 10/2/19 - Sagging and deterioration of beams and joists can be excelled by moisture and poor footers. It is likely these will take years to straighten out and may never fully repair themselves. If the work was performed by a contractor familiar with crawlspace foundations and conditions; I recommend you obtain a warranty from the contractor in writing guaranteeing the work and that the improvements were made per approved construction standards.

Re-inspection 10/2/19 - No moisture barrier

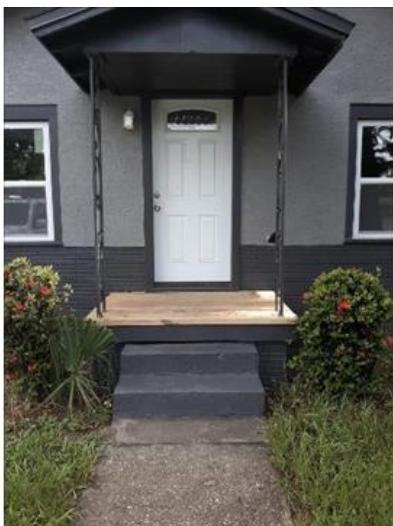
The heights of the various risers at one or more of the staircases are not uniform. This creates a potential trip hazard. Generally, industry standard dictates that "step risers" (the vertical distance from one step up to the next) not exceed 7-3/4" high and all be within 3/8" of the smallest riser. A "Licensed Carpenter or General Contractor" should repair or modify the stairs to ensure they are safe.

Re-inspection 10/2/19 - Not Corrected

Recommend adding handrails to all exterior steps for safety.

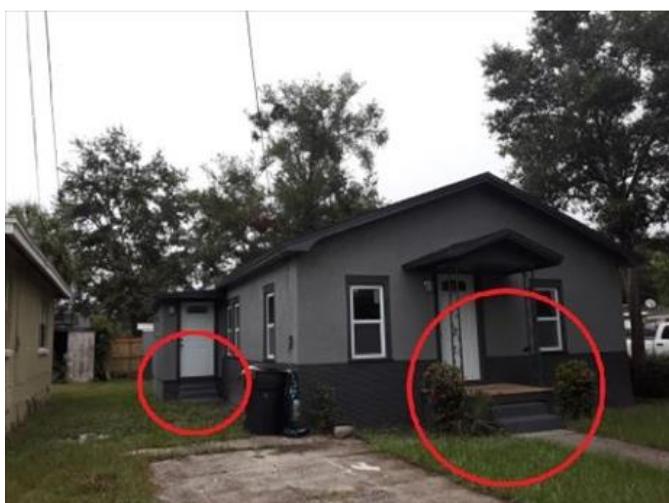
The heights of the various risers at one or more of the staircases are not uniform. This creates a potential trip hazard. Generally, industry standard dictates that "step risers" (the vertical distance from one step up to the next) not exceed 7-3/4" high and all be within 3/8" of the smallest riser. A "Licensed Carpenter or General Contractor" should repair or modify the stairs to ensure they are safe.

Re-inspection 10/2/19 - Not Corrected

Recommend adding handrails to all exterior steps for safety.

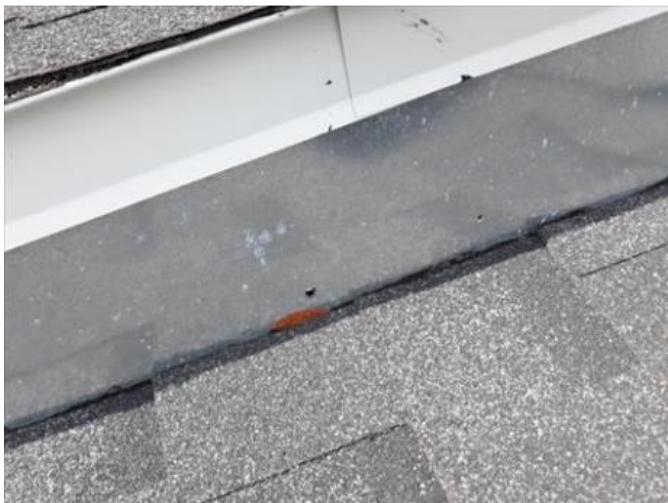
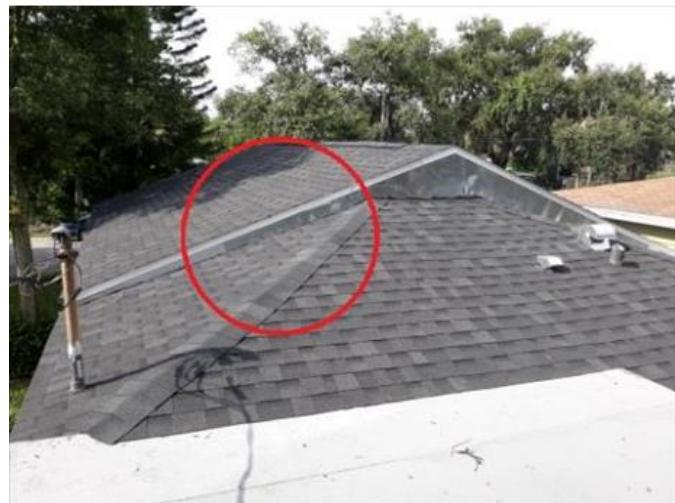
All exposed fasteners should be sealed to deter moisture penetration.

Re-inspection 10/2/19 - Not Corrected

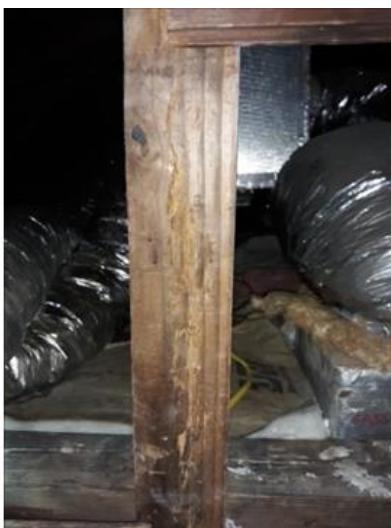
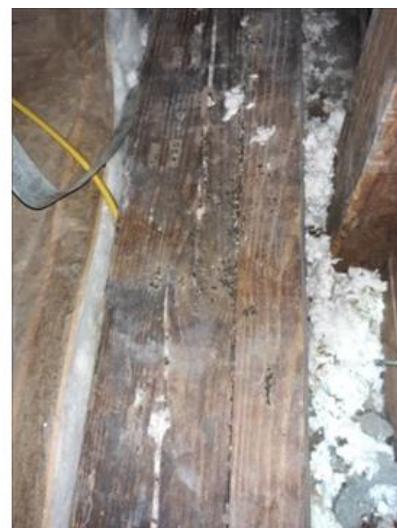
Excessive structural damage from past moisture leaks and termites are present in rafters and webs. Due to conditions observed, recommend further evaluation by a licensed structural engineer.

Re-inspection 10/2/19 - Completed satisfactory. Structural support has been added throughout the entire attic.

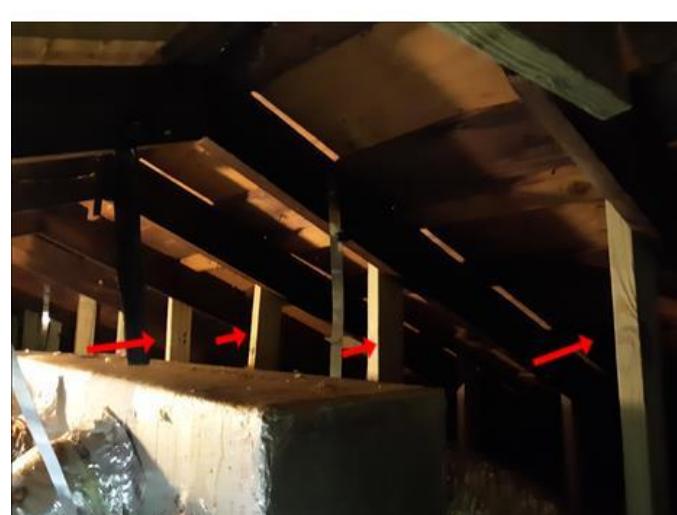
Re-inspection 10/2/19 - Improved supports

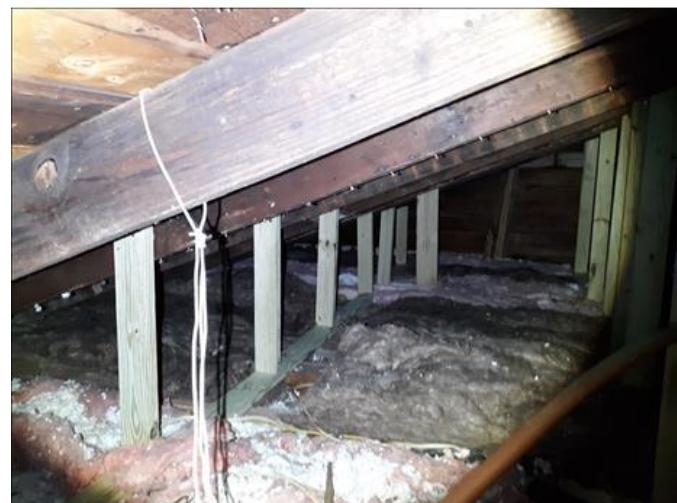
Re-inspection 10/2/19 - Improved supports

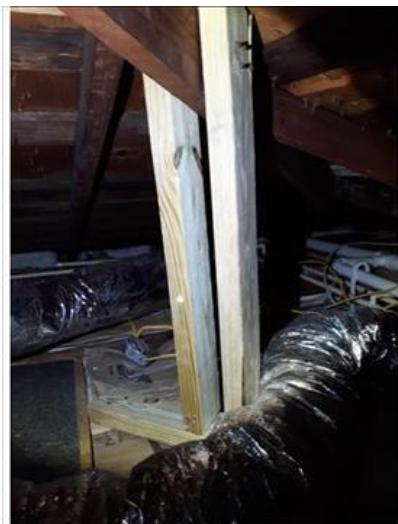
Re-inspection 10/2/19 - Improved supports

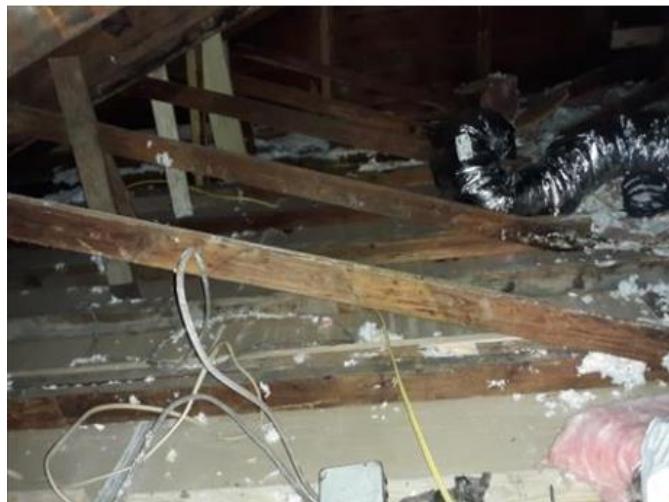
The insulation provided has poor coverage in the entire front of home. Additional insulation is recommended.

Re-inspection 10/2/19 - Not Corrected

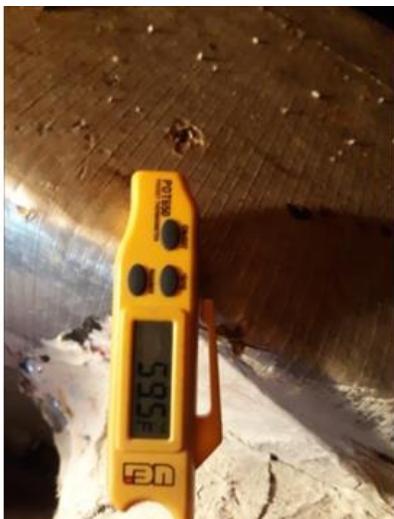
Supply

An ambient air test was performed on the cooling system to determine if the difference in temperatures of the supply and return air are between 15 degrees and 22 degrees, which indicates that the unit is cooling within industry standards. The return air temperature on the system was 82.3 degrees, and the supply air temperature was 58.4 degrees. For a temperature differential of 23.9 degrees. This indicates that the unit is NOT cooling within standards and may not be working properly. It is recommended that the service documentation be obtained from a licensed Heat/Air contractor verifying the unit is operating properly.

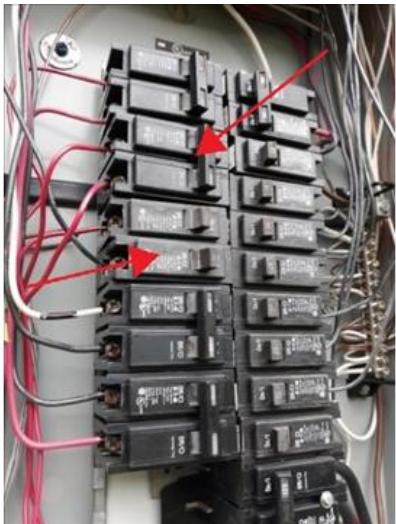
Loose breakers

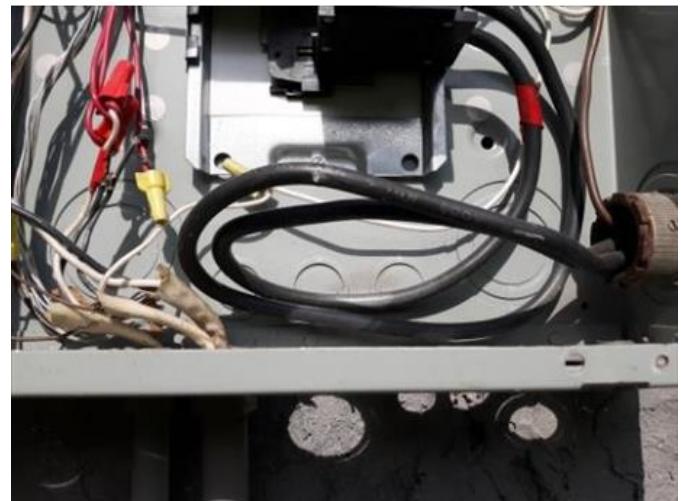
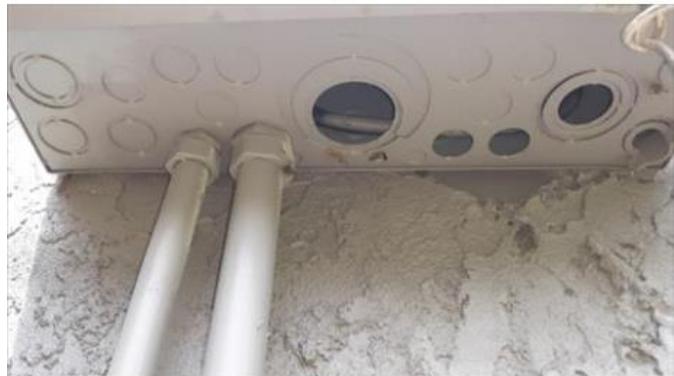
Missing knockouts

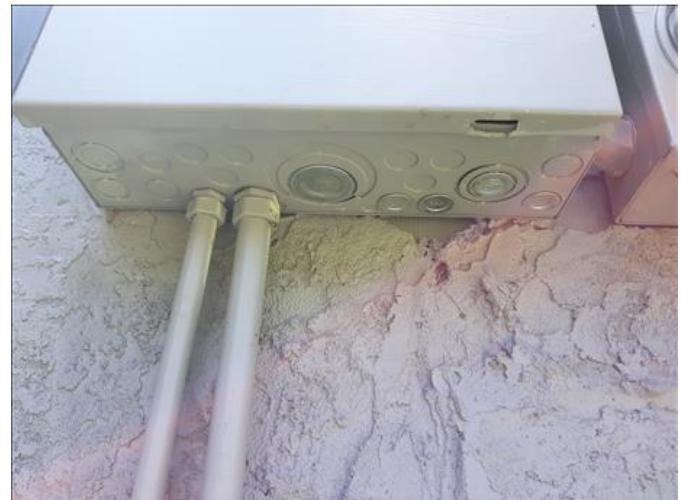
Re-inspection 10/2/19 - #4 Knock-out plugs added

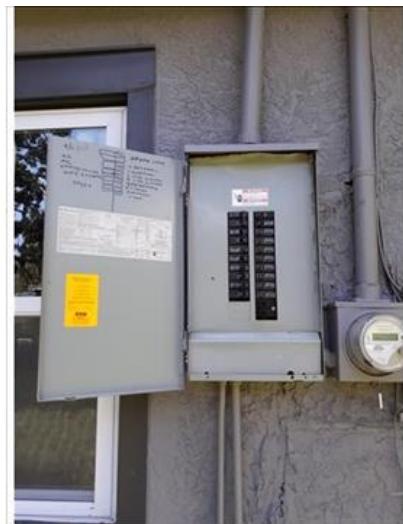
Re-inspection 10/2/19 - #2 Bolt securing dead front plate

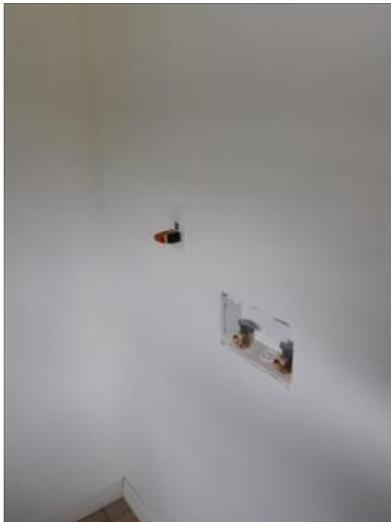
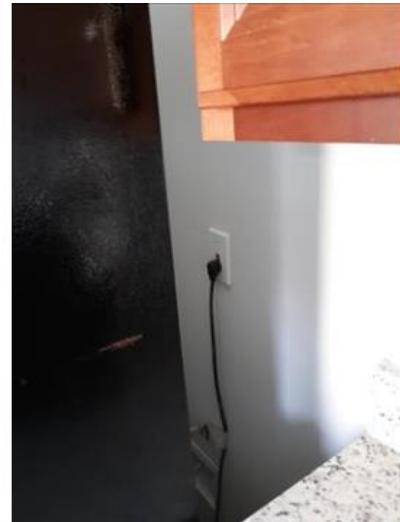
1. GFCI outlet are commonly used to control multiple outlets from one GFCI outlet. The GFCI outlets in the kitchen in the laundry room are all linked together and although this is not an issue it is unnecessary. You may need to press multiple GFCI in order to reset them all.
2. I strongly recommend against plugging any freezer or refrigerator in the garage into any electrical receptacle that is protected by a GFCI receptacle or circuit breaker. GFCI breakers and receptacles are prone to "nuisance tripping." If this happens, the refrigerator or freezer will shut down, and perishables can spoil. I recommend installation of a dedicated breaker and line from the main electrical panel to a single use receptacle for the appliance.

Re-inspection 10/2/19 - Not improved

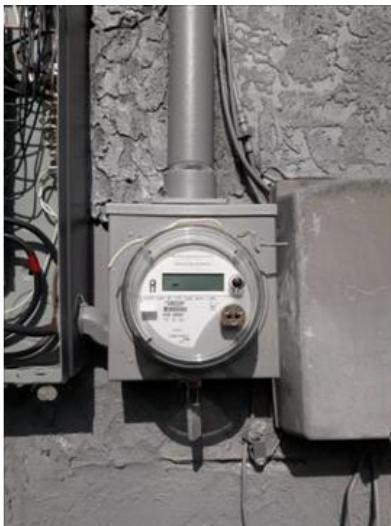
Completed satisfactory - Electrician replaced main breaker with 100 amp to match meter can size.

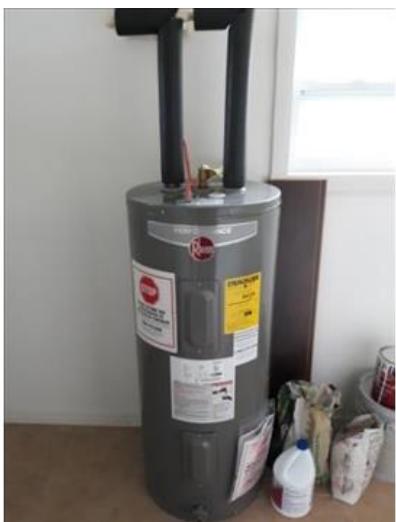
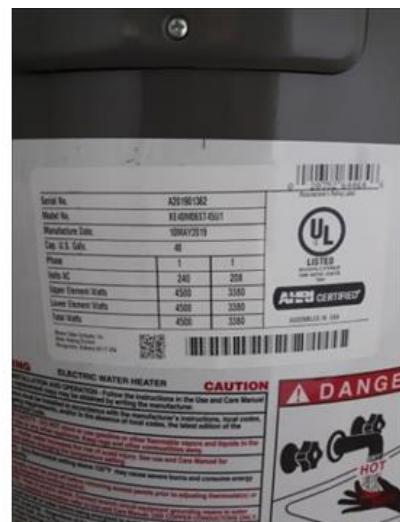
Install an overflow pan under the water heater that is required as of 2009 when water heaters are installed in attics or interior finished areas. The pan drain should also be routed to the exterior of the home. Failure of the unit and the resulting water could leak into finished areas causing substantial damage.

Re-inspection 10/2/19 - Completed satisfactory.

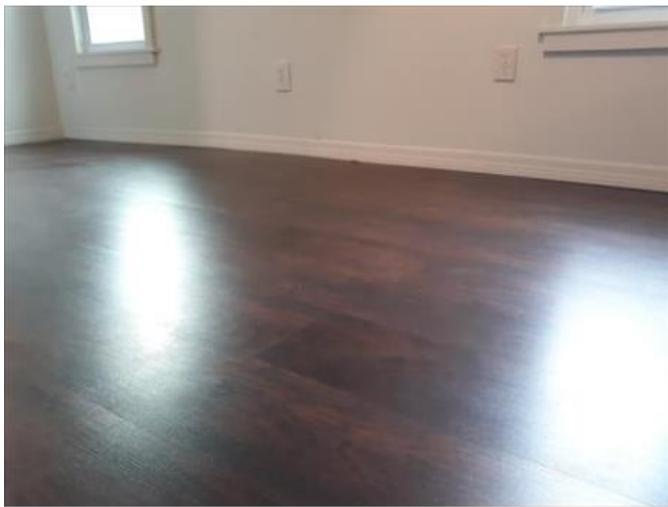
Master bedroom

Re-inspection 10/2/19 - Although several supports have been added the floor remained unlevel. This may indicate the structure is still unlevel or due to the memory in the materials from decades of being unlevel. The inspector can not provide an opinion as to if the floor can regain its levelness.

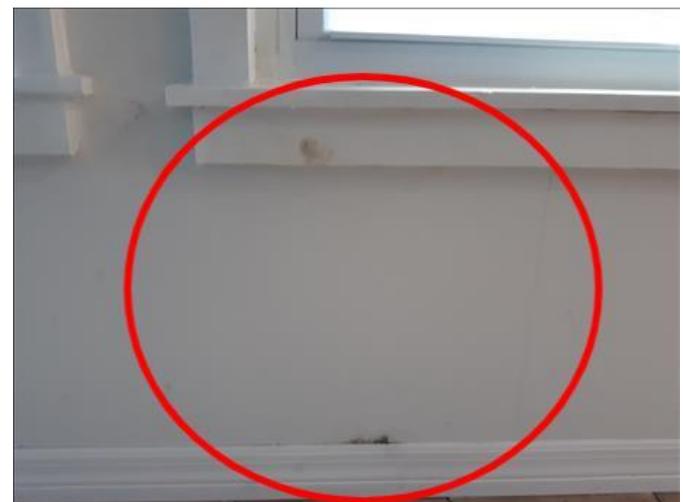
Note: The window to the south of the walkway between the kitchen and laundry room appears to have developed a leak. The area tested dry with a moisture meter during the reinspection, however it had clear signs of staining and organic growth was visible near the base molding. The leaky area should be identified and sealed to avoid further moisture intrusion. Repair by a qualified contractor is recommended.

Re-inspection 10/2/19 - Stained area and organic growth

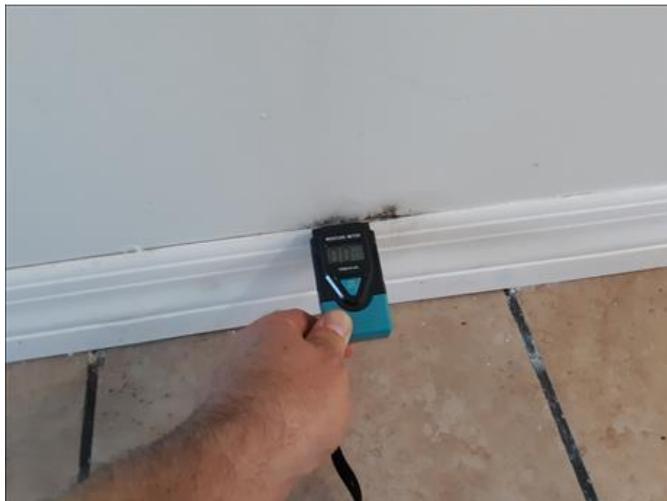
Re-inspection 10/2/19 - organic growth

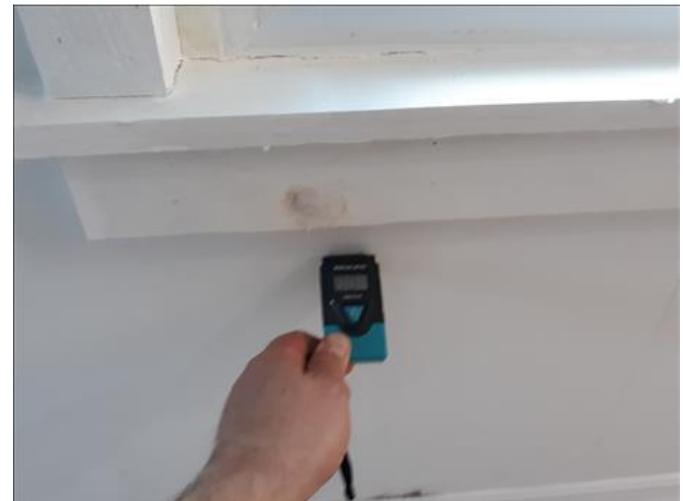
Re-inspection 10/2/19 - Stained area under window
