Drainage Woes: Orangeburg Pipes

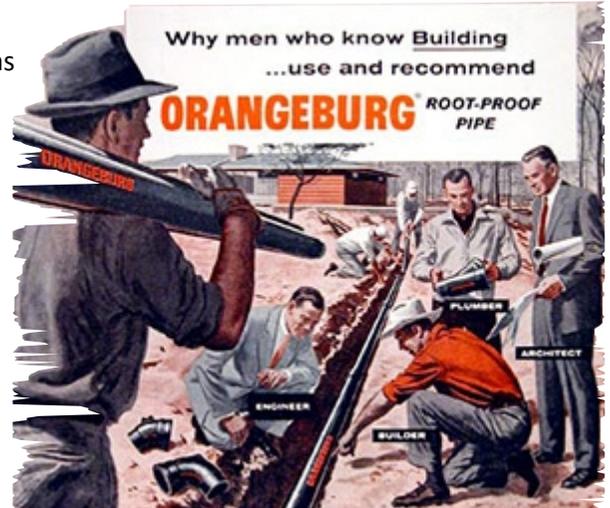
Orangeburg pipe, also referred to as fibre conduit or Bermico pipe, was made by combining and compacting wood chips and pulp with tar. The resulting pipe was rigid and waterproof; the two properties manufacturers were after when they first invented the process.

Orangeburg pipe was manufactured in diameters ranging from 5 to 46 cm (2 to 18 in) and could be made in longer lengths than its clay cousin, making it a good alternative for sewage and drainage. Plus, the longer lengths meant fewer joints to leak and that allow invasive roots to grow – two major issues with the clay pipe option. Orangeburg pipe was also made with a tapered end so that one could fit inside another to make a much more secure joint.

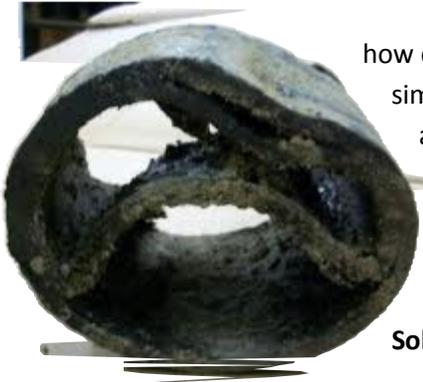
Problems with Orangeburg pipe only started to surface after years of use. It can last 50 years or more under ideal conditions, but has a tendency to collapse under the weight of the soil above. For this reason, it was removed from most 'suitable materials' lists long ago.
