# Inspection Report

## Sample Report

**Property Address:**  
Wayneswood Rd  
FortWashington MD 20774

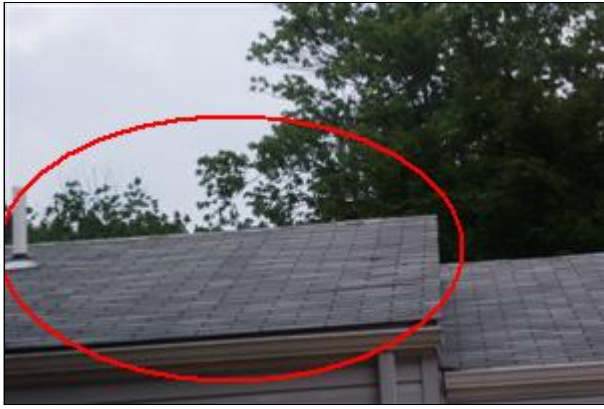
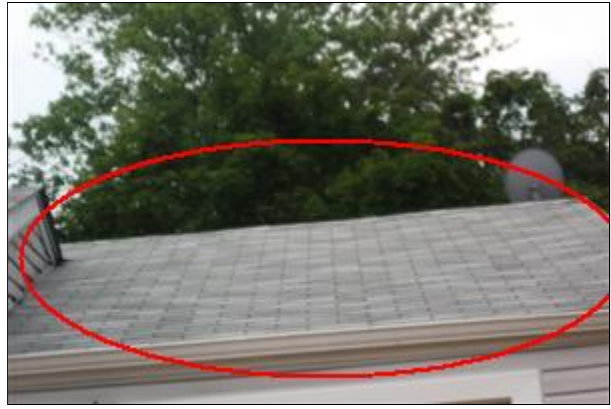
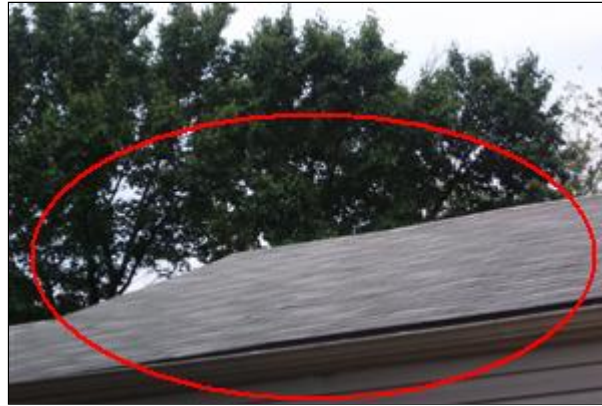
1. The roof covering sag in several area at the front and rear of the home. This is an indication that the roof decking is defective form poor ventilation. The sheathing condensates and begin to sag. (see section 4.5 for further details)

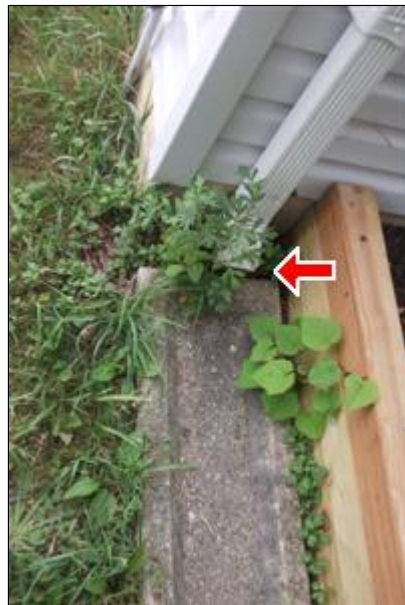
Item 2 - Picture 1

2. The downspout needs an extension drain line to carry water away from the home at least 6 feet (at the left side) (facing front).

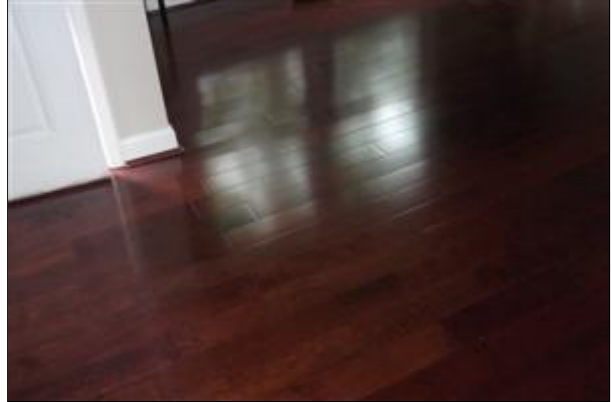
3. The Wood covering is weak and not supported from underneath at the Living Room. The repair work will likely involve the removal of covering in order to repair the framing. The extent of damage cannot be realized until the covering is removed. A qualified contractor should inspect and repair as needed.

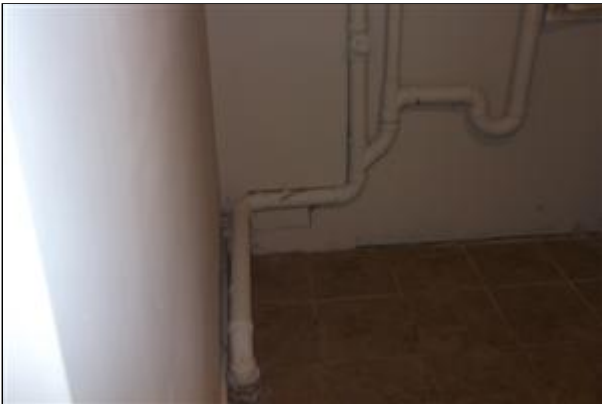
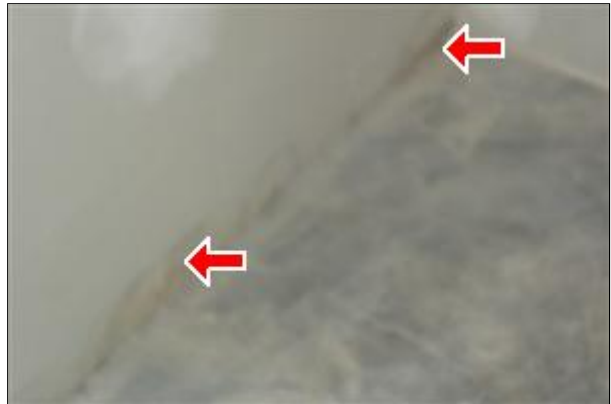
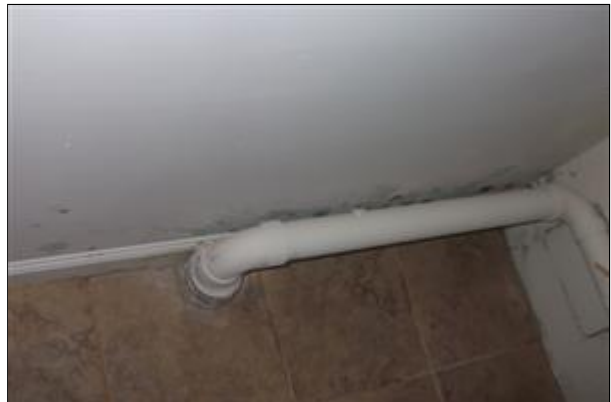
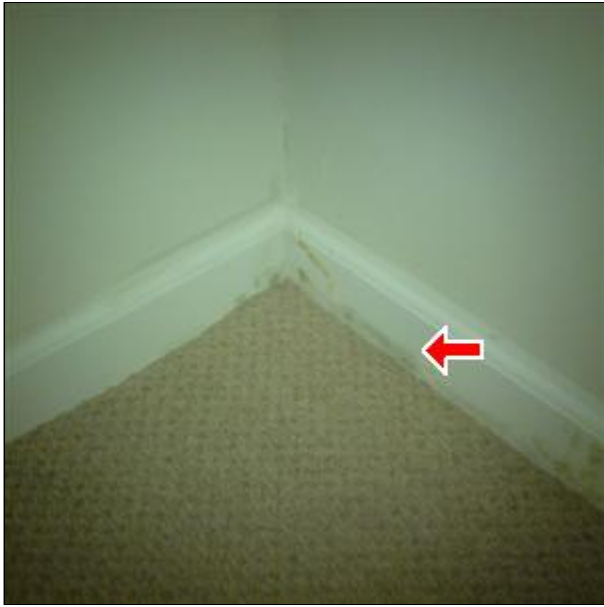
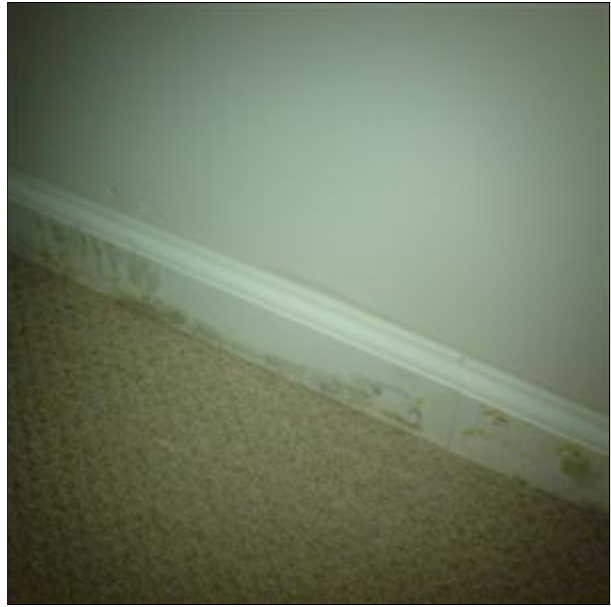
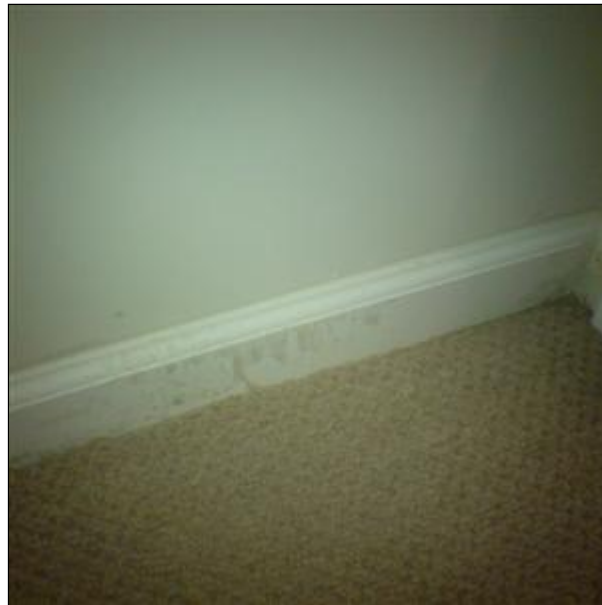
4. (1) Signs of fungi growth is present on the walls along basement walls in washer dryer room, under the steps and closet of basement bedroom. We did not inspect, test or determine if this growth is or is not a health hazard. The underlying cause is moisture. I recommend you contact a mold inspector or expert for investigation or correction if needed.

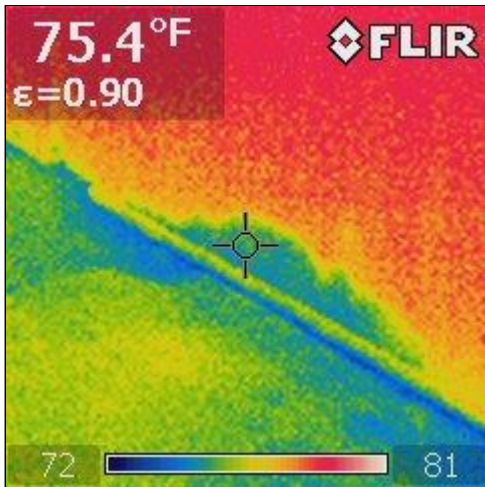
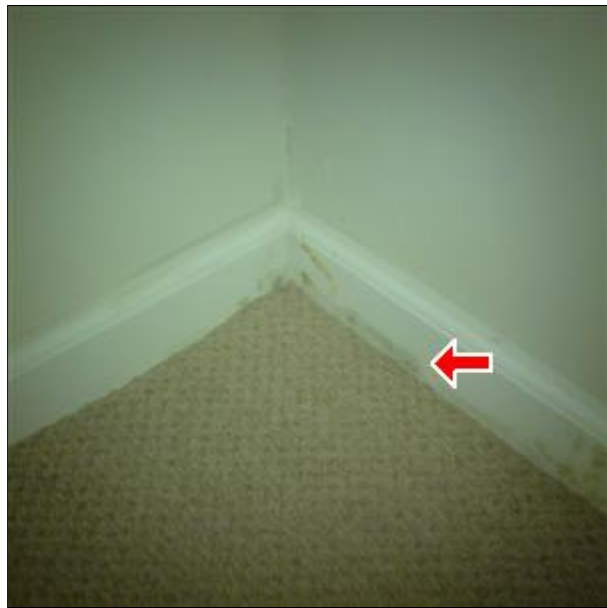
5. (2) Visible signs of water intrusion in the basement (along rear of home) are present from dampness on carpet. Water intrusion can cause deterioration and excessive moisture on building components if not corrected. Sloping the ground or trenching may be needed to direct water, or a french drain system

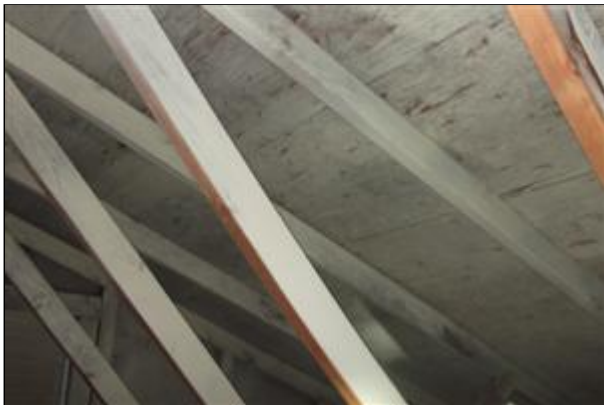
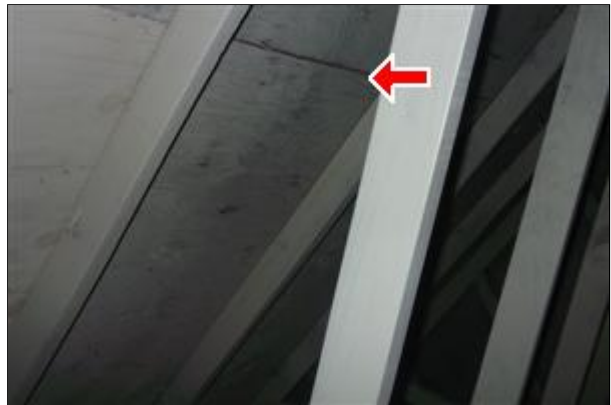
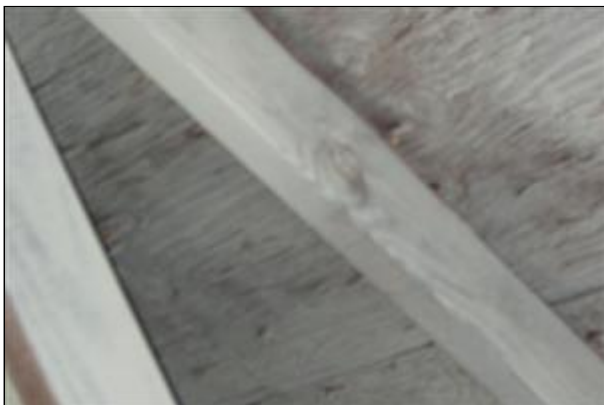
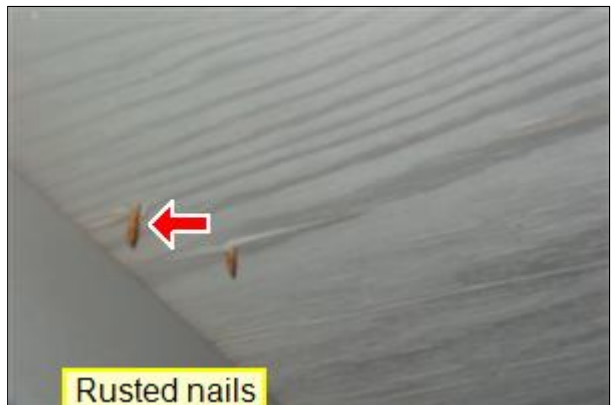
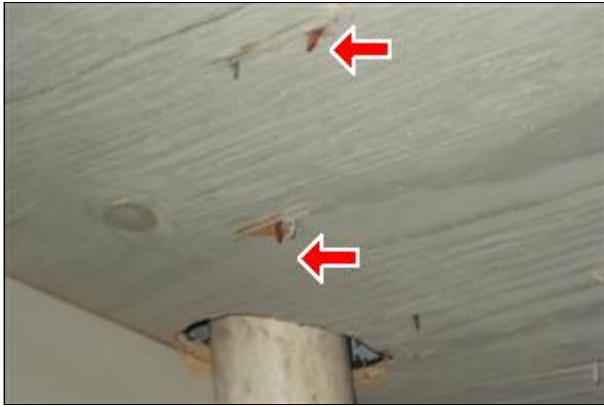
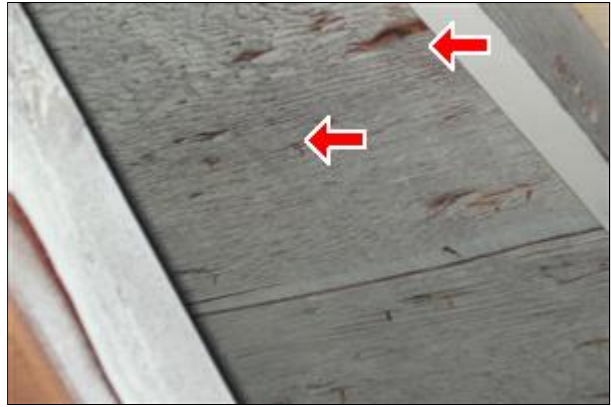
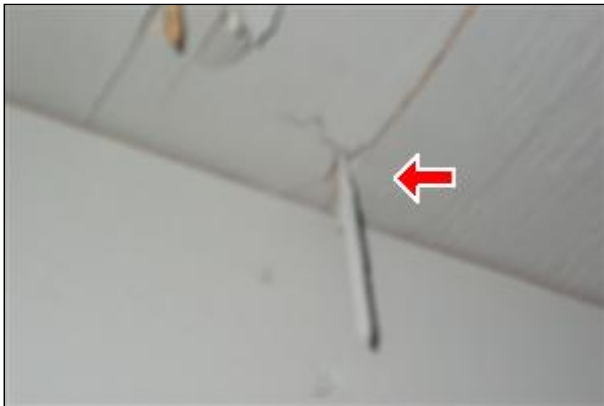
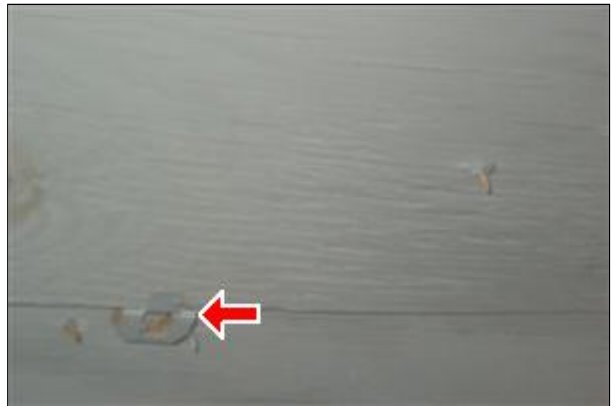
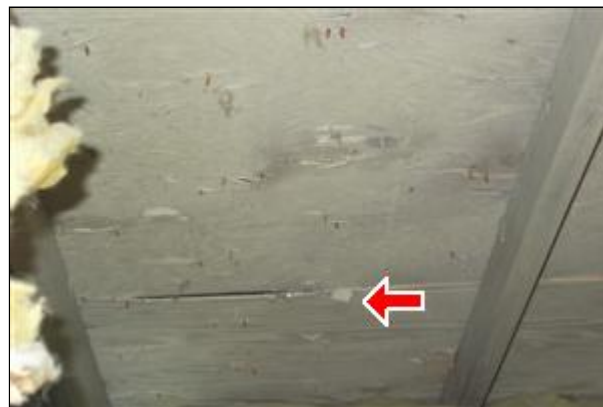
6. There are some dips or sags in the roof sheathing, several Hclaps have come loose. There is a previous mold remediation performed on the roof decking. The attic space doesn't have the proper ventilation. Which has cause the roof sheathing to condensate and sag and allowed previous mold growth. Also the nails are rusted inside of the attic space. In order to the repair the problem the damage roof decking will need to be replaced. This will involve shingle replacement as well. The previous damage is over 80% of the attic space. The entire roof sheathing covering should be replaced. Have a licensed roofing contractor evaluate further and perform al repair or replacements. (provide a roof certification upon completion of work performed).

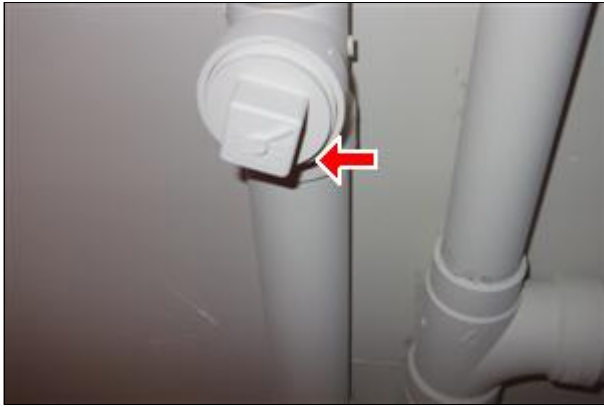
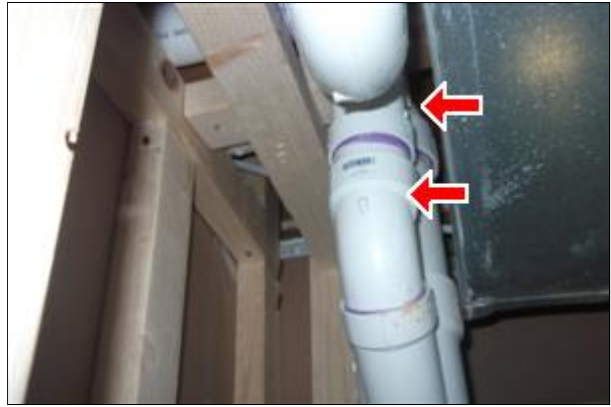
7. The plumbing waste line leaks in the basement front of the airhandler(Picture 3) and at the drain line in the washer dryer(Picture 1)(Picture 4)room. A qualified licensed plumber should repair or correct as needed.

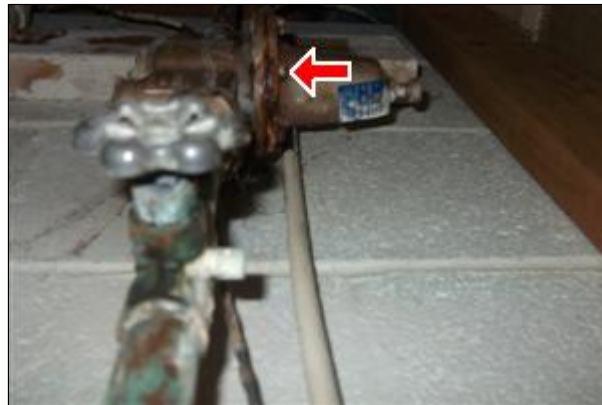
Item 8 - Picture 1

8. The regulator at the main water supply leaks. Have a licensed plumber repair as needed.

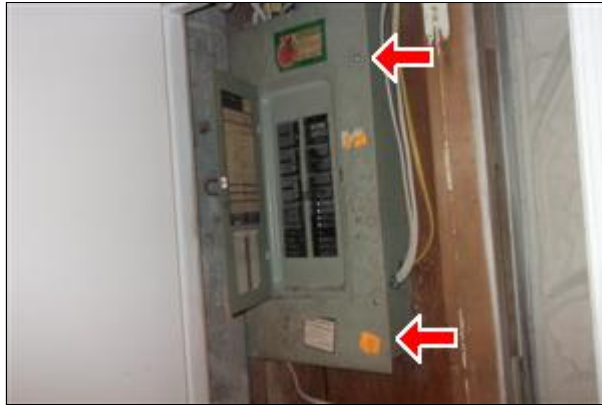
Item 9 - Picture 1

9. The dead front (panel cover) of the electrical panel has extensive rust build up. I was unable to inspect the interior of the panel for rust. (unsafe arcing) Have a licensed inspect further to insure there is no water intrusion entering the panel.

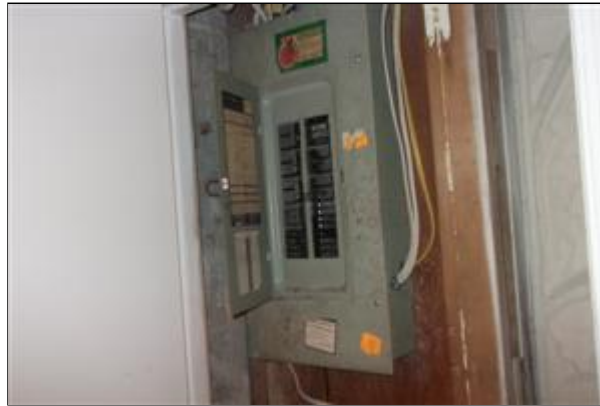
Item 10 - Picture 1

10. Problem(s) discovered with Branch Circuits such as breaker(s) tripped, will not reset, Arcing noise, several light fixtures and outlets non functional and any other problems that an electrical contractor may discover while performing repairs need correcting. I recommend a licensed electrical contractor inspect further and correct as needed.

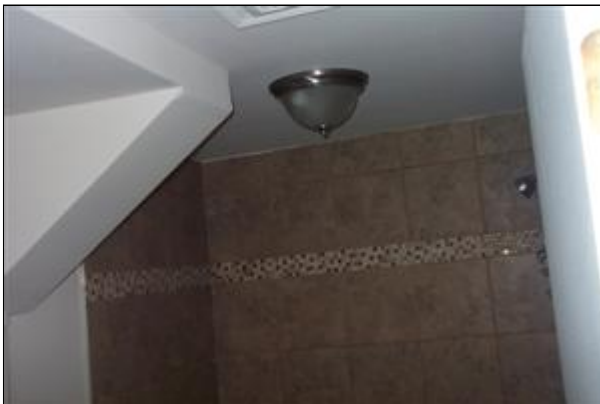
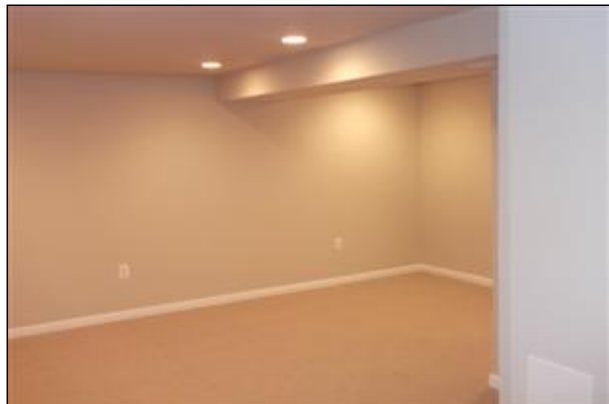
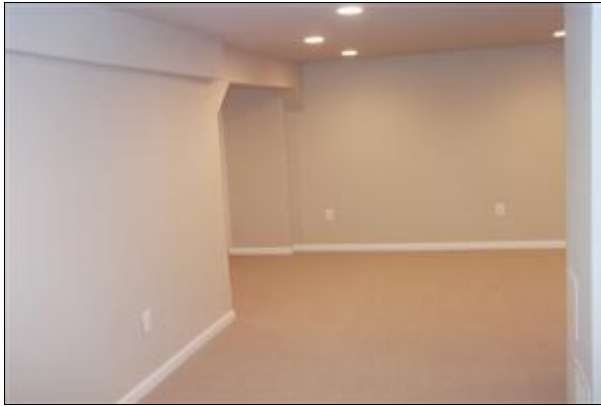
11. The light fixture "flickers" indicating a loose connection at fixture or switch. Also the recess lights show signs of extensive heating. The lights heat is conducting on the living room floor above This is a safety issue that needs to be corrected. A qualified licensed electrical contractor should correct as needed.

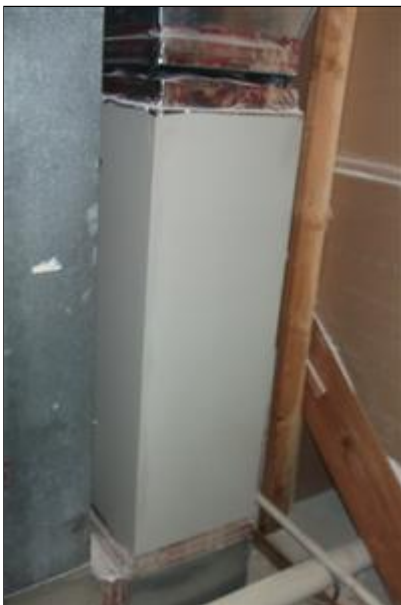
Item 13 - Picture 1

13. There is no access to the front of the unit. The door is nail shut. A easy access is needed for service or the changing of a filter. Have the adequate access provided.

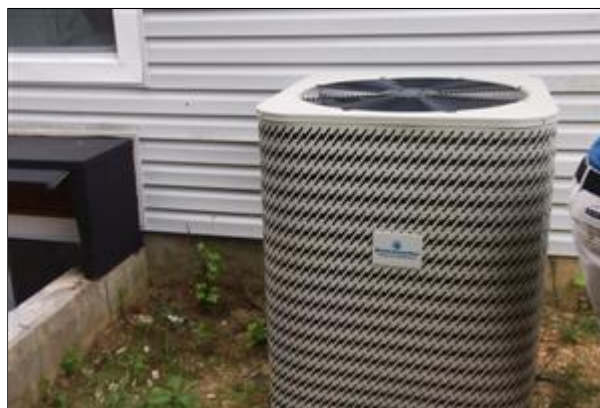
Item 14 - Picture 1

14. The air conditioner did operate but failed to produce cold air. I recommend a licensed HVAC inspect and repair as needed.

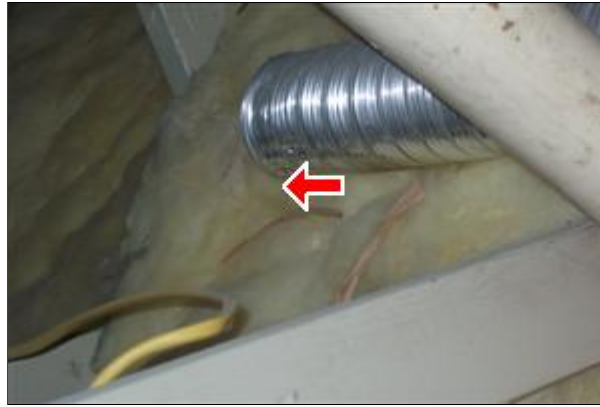
Item 16 - Picture 1

16. The Exhaust fan does not vent to outside at the hall bath. Vent pipes that terminate in attic space can sometimes cause moisture that can lead to mold or cause condensation. A qualified contractor should inspect and repair as needed.

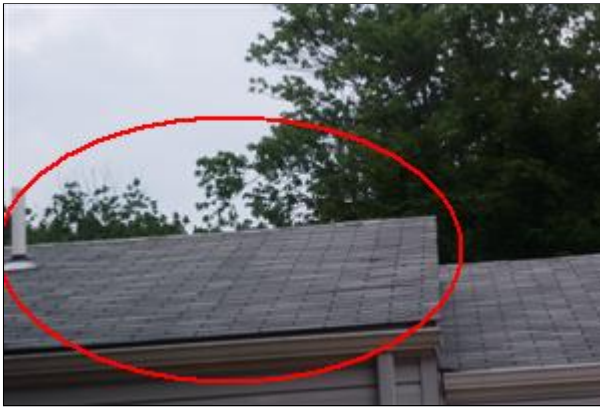
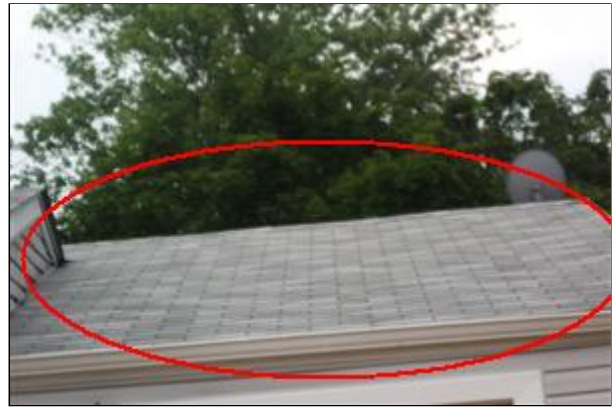
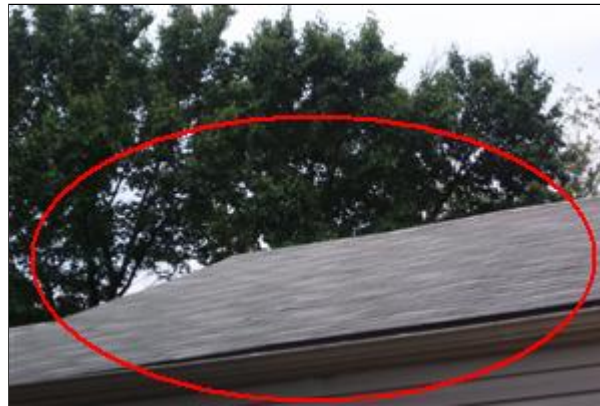
The roof covering sag in several area at the front and rear of the home. This is an indication that the roof decking is defective form poor ventilation. The sheathing condensates and begin to sag. (see section 4.5 for further details)

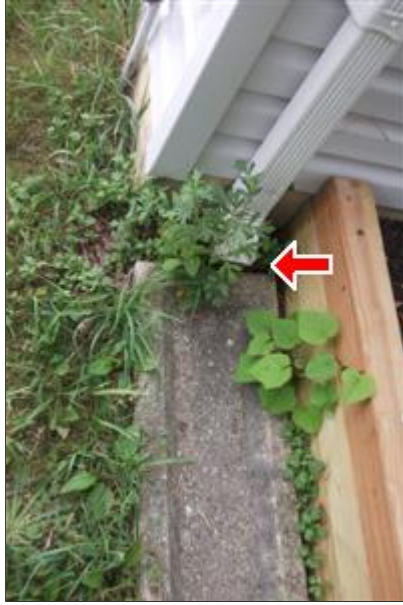
1.3 Picture 1

The downspout needs an extension drain line to carry water away from the home at least 6 feet (at the left side) (facing front).

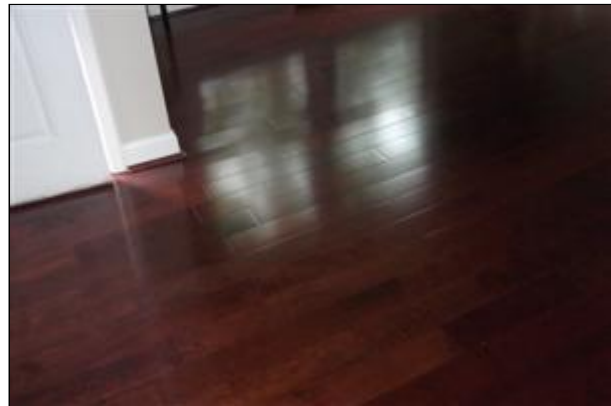
The Wood covering is weak and not supported from underneath at the Living Room. The repair work will likely involve the removal of covering in order to repair the framing. The extent of damage cannot be realized until the covering is removed. A qualified contractor should inspect and repair as needed.

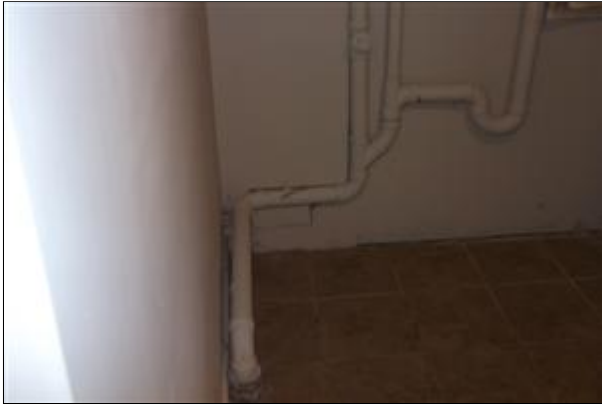
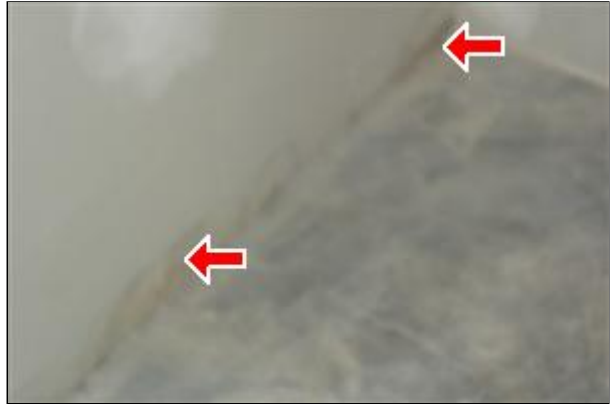
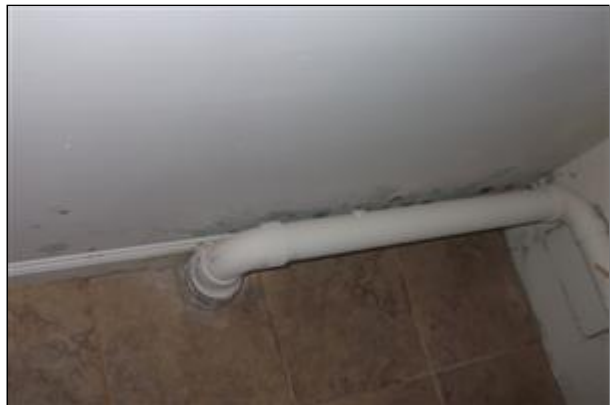
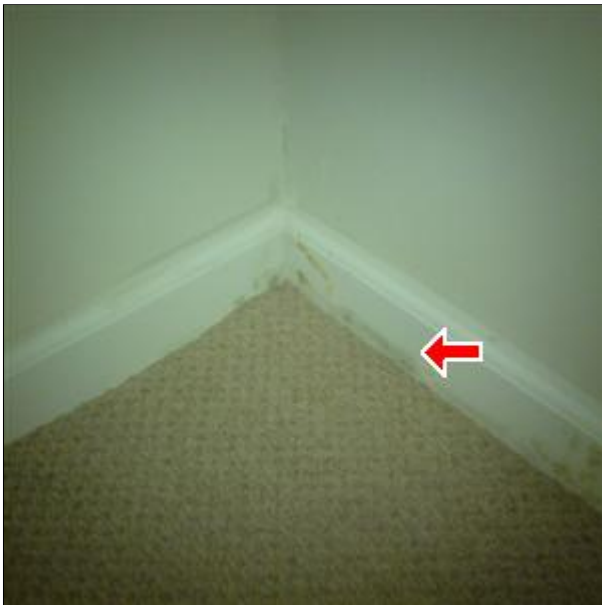
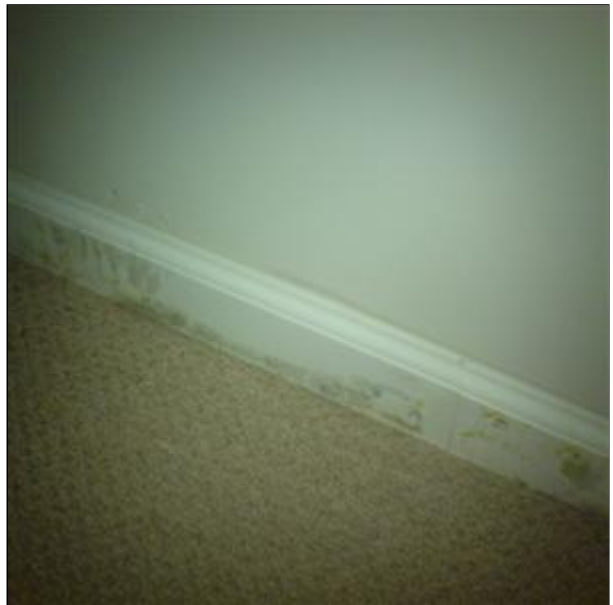
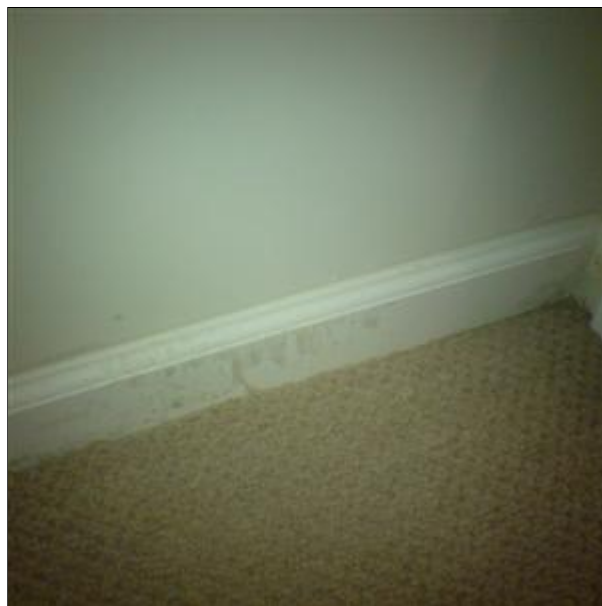
(1) Signs of fungi growth is present on the walls along basement walls in washer dryer room, under the steps and closet of basement bedroom. We did not inspect, test or determine if this growth is or is not a health hazard. The underlying cause is moisture. I recommend you contact a mold inspector or expert for investigation or correction if needed.

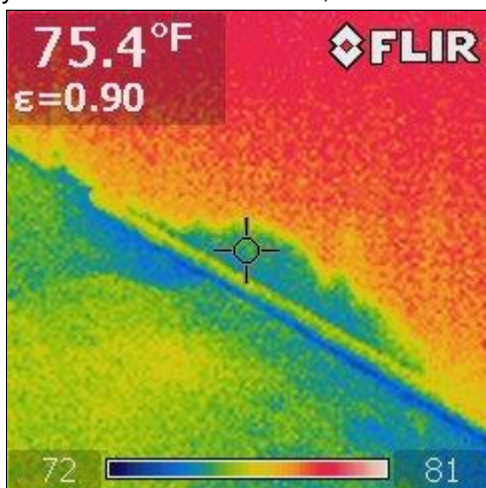
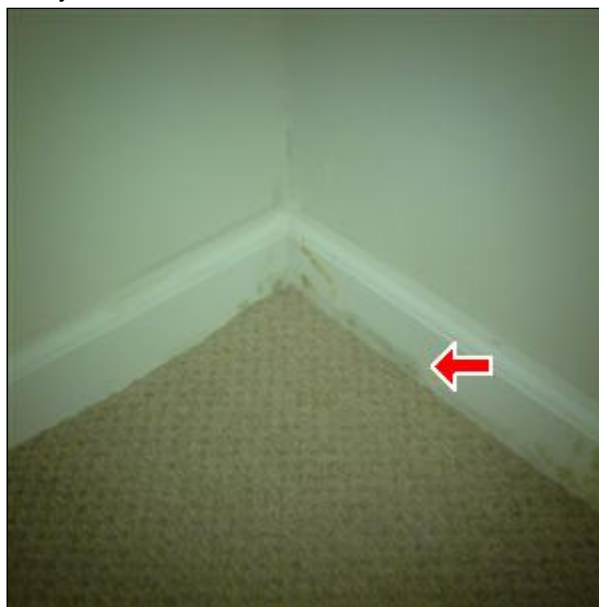
(2) Visible signs of water intrusion in the basement (along rear of home) are present from dampness on carpet. Water intrusion can cause deterioration and excessive moisture on building components if not corrected. Sloping the ground or trenching may be needed to direct water, or a french drain system

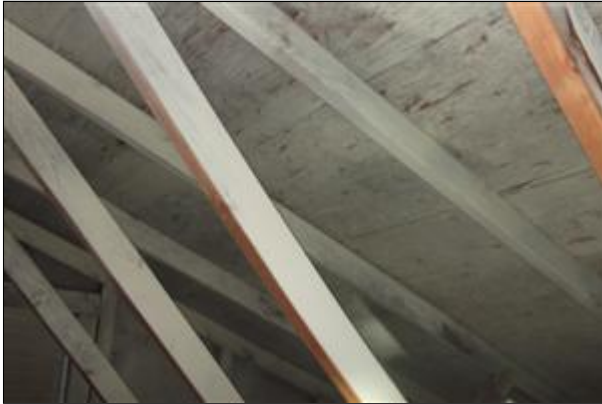
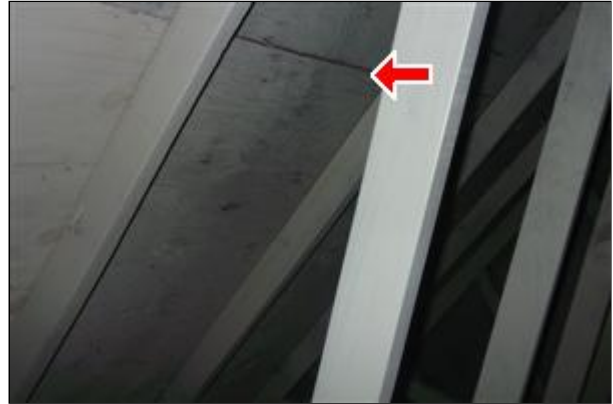
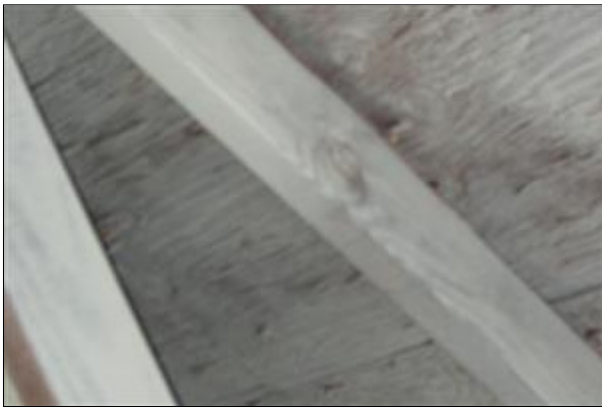
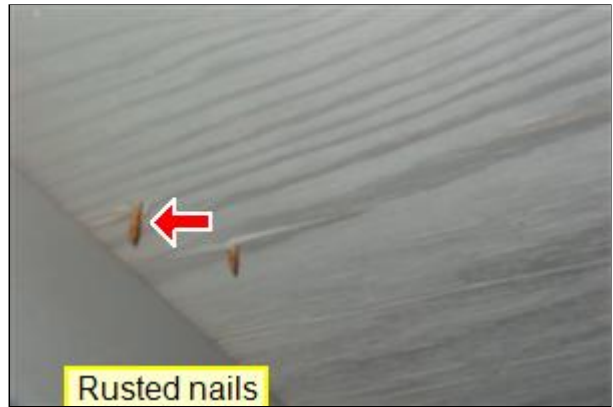
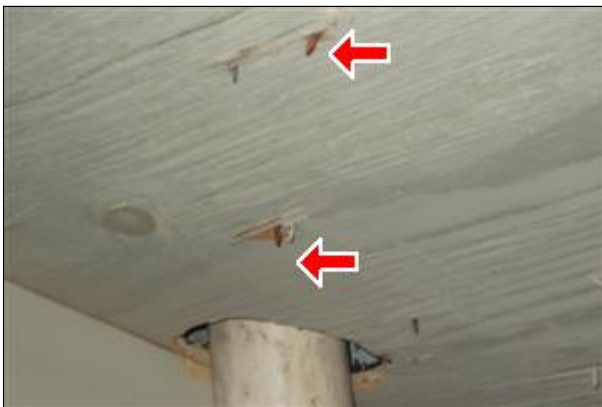
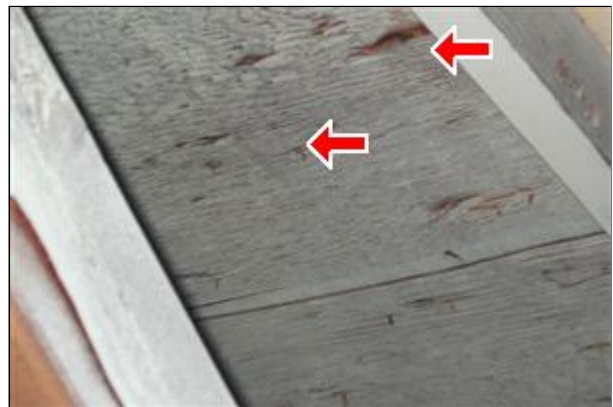
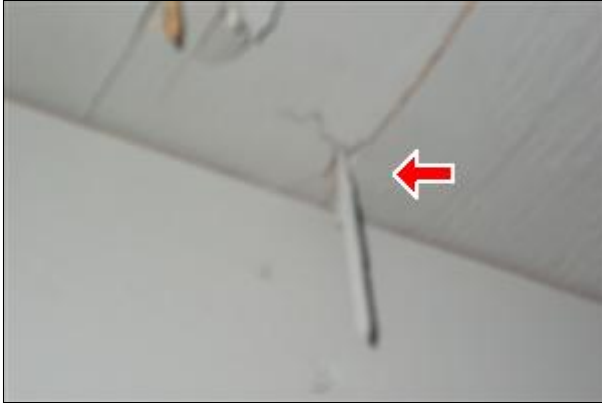
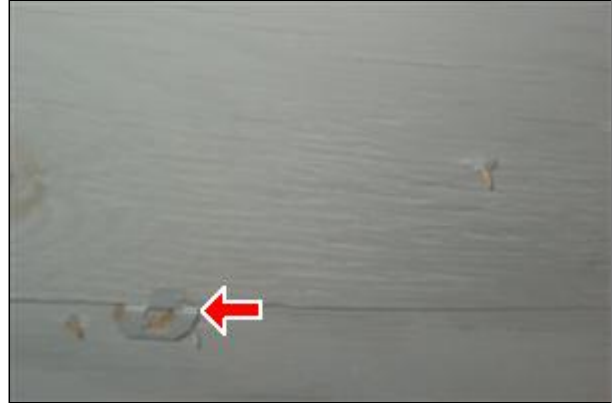
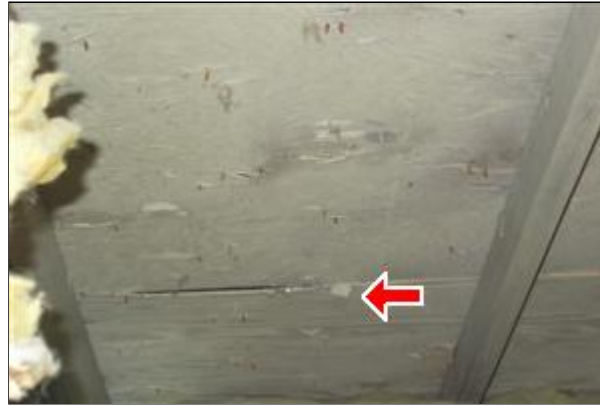
There are some dips or sags in the roof sheathing, several Hclaps have come loose. There is a previous mold remediation performed on the roof decking. The attic space doesn't have the proper ventilation. Which has cause the roof sheathing to condensate and sag and allowed previous mold growth. Also the nails are rusted inside of the attic space. In order to the repair the problem the damage roof decking will need to be replaced. This will involve shingle replacement as well. The previous damage is over 80% of the attic space. The entire roof sheathing covering should be replaced. Have a licensed roofing contractor evaluate further and perform al repair or replacements. (provide a roof certification upon completion of work performed).

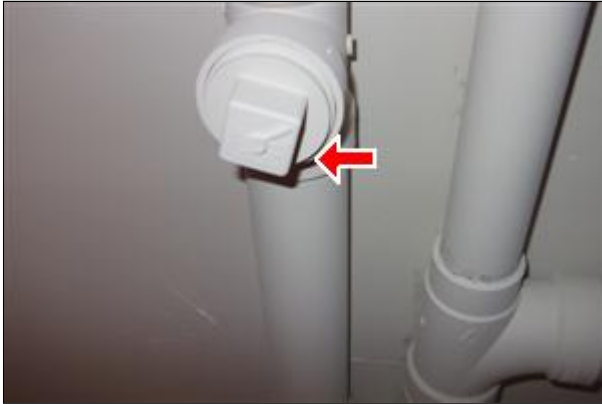
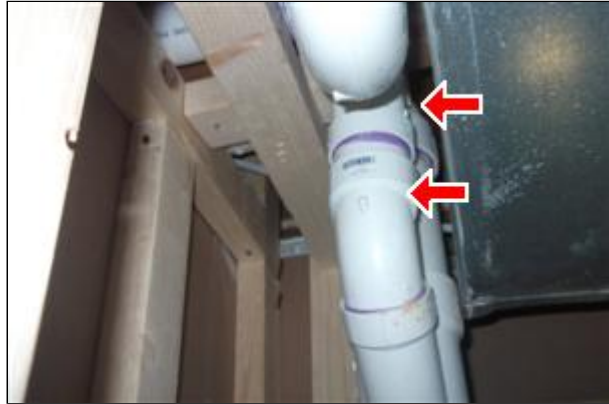
The plumbing waste line leaks in the basement front of the airhandler(Picture 3) and at the drain line in the washer dryer(Picture 1)(Picture 4)room. A qualified licensed plumber should repair or correct as needed.

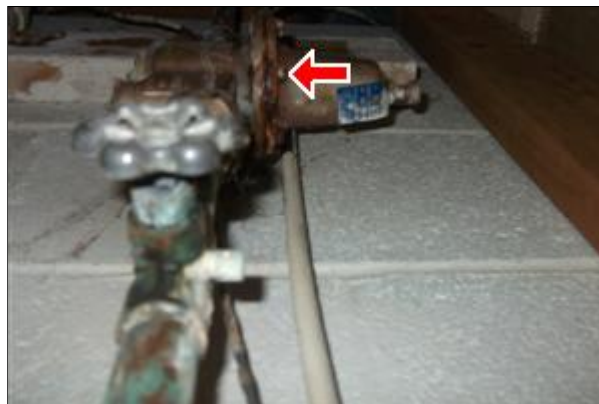
5.1 Picture 1

The regulator at the main water supply leaks. Have a licensed plumber repair as needed.

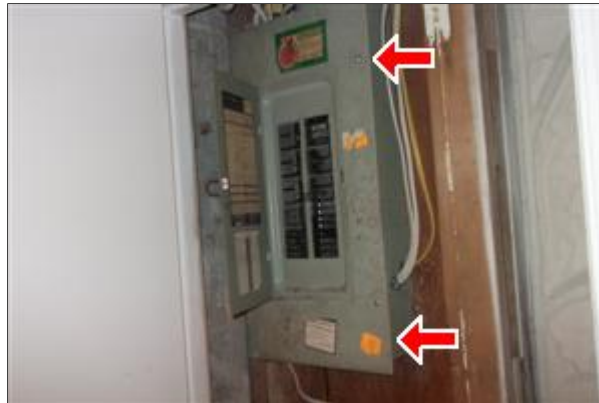
6.1 Picture 1

The dead front(panel cover) of the electrical panel has extensive rust build up. I was unable to inspect the interior of the panel for rust. (unsafe arcing) Have a licensed inspect further to insure there is no water intrusion entering the panel.

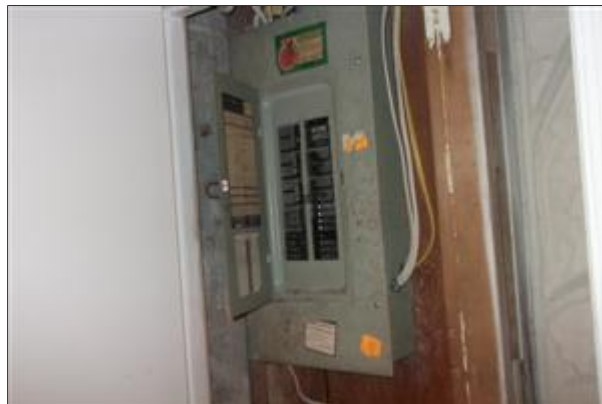
6.2 Picture 1

Problem(s) discovered with Branch Circuits such as breaker(s) tripped, will not reset, Arcing noise, several light fixtures and outlets non functional and any other problems that an electrical contractor may discover while performing repairs need correcting. I recommend a licensed electrical contractor inspect further and correct as needed.

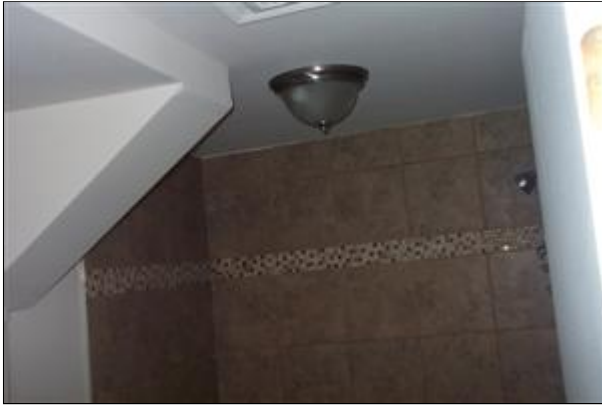
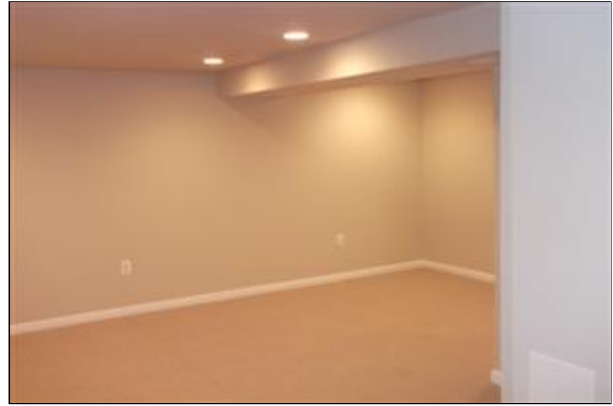
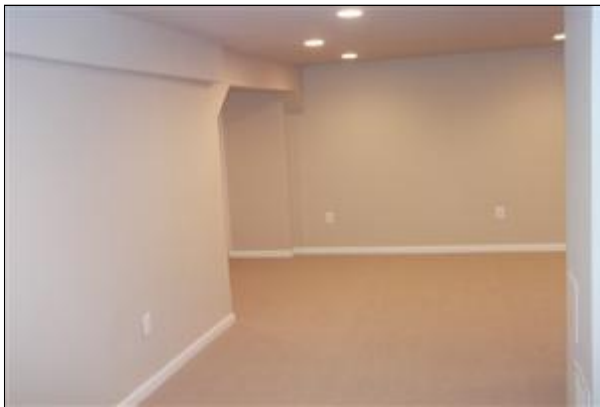
The light fixture "flickers" indicating a loose connection at fixture or switch. Also the recess lights show signs of extensive heating. The lights heat is conducting on the living room floor above This is a safety issue that needs to be corrected. A qualified licensed electrical contractor should correct as needed.

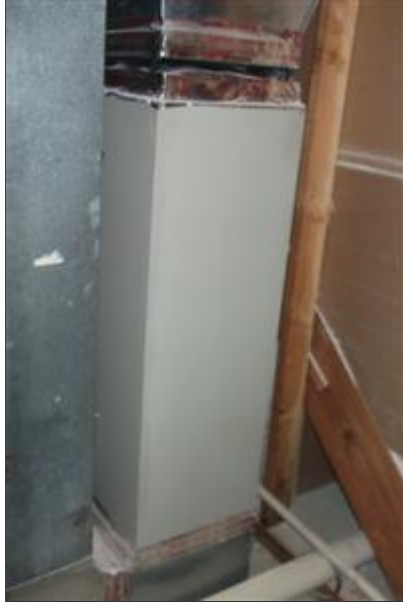
7.3 Picture 1

There is no access to the front of the unit. The door is nail shut. A easy access is needed for service or the changing of a filter. Have the adequate access provided.

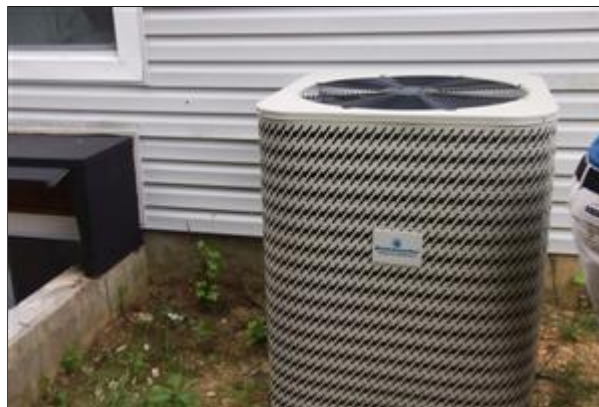
7.8 Picture 1

The air conditioner did operate but failed to produce cold air. I recommend a licensed HVAC inspect and repair as needed.

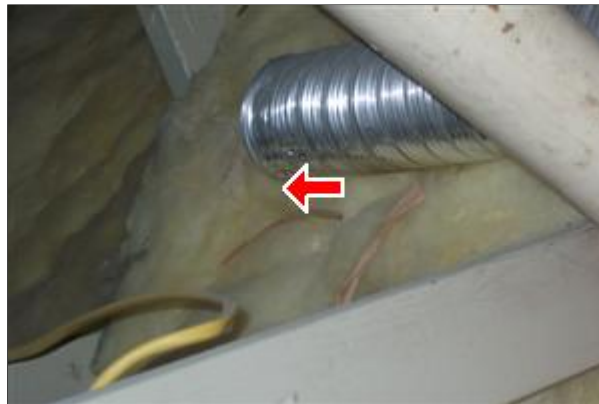
8.4 Picture 1

The Exhaust fan does not vent to outside at the hall bath. Vent pipes that terminate in attic space can sometimes cause moisture that can lead to mold or cause condensation. A qualified contractor should inspect and repair as needed.
