Inspection Report

Property Address:
1234 Main St
The Villages FL 32162

The Village Home Inspector

General Summary

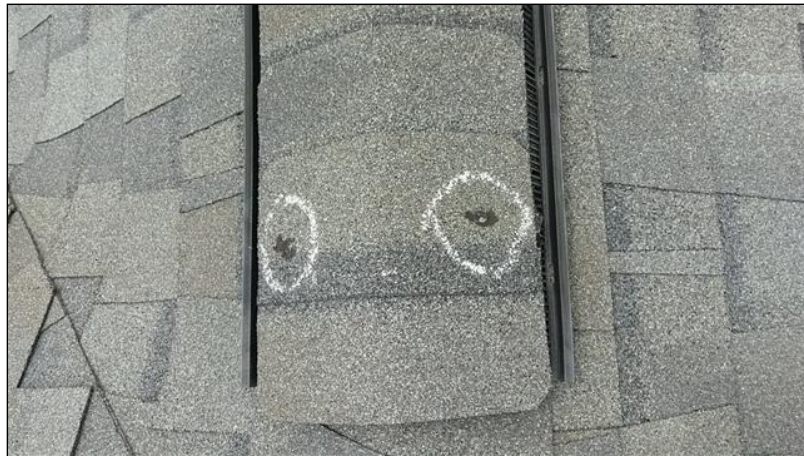
1.0 Roof Coverings**Repair or Replace**

One Ridge vent has exposed nails at the right side (facing front). Repairs are needed. Recommend a licensed roofing contractor apply roof cement or caulking to cover nails.

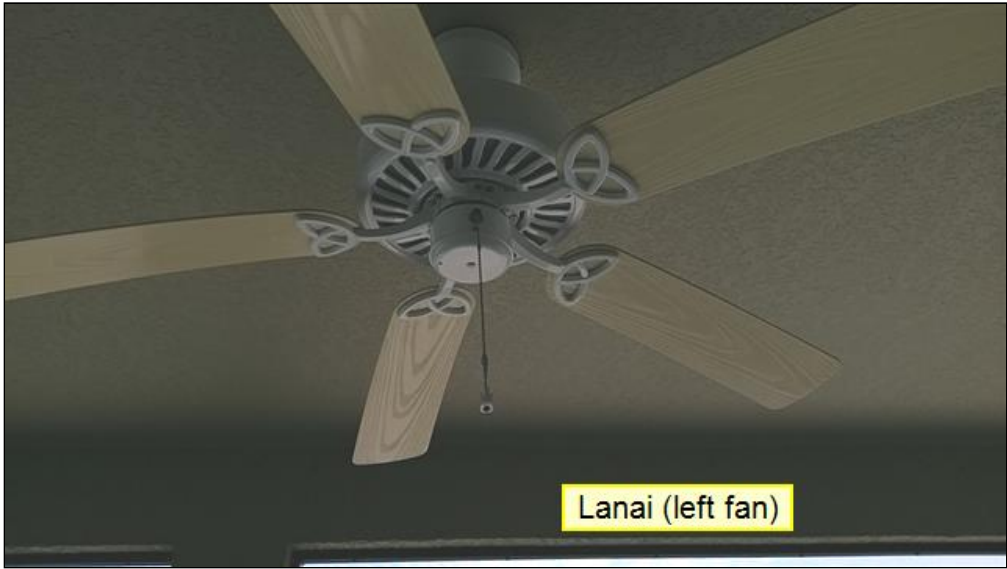
2.7 Outlets (Exterior)**Repair or Replace**

The ceiling fan in the Lanai does work, but only two speeds of the three speeds are working. A qualified licensed electrical contractor should perform repairs that involve wiring.

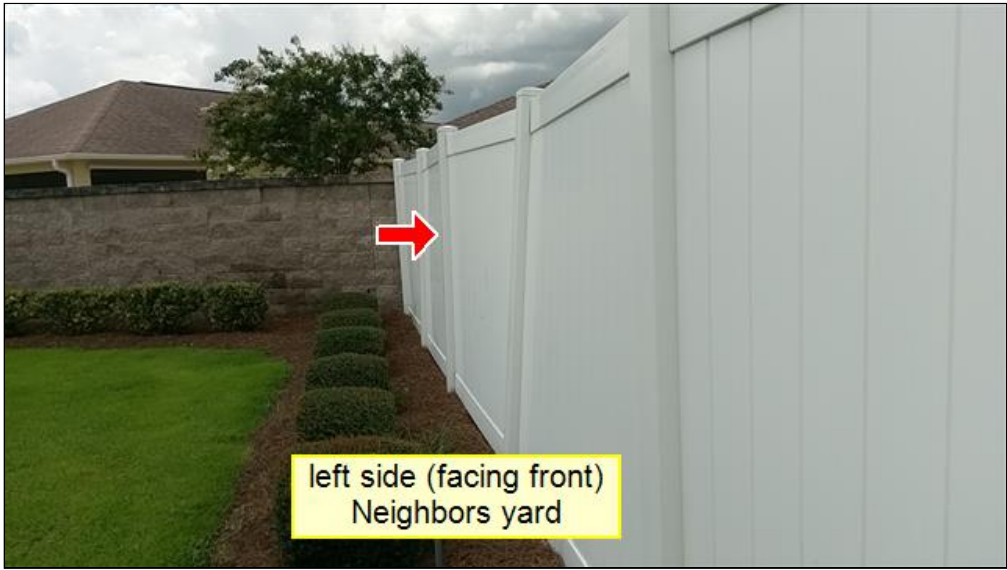
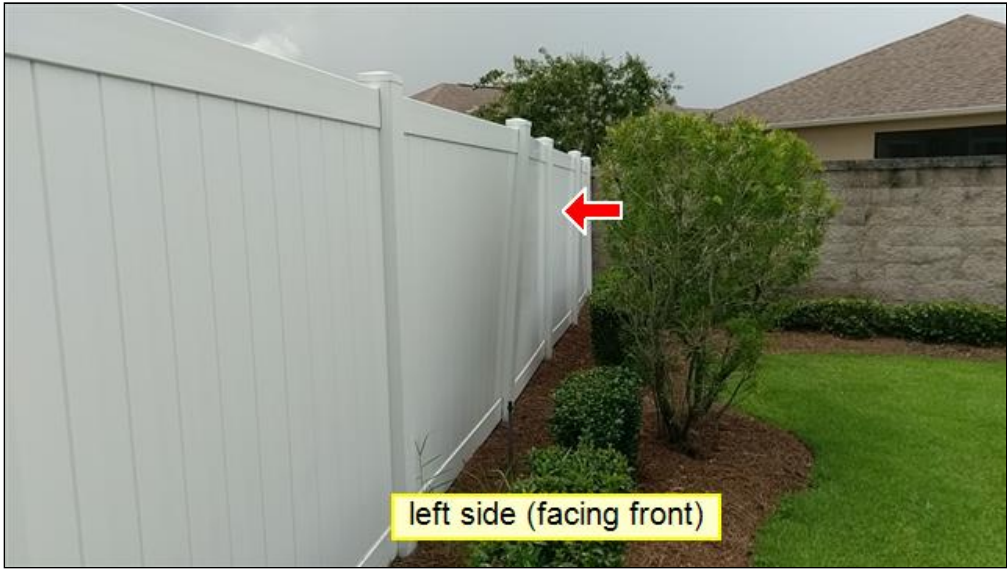
2.9 Fences, Gates, and Boundary Walls

Fence had post that had failed due to possibly being hit by landscapers. The fences were leaning in these areas.

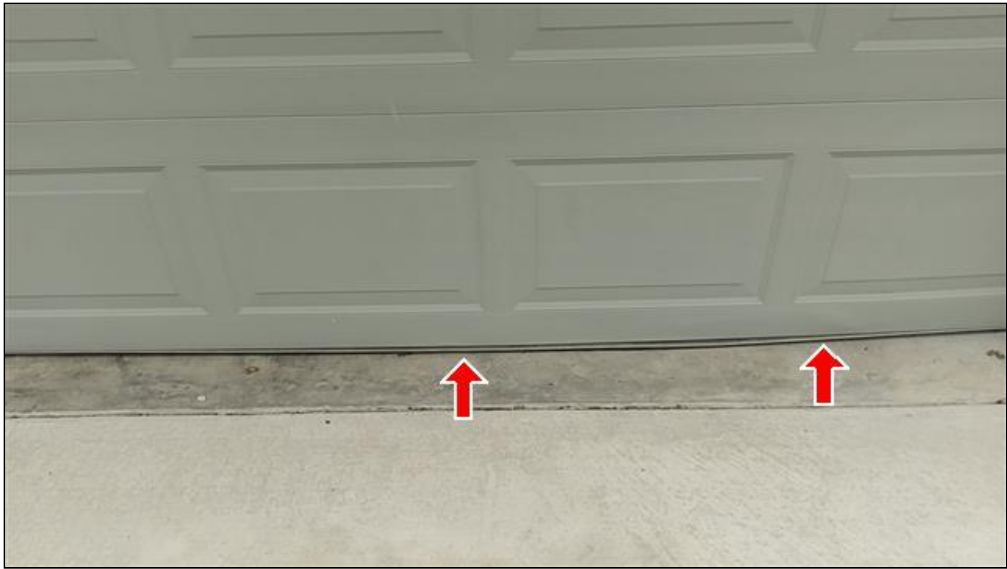
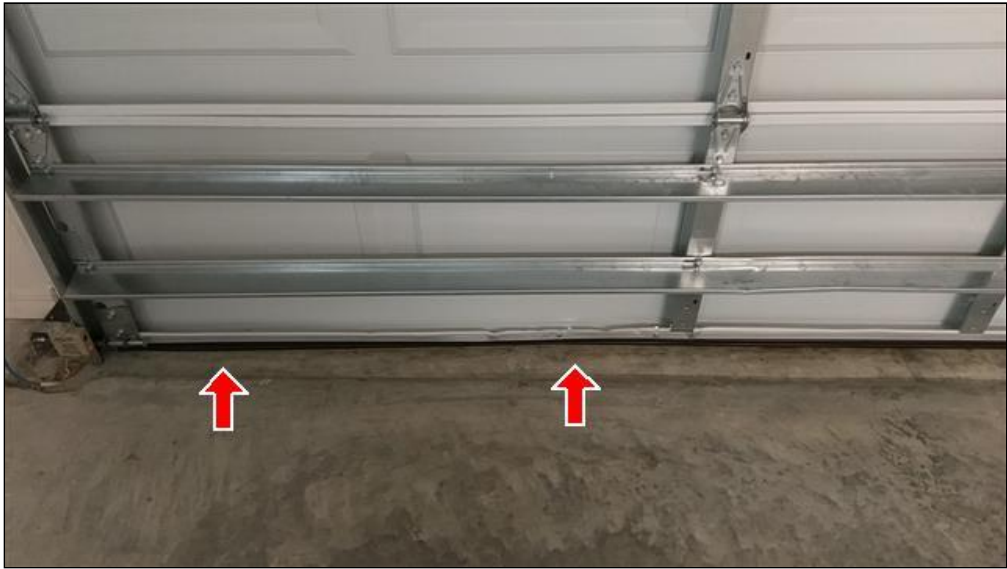
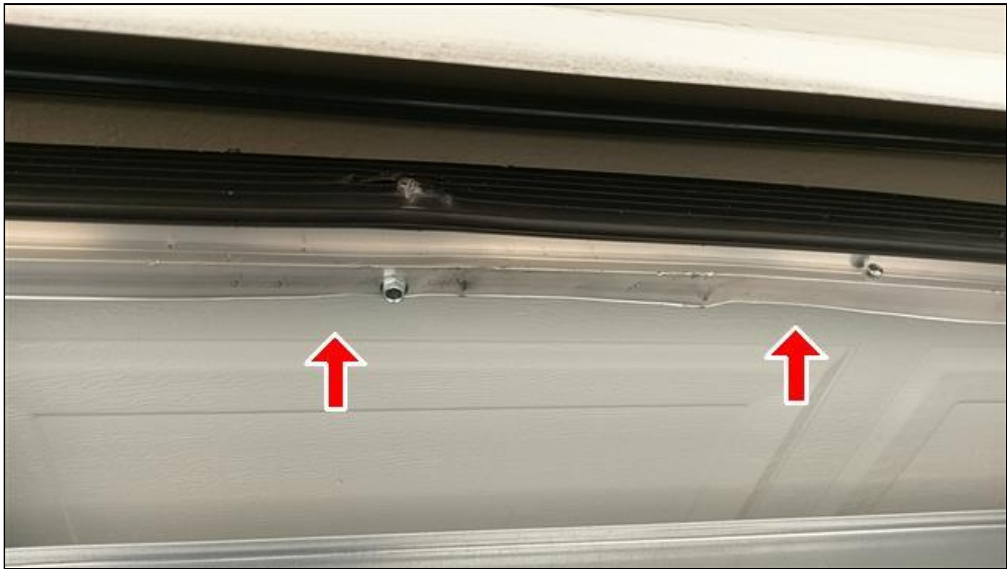
4.8 Vehicle Doors

A garage vehicle door panel had moderate damage visible and is very noisy (bangs) when first opening. The Inspector recommends maintenance be performed by a qualified contractor.

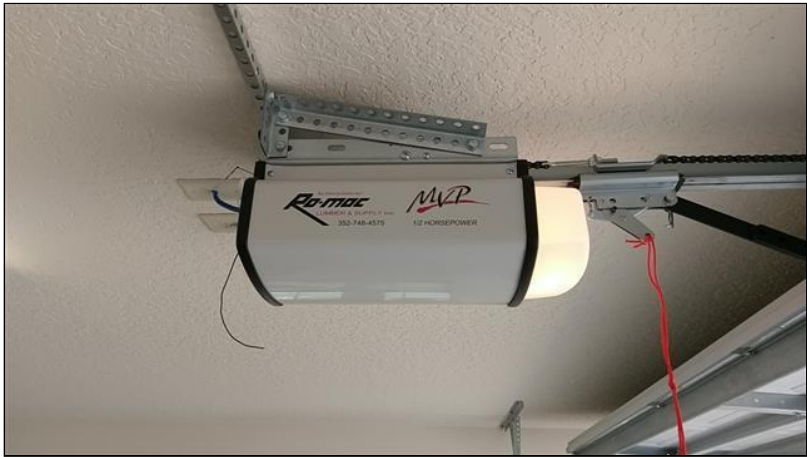
The automatic garage door opener did not respond to testing of the pressure-activated automatic-reverse feature. Garage doors are required to have at least one automatic-reverse device. The door did have an operable photo-sensor activated automatic reverse device installed.

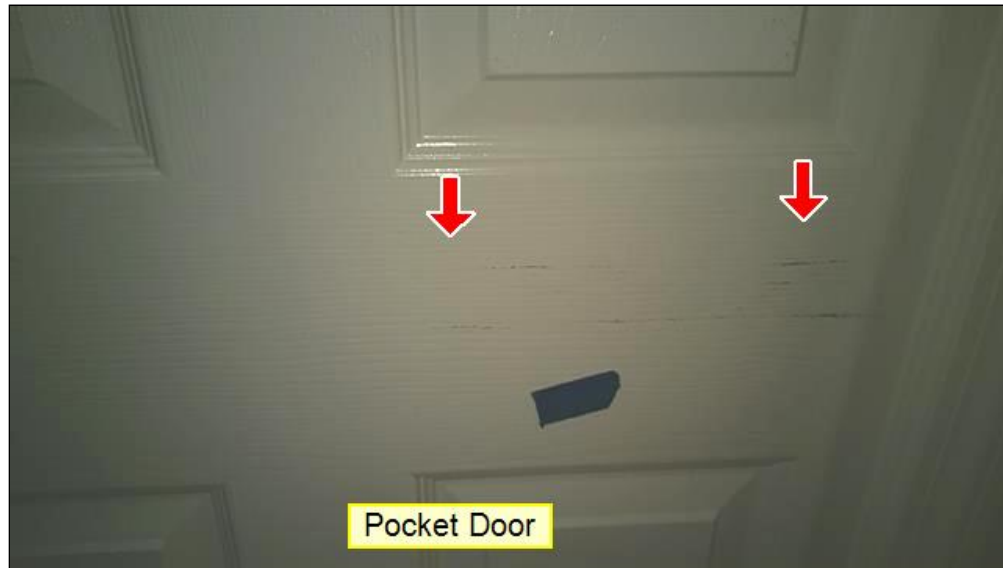
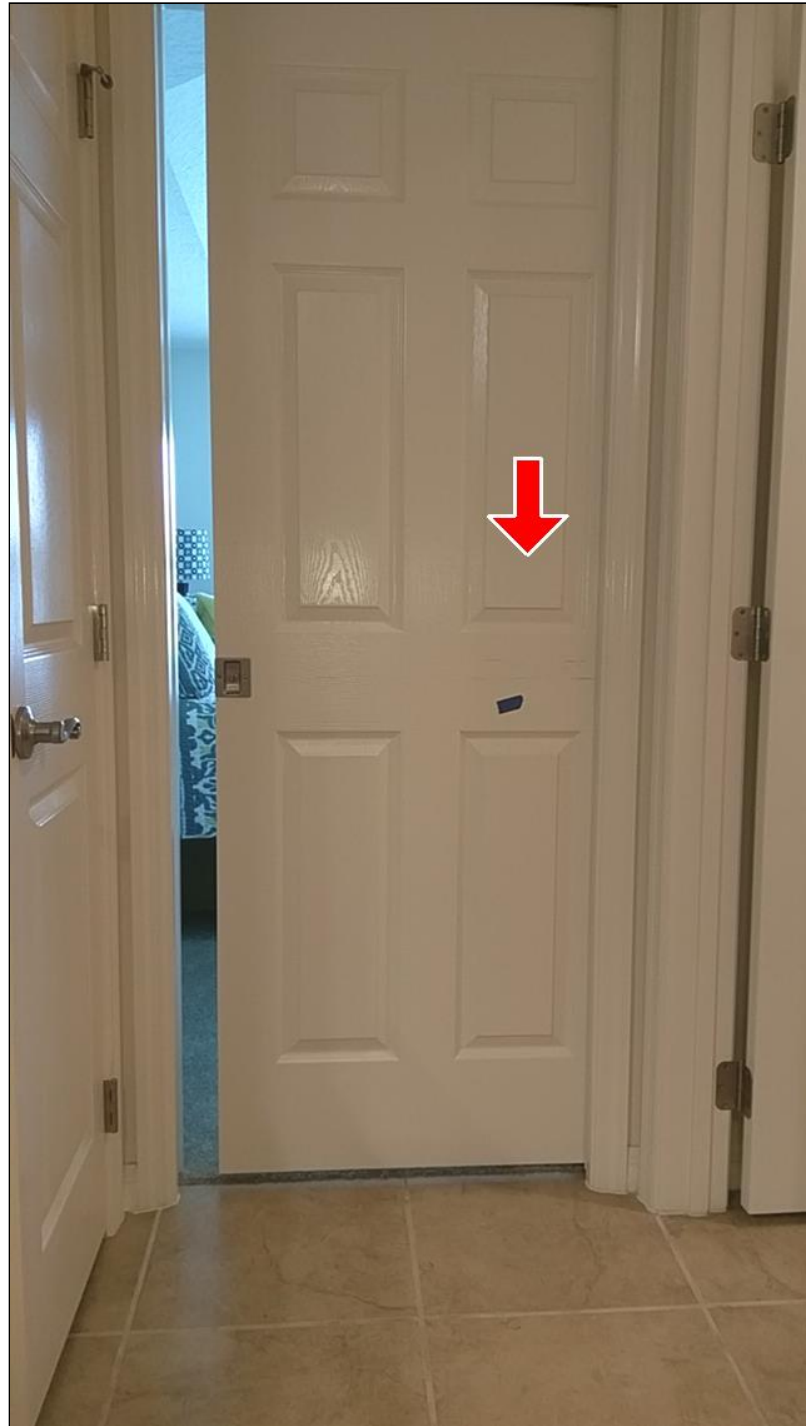
9(A) . Master Bath**9.3.A Doors (Representative number)****Repair or Replace**

The Pocket door is damaged and needs adjustment at the master bathroom. This is a small repair. A qualified person should repair or replace as needed.

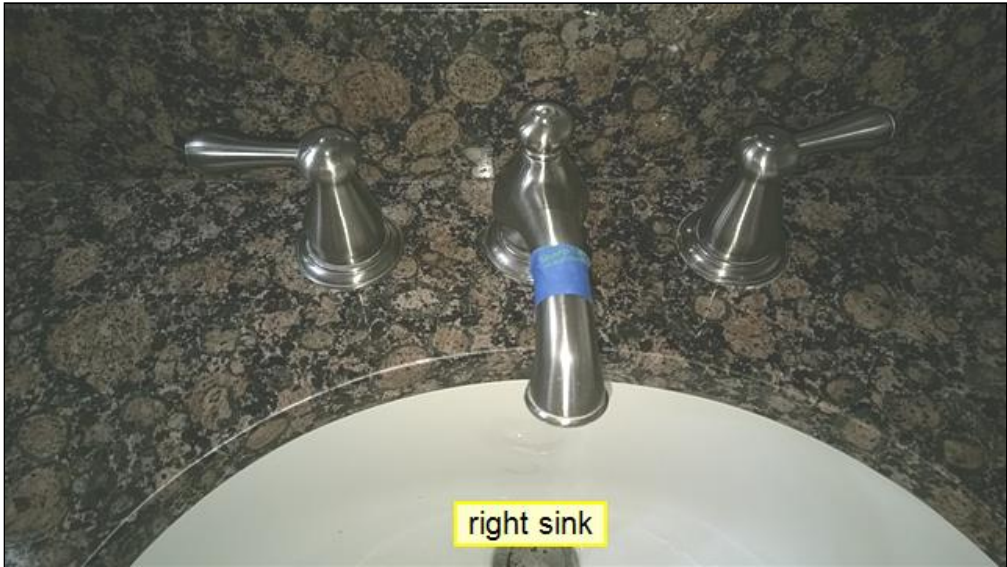
9.7.A Plumbing Water Supply and Distribution Systems and Fixtures

The sink faucet (right sink) is loose at the master bathroom. Repairs are needed. A qualified licensed plumber should repair or correct as needed.

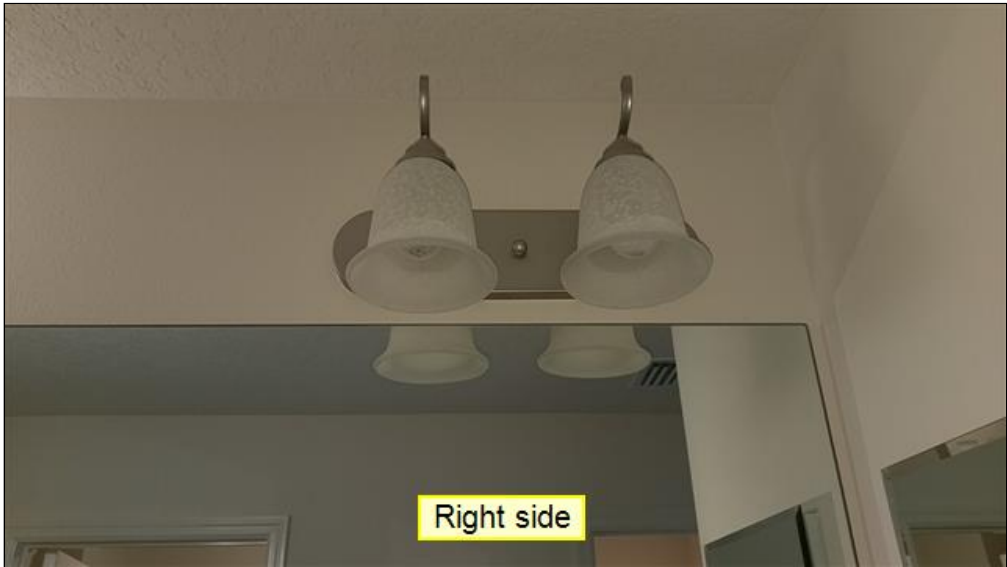
9.8.A Outlets Switches and Fixtures

The right light fixture does not work (try bulb first) at the master bathroom. This is for your information. A qualified licensed electrical contractor should perform repairs that involve wiring.

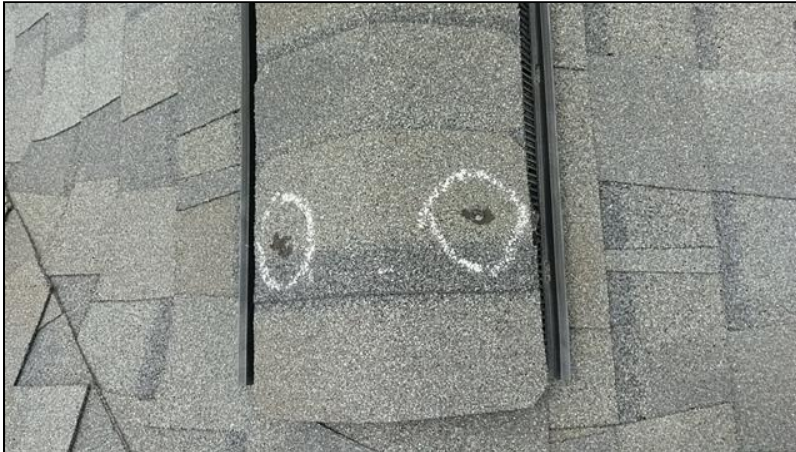
1.0 One Ridge vent has exposed nails at the right side (facing front). Repairs are needed. Recommend a licensed roofing contractor apply roof cement or caulking to cover nails.

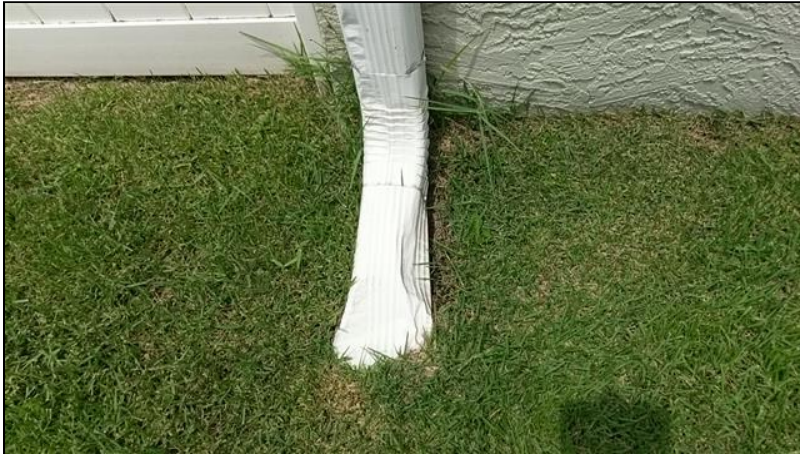
1.4 The downspout is damaged at the left side of home (facing front). Erosion can continue or become worse if not corrected. A qualified person should repair or replace as needed.

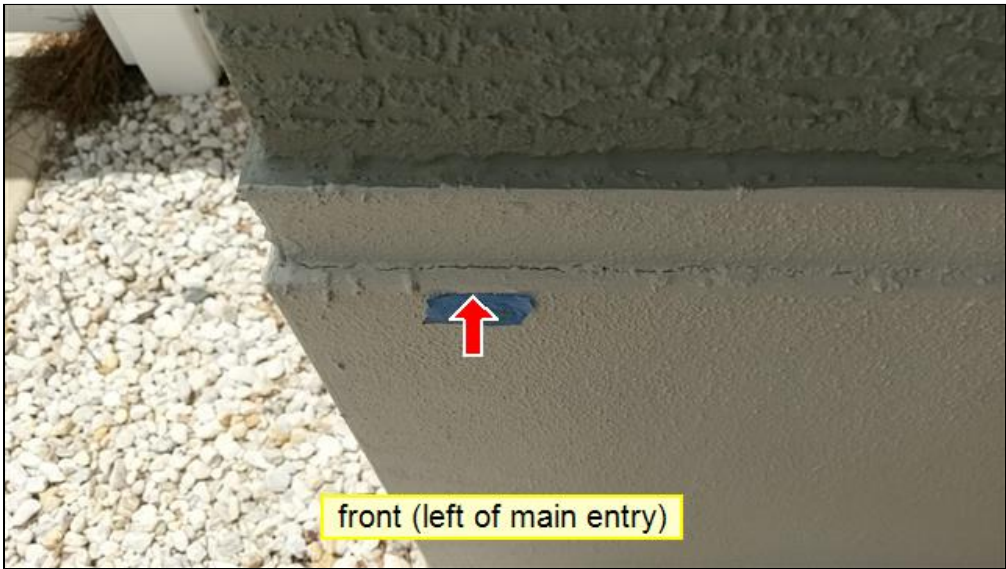
front left

2.0 The Stucco coating at the exterior in areas has hairline cracks. Deterioration can eventually occur if not corrected. A qualified person should repair or replace as needed.

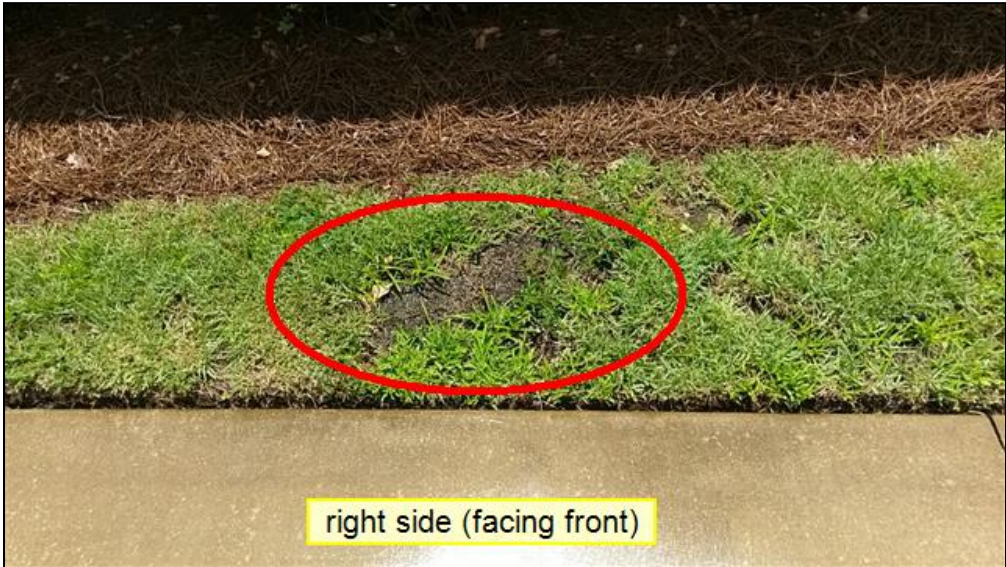
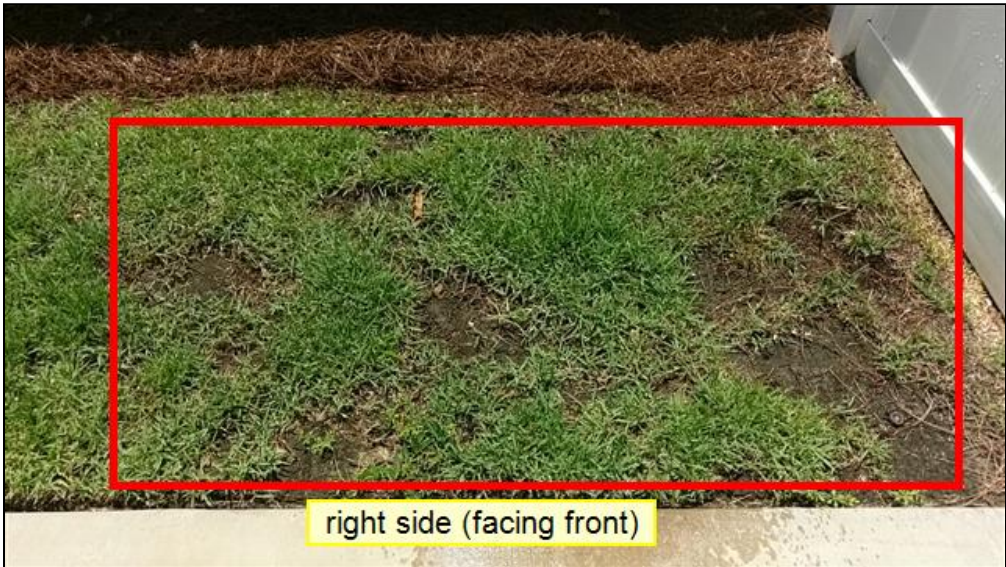
2.4 Grass is brown in several areas. Recommend adjusting sprinkler heads to ensure full coverage or consulting a landscape specialist to check for a fungus.

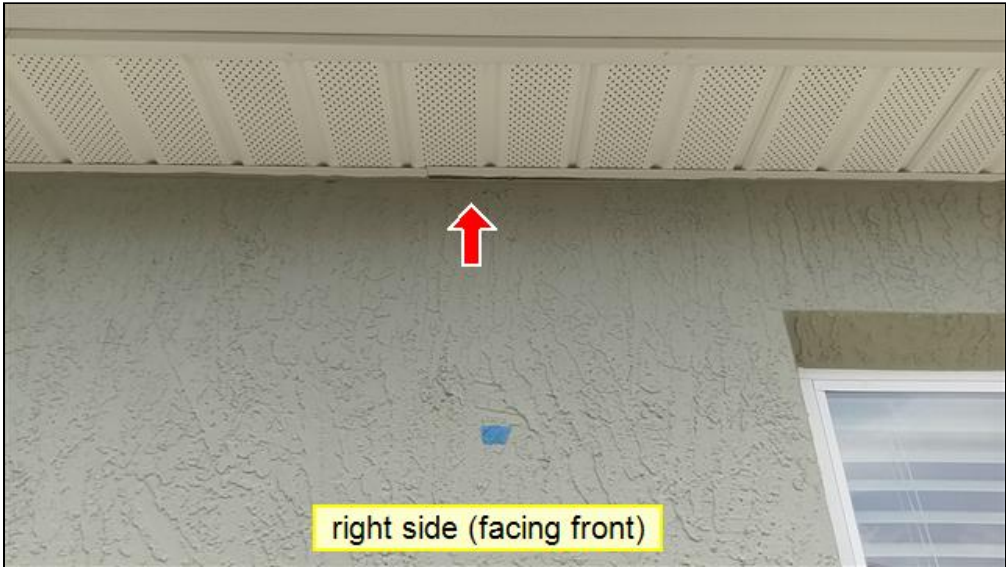
2.5 A gap between the fascia and roof sheathing exists which allows insects or bees to enter attic.

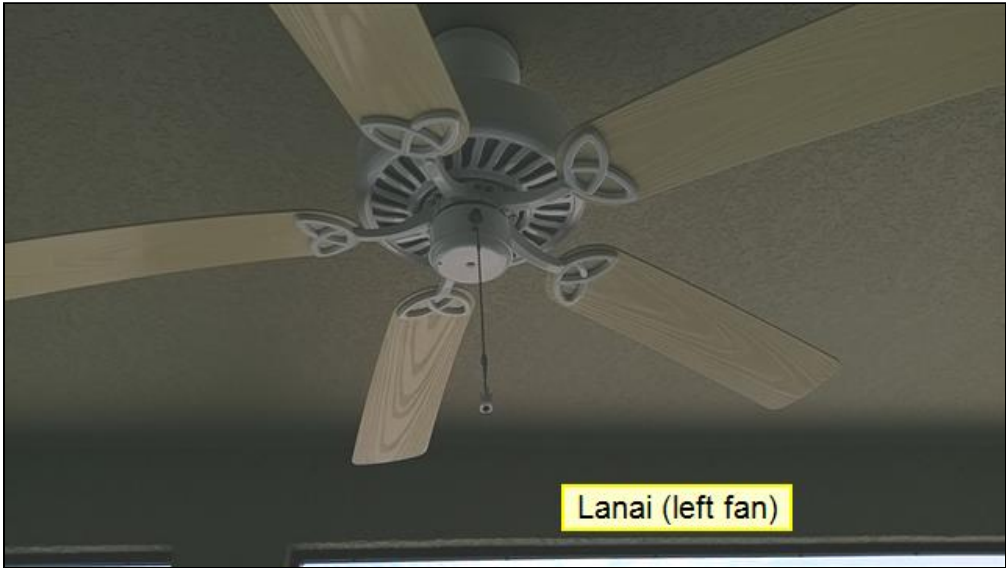
**2.7** The ceiling fan in the Lanai does work, but only two speeds of the three speeds are working. A qualified licensed electrical contractor should perform repairs that involve wiring.

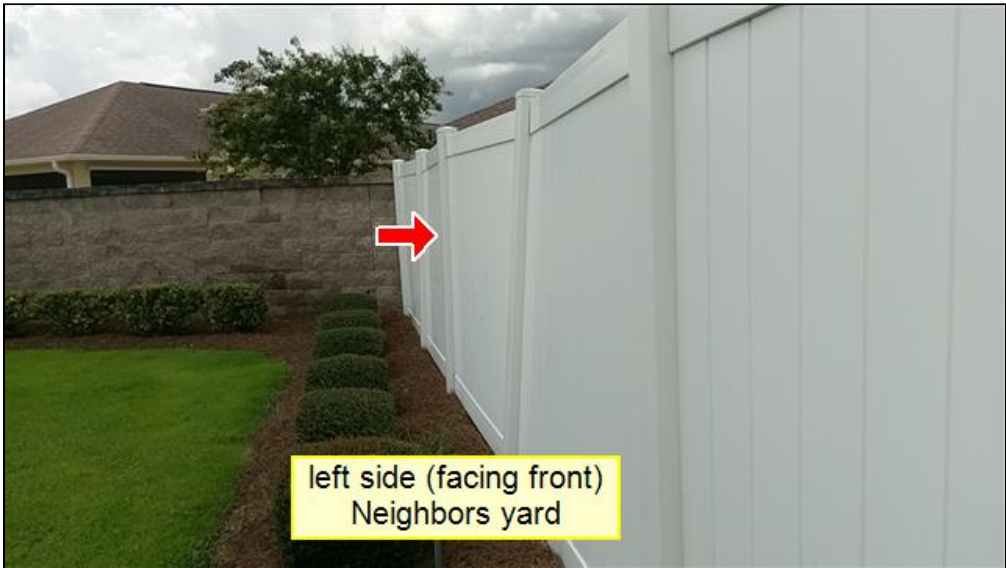
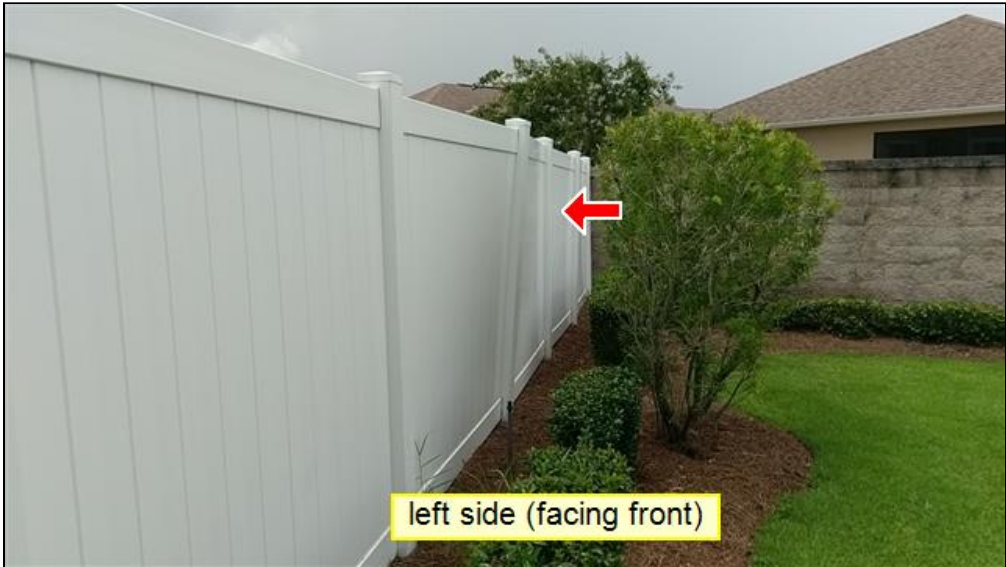
**2.9** Fence had post that had failed due to possibly being hit by landscapers. The fences were leaning in these areas.

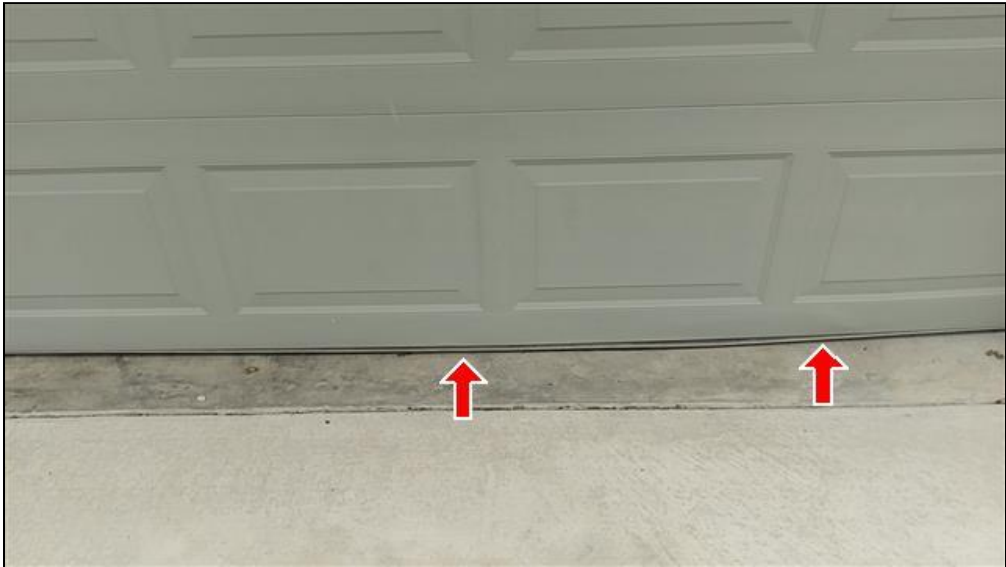
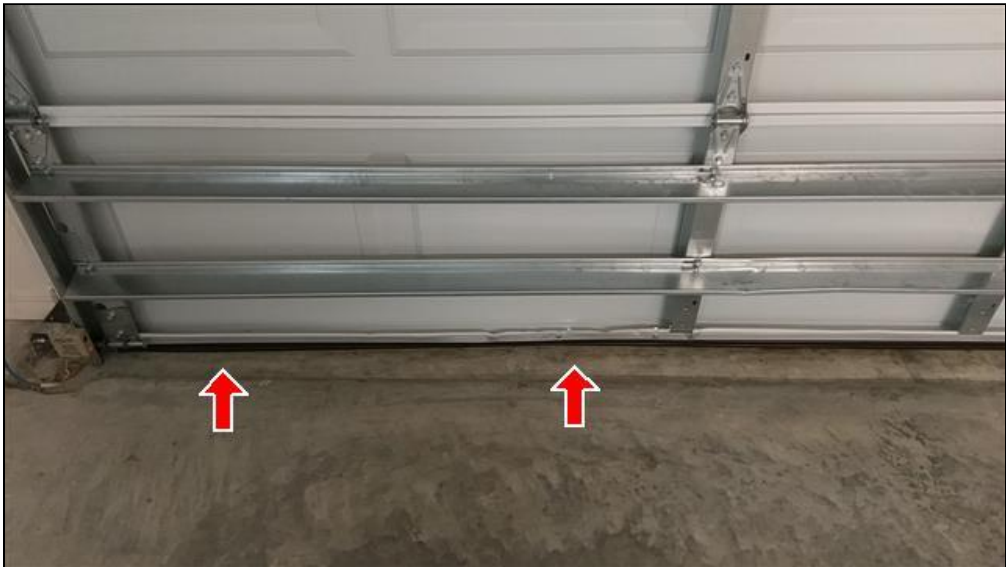
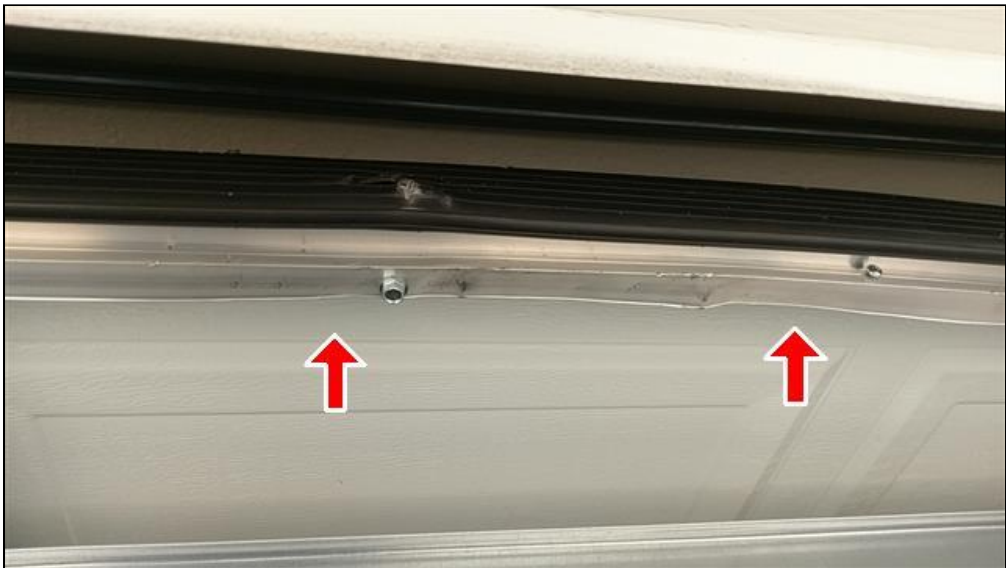
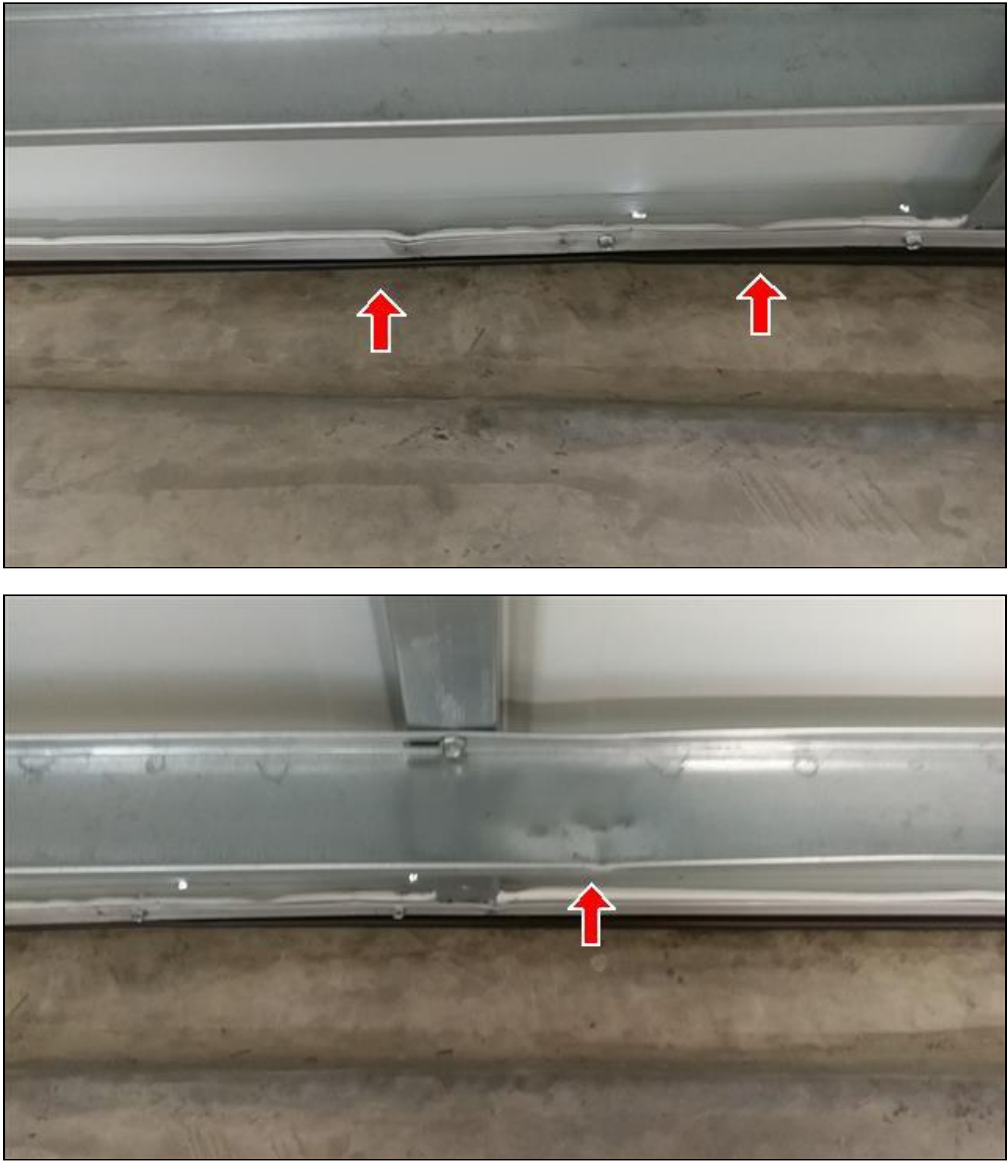
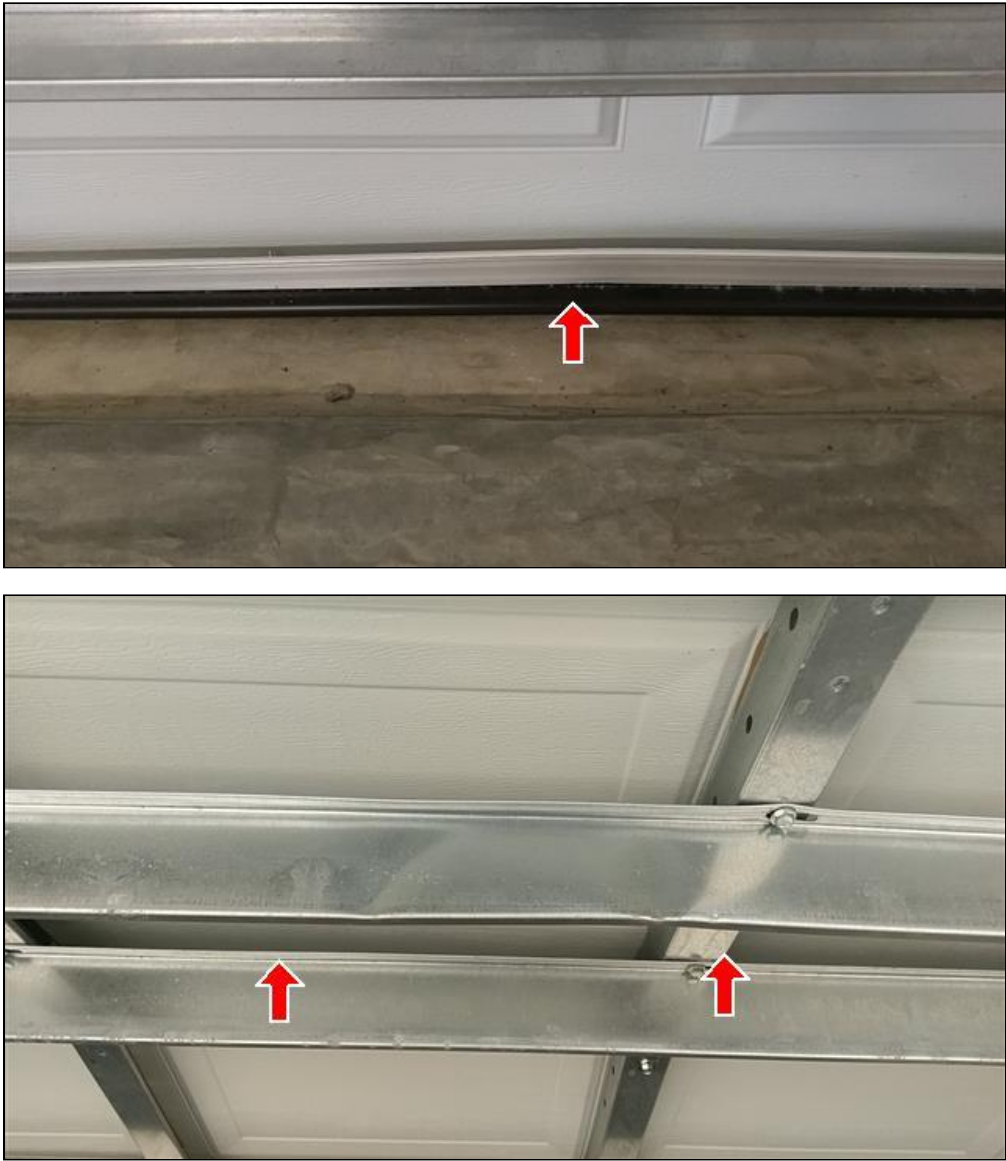
**4.8** A garage vehicle door panel had moderate damage visible and is very noisy (bangs) when first opening. The Inspector recommends maintenance be performed by a qualified contractor.

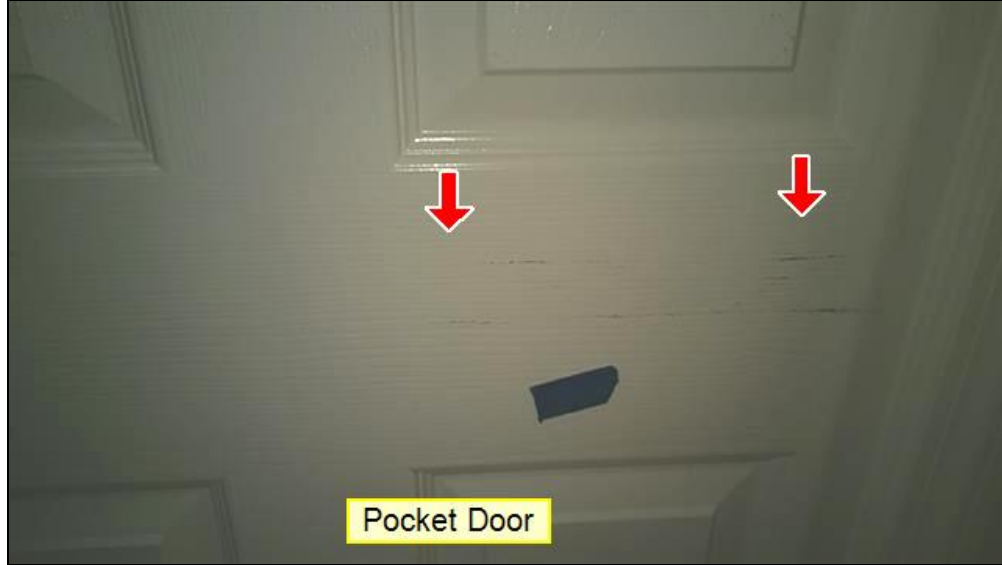
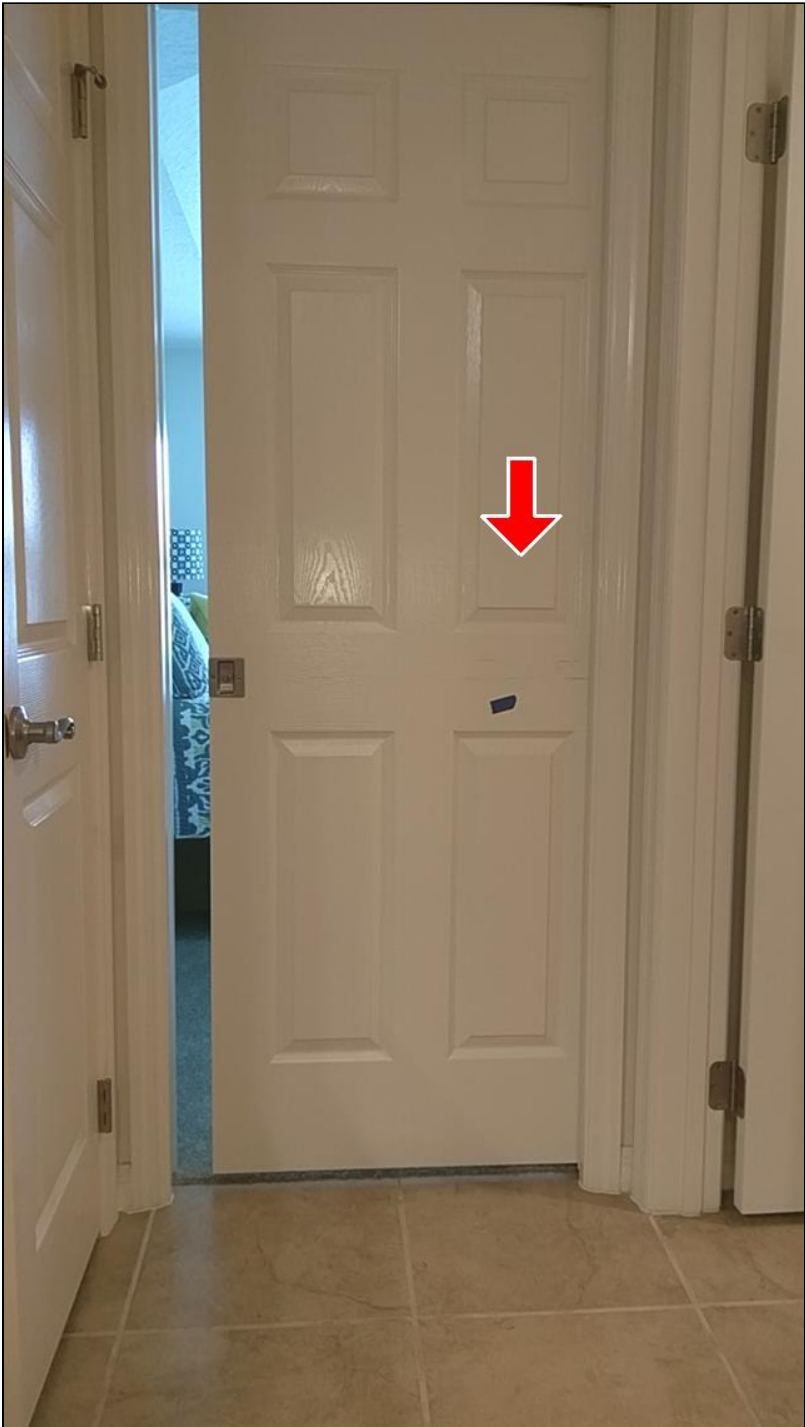
**9.3.A** The Pocket door is damaged and needs adjustment at the master bathroom. This is a small repair. A qualified person should repair or replace as needed.

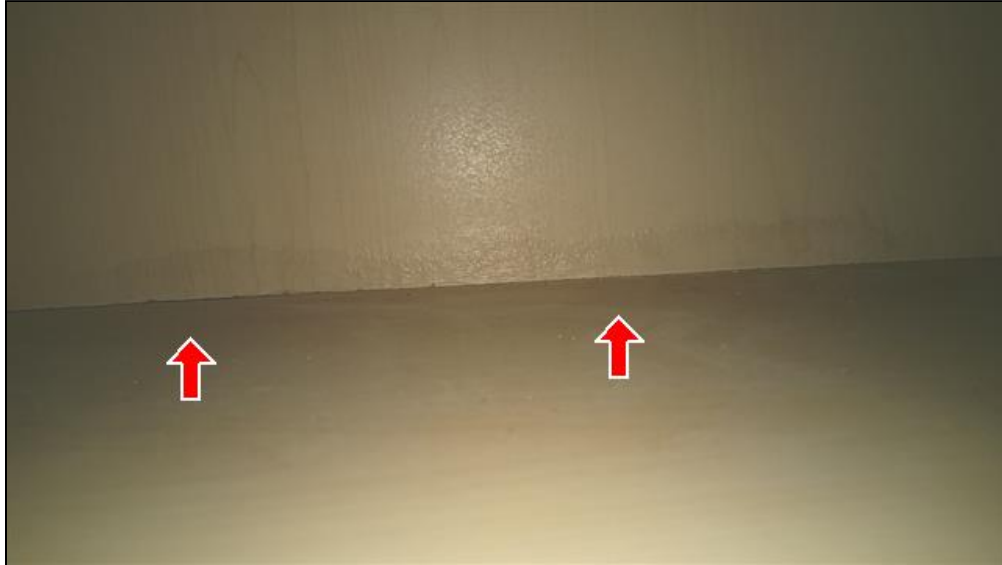
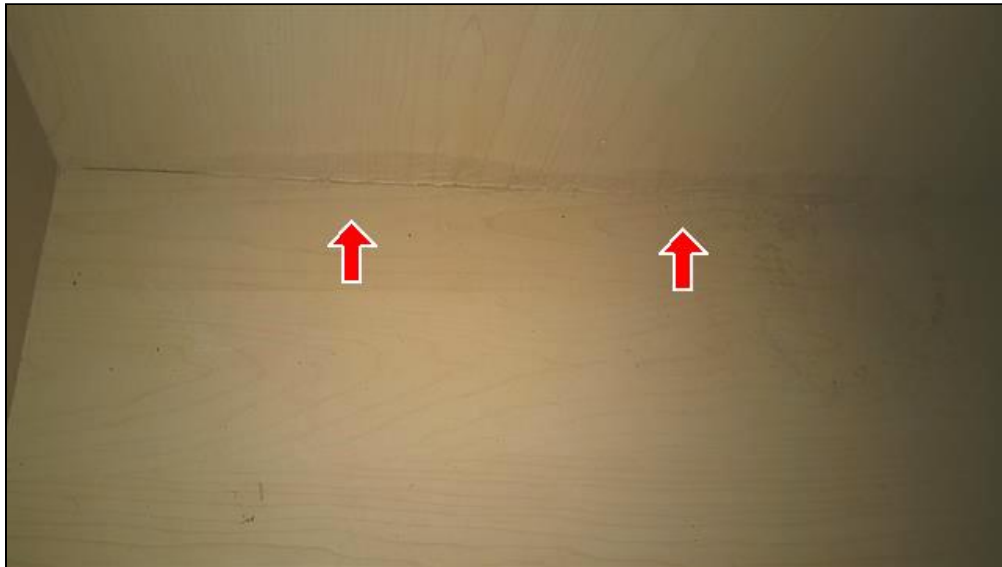
9.5.A Base cabinetry in master bathroom is damaged (under sink at bottom shelf) from a previous leak. This is a cosmetic issue for your information. I recommend repair or replace as necessary.

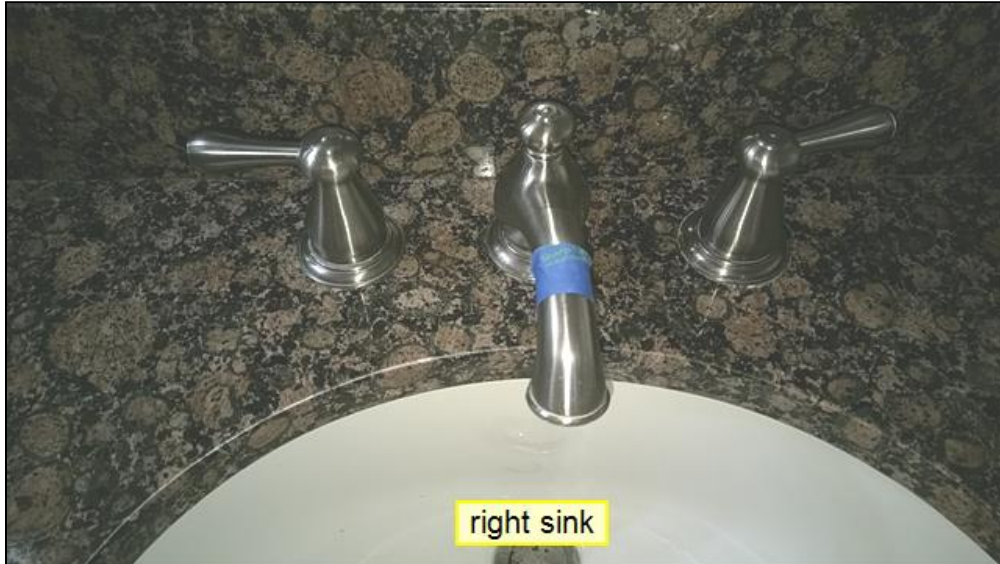
right

**9.7.A** The sink faucet (right sink) is loose at the master bathroom. Repairs are needed. A qualified licensed plumber should repair or correct as needed.

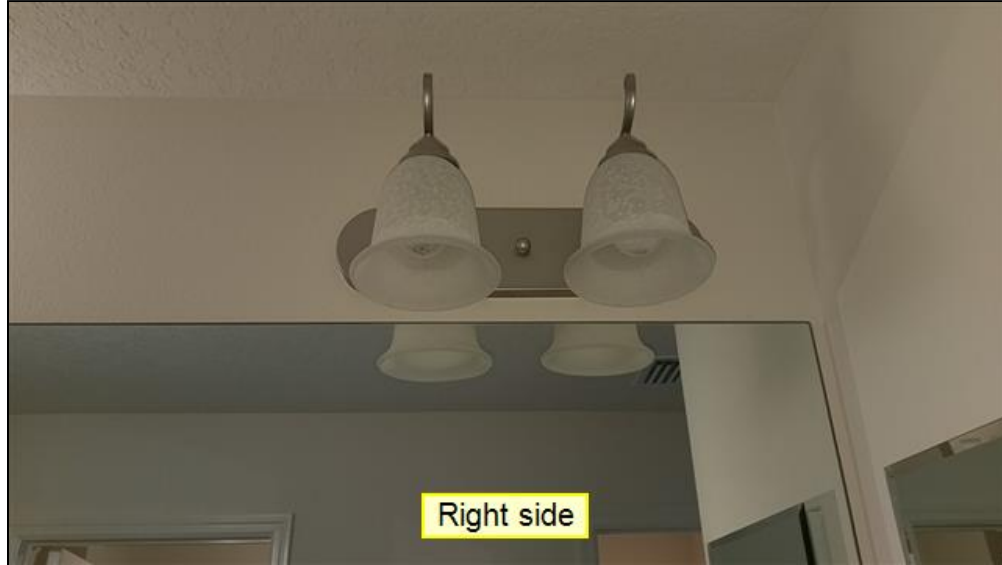
**9.8.A** The right light fixture does not work (try bulb first) at the master bathroom. This is for your information. A qualified licensed electrical contractor should perform repairs that involve wiring.

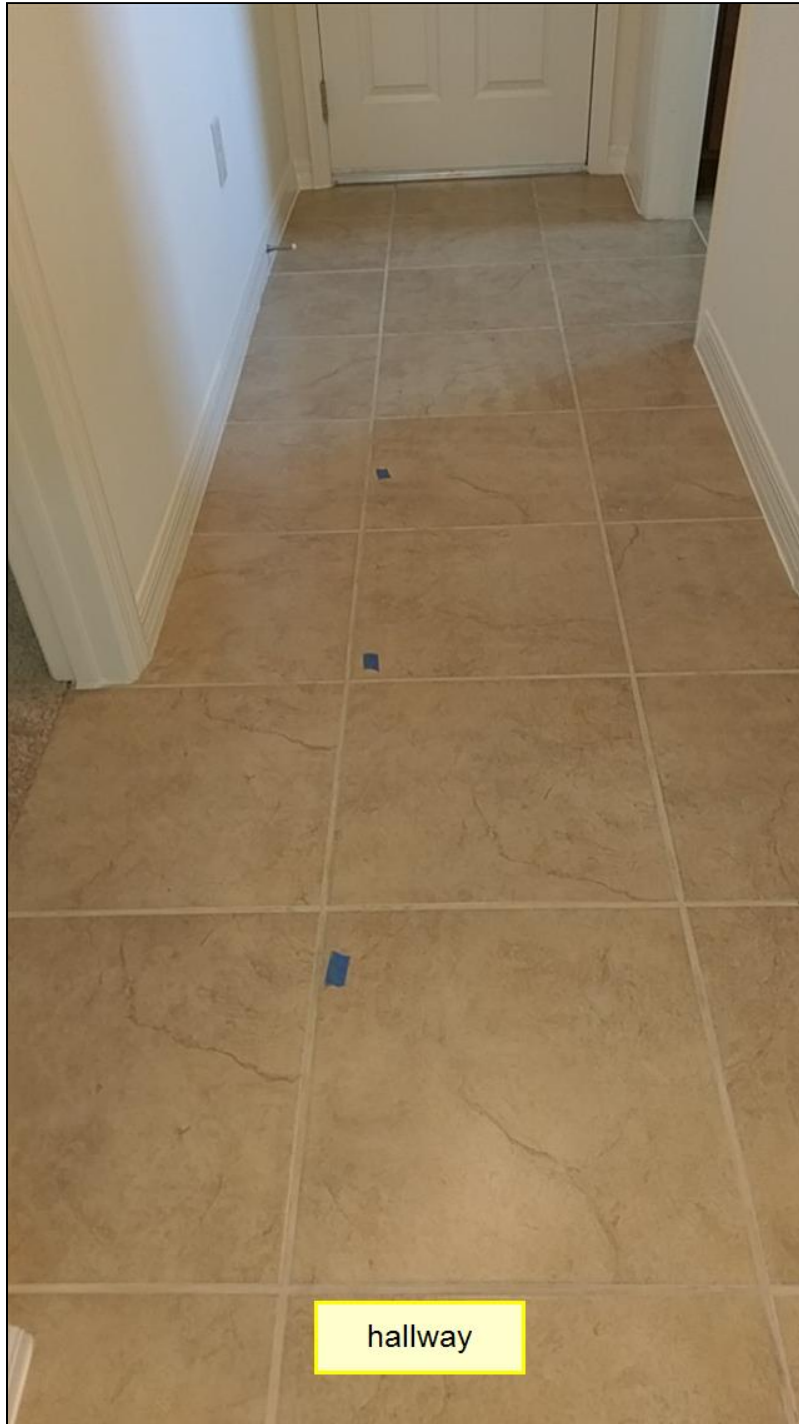
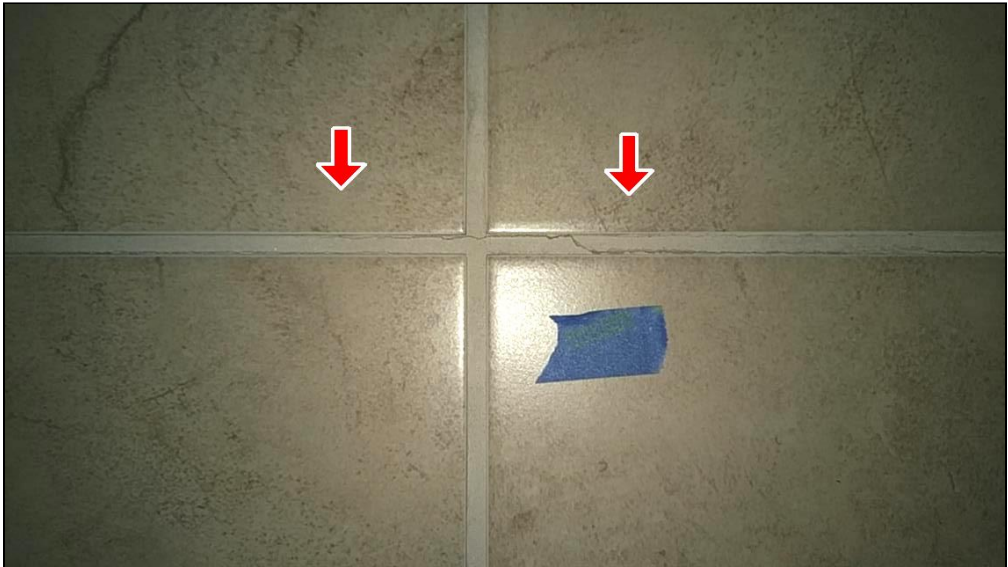
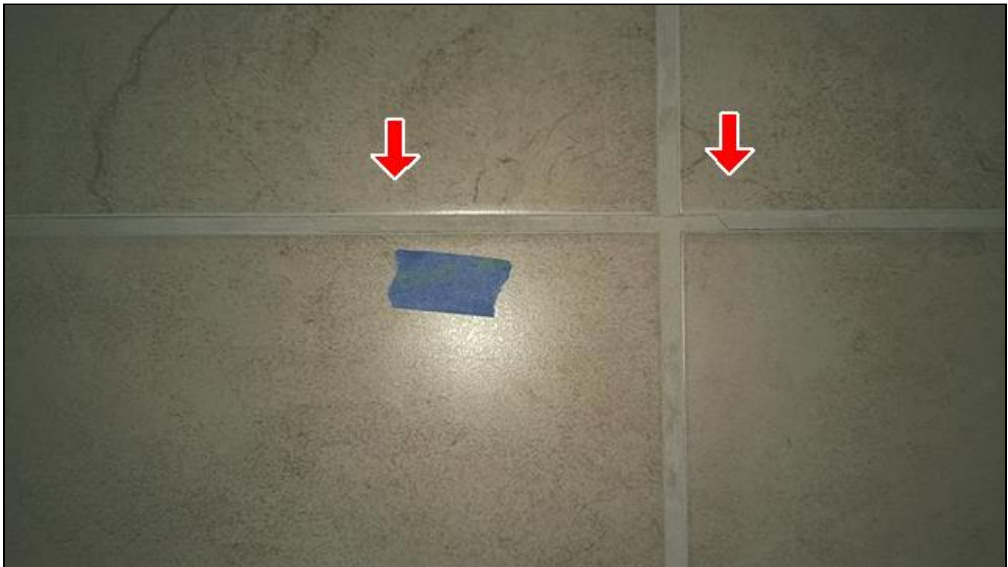
10.2 The Tile has cracked mortar at various places in the hallway. While this is cosmetic, it needs to be repaired. A qualified person should repair or replace as needed.
