Inspection Report

Property Address:
1234 Main St
The Villages FL 32162

The Village Home Inspector

General Summary

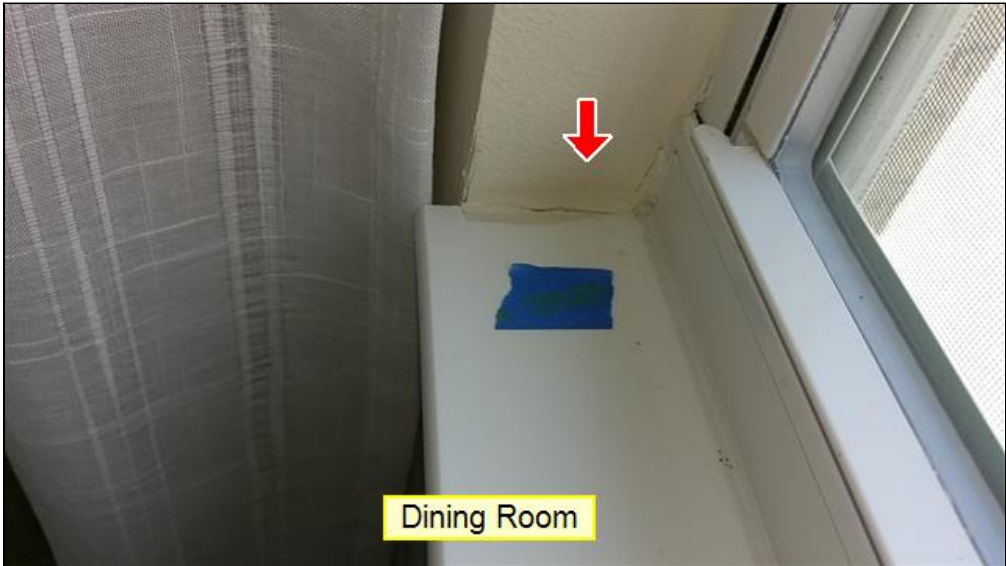
dr

10.5 Two windows have cracks in the walls around the frame, should be repaired to prevent further damage at the at the Living Room and Dining Room. This is a cosmetic issue for your information. I recommend prep and paint using a qualified contractor.
