GoldEye Home Inspection Ltd

Home Inspection Report

RE: Report No. SAMPLE
Guelph, ON

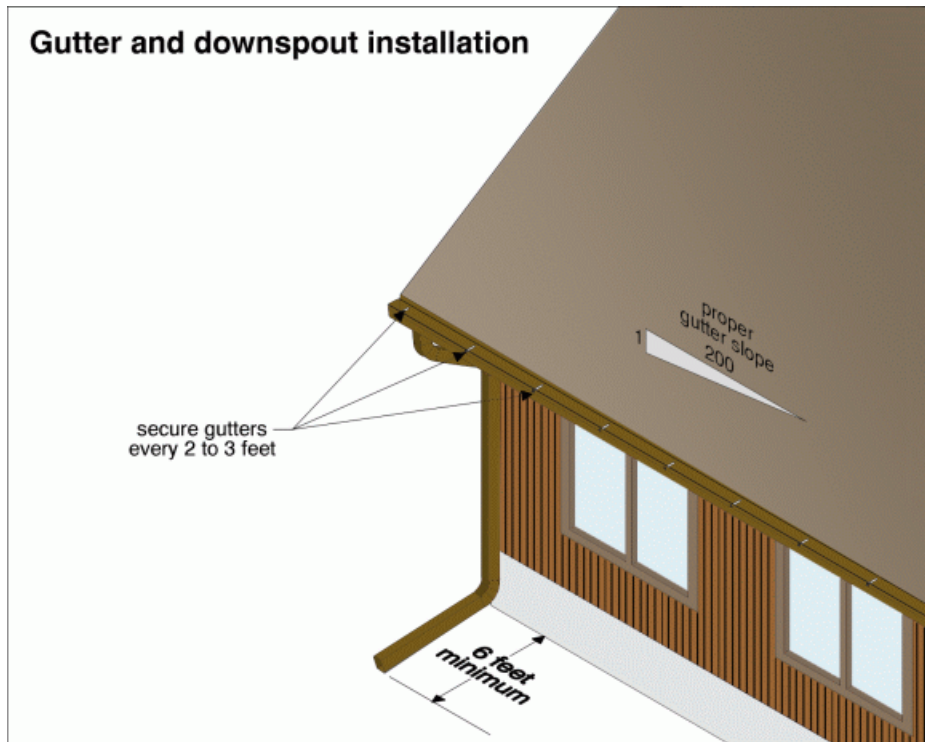
Improper slope, ponding

Condition: • [Improper slope, ponding](#)

Implication(s): Chance of water damage to contents, finishes and/or structure

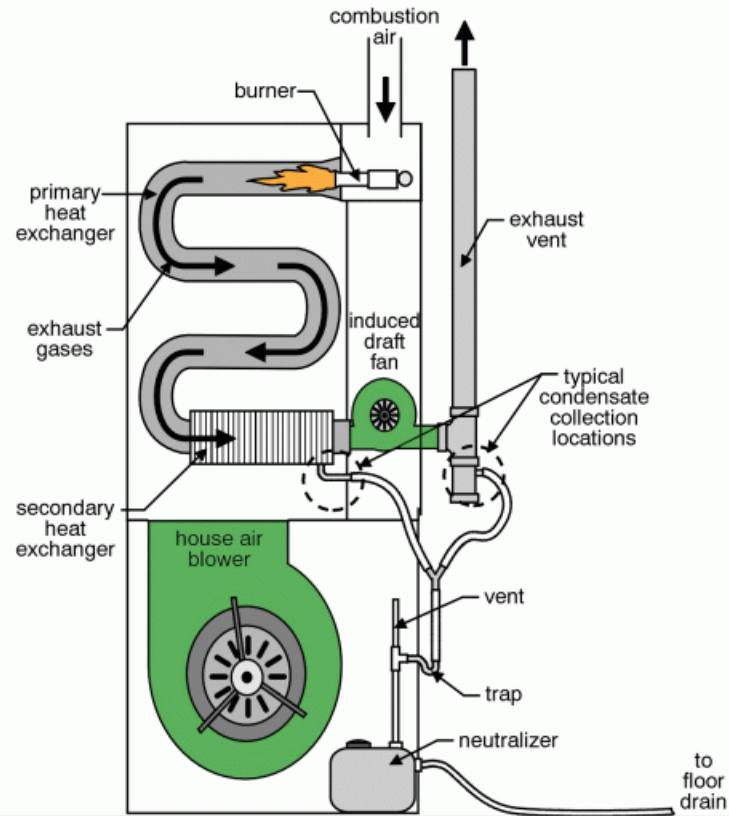
Condensate problems

Condition: • [Condensate problems](#)

Recommend servicing furnace by qualified HVAC (Heating Ventilation Air Conditioning) technician prior to winter. Ensure leak is repaired.

Implication(s): Chance of water damage to contents, finishes and/or structure | Reduced system life expectancy

Task: Repair/Further evaluation

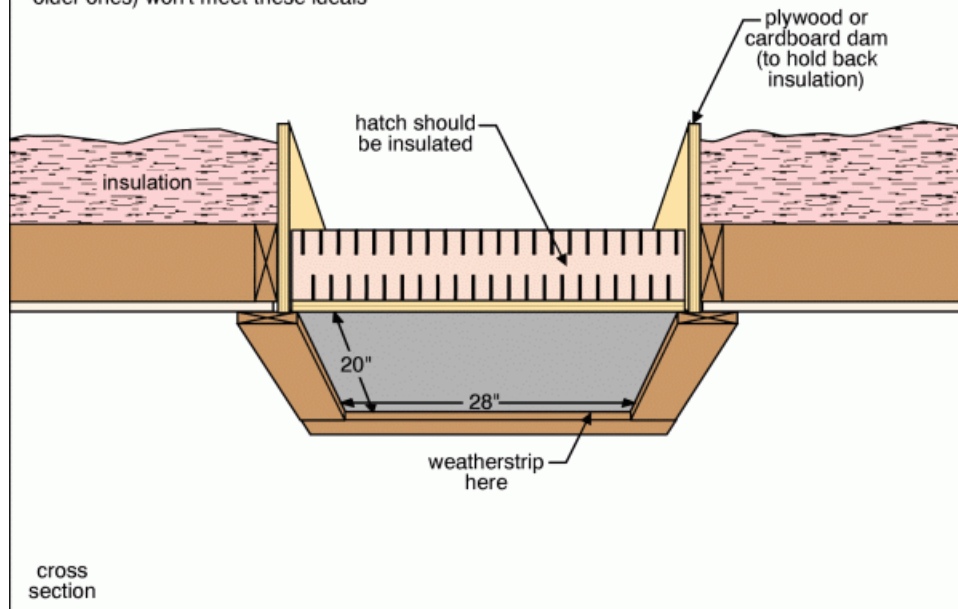
Not weatherstripped

Condition: • [Not weatherstripped](#)

Black stains on wood are possibly mold. Warm air leaking past hatch door can condense on the wood when attic is cold. Weatherstripping should be provided to reduce chance of further moisture damage.

Implication(s): Chance of condensation damage to finishes and/or structure | Increased heating and cooling costs

Task: Repair or replace

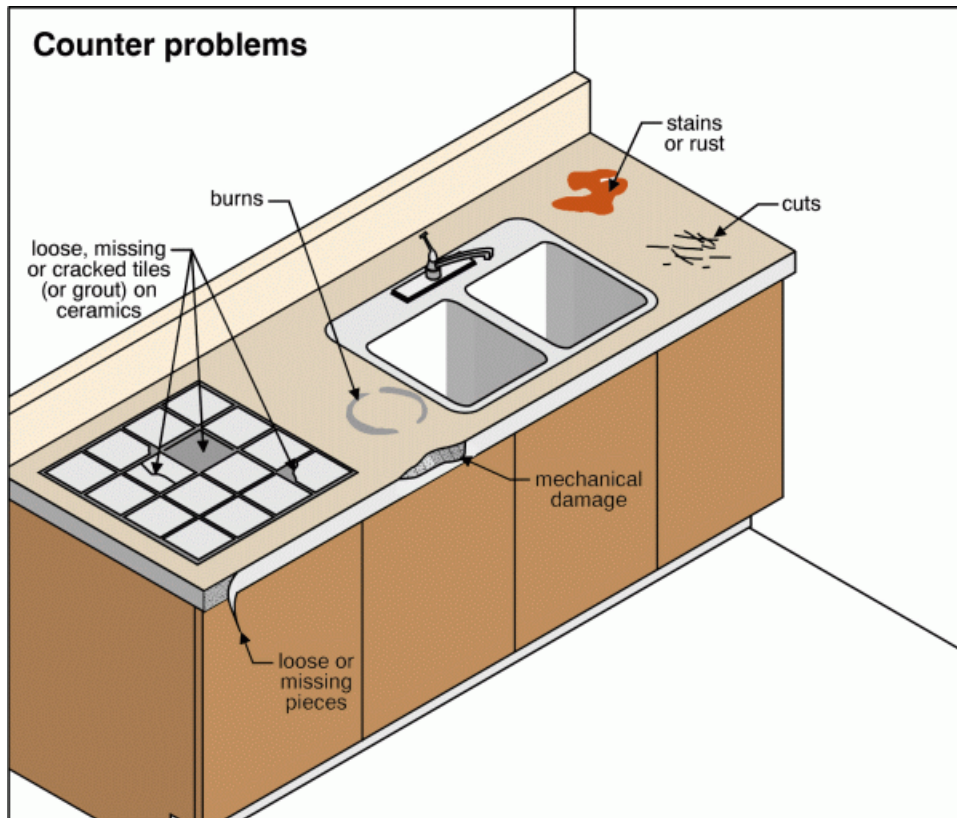
Damage, stained

Condition: • [Damage, stained](#)

Task: Correct

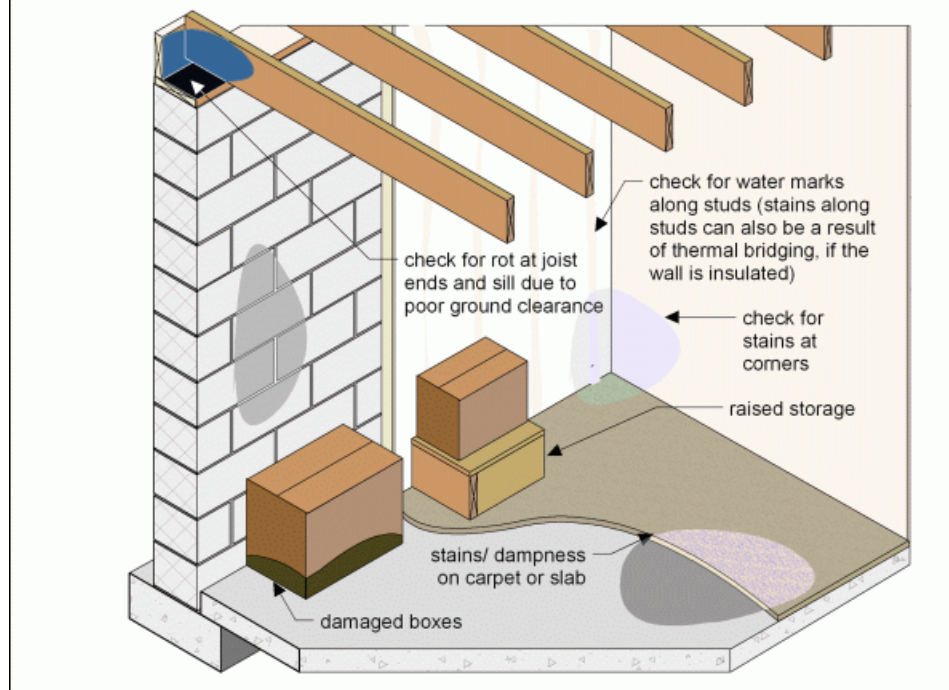
Stains

Condition: • [Stains](#)

Staining on the floor joists above the basement bathroom indicates an ongoing problem with humidity in this area. It could be related to the use of the Heat Recovery Ventilator fan for ventilation in this area. Operating the primary fan frequently or continuously can help to remove moisture from the house and reduce the chance of mildew or mold growth in these areas.

Implication(s): Cosmetic defects | Chance of water damage to contents, finishes and/or structure
