# Confidential Inspection Report

LOCATED AT:  
777 Luck Ln  
Happyville Utah

Inspector, Heath Madsen  
J-Pro Inspects

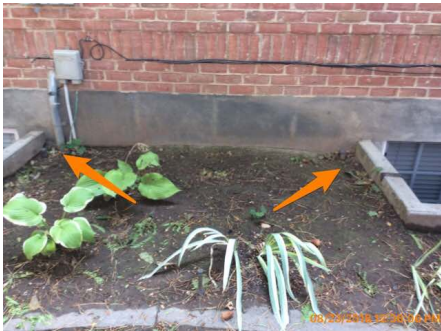
**RM Mo s-22:** - The soil or grading sloped towards building(s). This can result in water accumulating around/under the foundation and in basements. Recommend grading soil so it slopes away from the structure. The recommended slope is at least 1 inch per horizontal foot for every 6 feet out from buildings.

**RM Mo 22:** - The soil or grading sloped towards building(s). This can result in water accumulating around/under the foundation and in basements. Recommend grading soil so it slopes away from the structure. The recommended slope is at least 1 inch per horizontal foot for every 6 feet out from buildings.

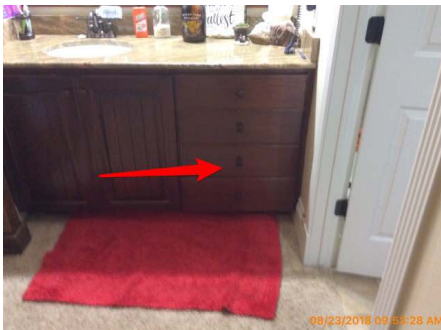
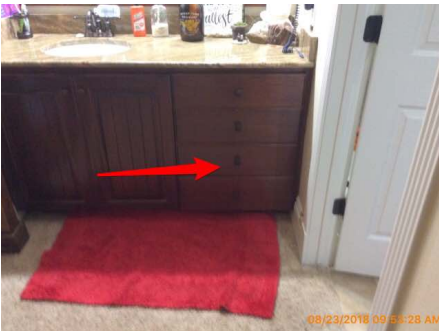
**s-99:** - The main water line entry and shut off was located behind the drawers in the NW bedroom/bathroom vanity. The seller was unable to get the drawer catches to release so the shut off could be evaluated. The main line and shut off valve are excluded from this inspection. Recommend a qualified plumber move the shut off to an accessible location so the water can be turned off quickly in the event of an emergency.

**99:** - The main water line entry and shut off was located behind the drawers in the NW bedroom/bathroom vanity. The seller was unable to get the drawer catches to release so the shut off could be evaluated. The main line and shut off valve are excluded from this inspection. Recommend a qualified plumber move the shut off to an accessible location so the water can be turned off quickly in the event of an emergency.

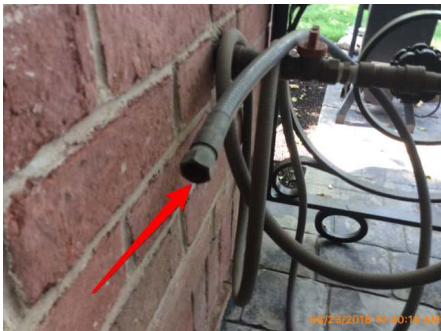
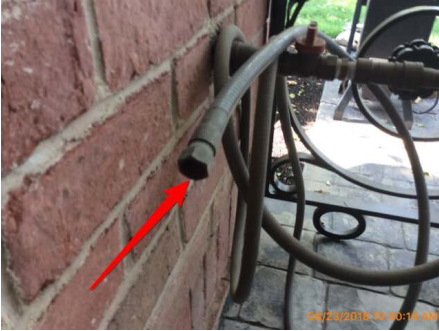
**Safe RR s-110:** - The natural gas supply terminations at the BBQ were unused (no appliance connected) and no cap was installed on the gas shut-off valve(s). Gas can flow directly out of the termination with the shut-off valve is opened. This is a potential fire hazard. Recommend that a qualified person install caps where missing per standard building practices.

**Safe RR 110:** - The natural gas supply terminations at the BBQ were unused (no appliance connected) and no cap was installed on the gas shut-off valve(s). Gas can flow directly out of the termination with the shut-off valve is opened. This is a potential fire hazard. Recommend that a qualified person install caps where missing per standard building practices.

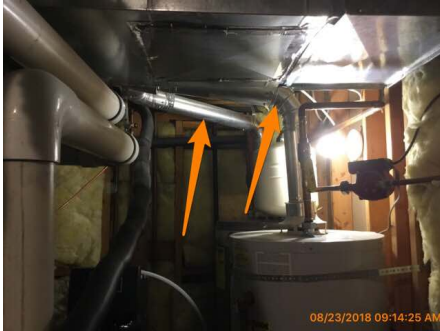
**Safe** **RR** **s-122:** - The flues were undersized for the units. Units with a BTU rating 38,000 or greater should have a four inch flue pipe installed. Recommend having a plumber replace the 3 inch flue pipe with a 4 inch flue.

**Safe** **RR** 122: - The flues were undersized for the units. Units with a BTU rating 38,000 or greater should have a four inch flue pipe installed. Recommend having a plumber replace the 3 inch flue pipe with a 4 inch flue.

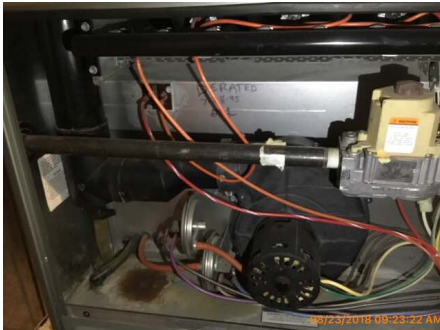
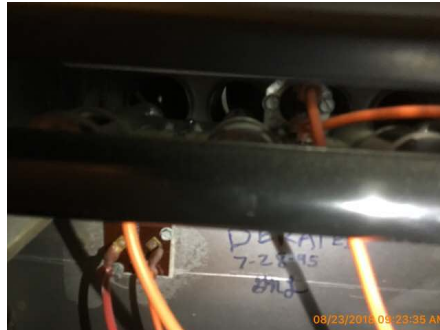
**Safe** **E** **s-133:** - Because of the age of and condition of the forced air furnace, recommend that a qualified HVAC contractor inspect the heat exchanger and perform a carbon monoxide test when it's serviced. Note that these tests are beyond the scope of a standard home inspection. Recommend having this service completed prior to the due diligence date.

**Safe E** 133: - Because of the age of and condition of the forced air furnace, recommend that a qualified HVAC contractor inspect the heat exchanger and perform a carbon monoxide test when it's serviced. Note that these tests are beyond the scope of a standard home inspection. Recommend having this service completed prior to the due diligence date.

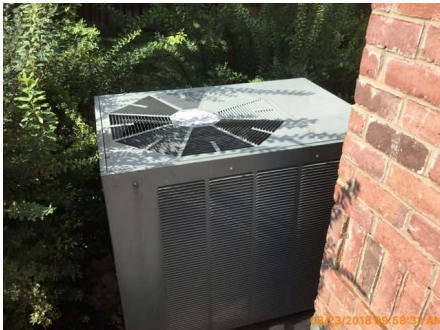
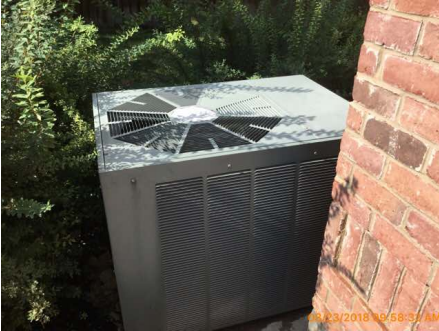
**MD** **s-146:** - The estimated useful life for most heat pumps and air conditioning condensing units is 10-15 years. The inspector was unable to determine the age of this unit. Be aware that it may be near, at, or beyond its useful life and may need replacing or significant repairs at any time. Recommend attempting to determine the age (ask property owner or service technician), and budgeting for a replacement.

**MD 146:** - The estimated useful life for most heat pumps and air conditioning condensing units is 10-15 years. The inspector was unable to determine the age of this unit. Be aware that it may be near, at, or beyond its useful life and may need replacing or significant repairs at any time. Recommend attempting to determine the age (ask property owner or service technician), and budgeting for a replacement.

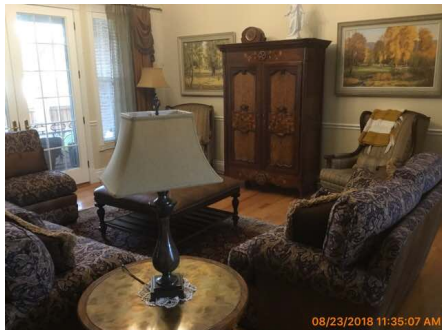
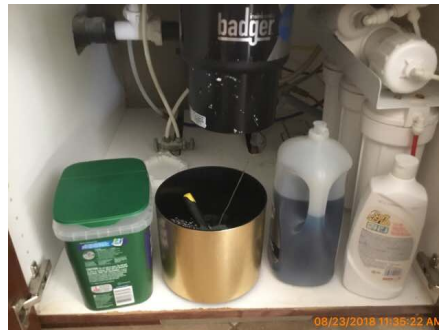
**E** 5: - Many areas and items at this property were obscured by furniture, stored items and debris. This often includes but is not limited to walls, floors, windows, inside and under cabinets, under sinks, on counter tops, in closets, behind window coverings, under rugs or carpets, and under or behind furniture. Areas around the exterior, under the structure, in the garage and in the attic may also be obscured by stored items. The inspector in general does not move personal belongings, furnishings, carpets or appliances. When furnishings, stored items or debris are present, all areas or items that are obscured, concealed or not readily accessible are excluded from the inspection. The client should be aware that when furnishings, stored items or debris are eventually moved, damage or problems that were not noted during the inspection may be found.

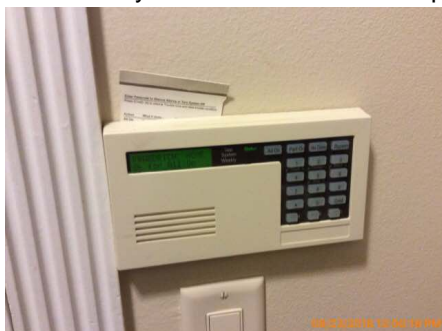
6: - Based on visible equipment an alarm system was installed at this property. This is a specialty system that is excluded from this inspection. Comments in this report related to this system are made as a courtesy only and are not meant to be a substitute for a full evaluation by a qualified specialist. Recommend that a qualified specialist evaluate the these systems for defects and repair if necessary.

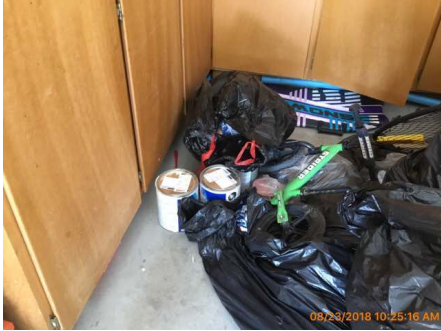
**E 7:** - Items that require special disposal and sometime a fee such as paint were found at the home. Client may wish to ask the sellers to remove these items before closing.

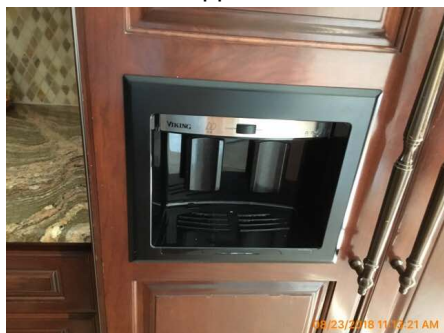
17: - No water appeared to be attached to the fridge or the dispenser controls did nothing.

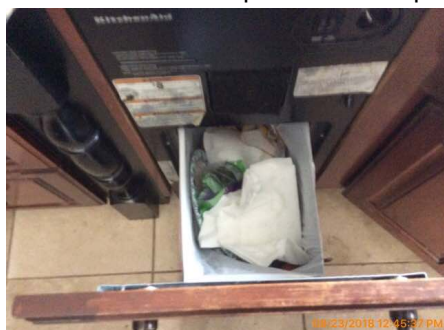
19: - The trash compactor was inoperable. Did not respond to testing.

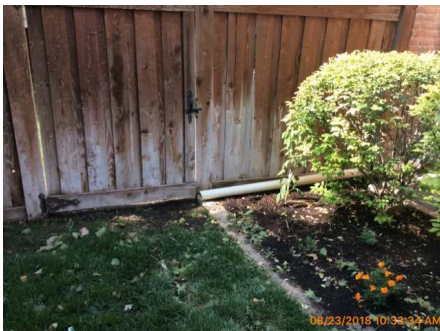
33: - The wood fencing was damaged or in need of general maintenance.

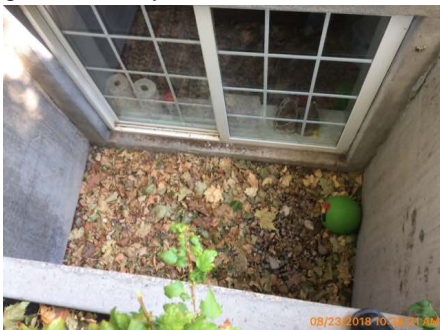
34: - Due to the size/depth or close proximity to walkways of the window wells, recommend installing covers for greater safety.

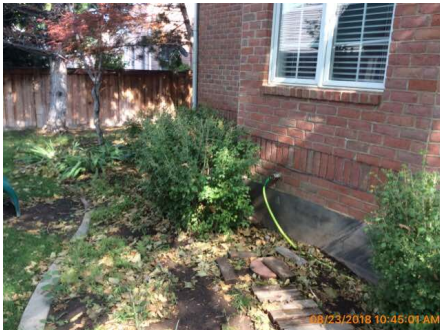
**RM 38:** - Vegetation such as trees, shrubs and/or vines was in contact with or close to the building exterior. Vegetation can serve as a pathway for wood-destroying insects and can retain moisture against the exterior after it rains. This is a conducive condition for wood-destroying organisms. Recommend pruning, moving or removing vegetation as necessary to maintain at least 6 inches of space between it and the building exterior. A 1-foot clearance is better.

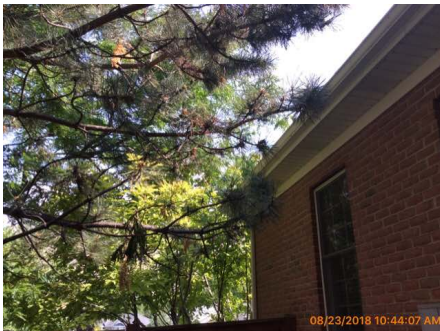
**RM 39:** - Trees were in contact with or were close to the building at one or more locations. Damage to the building can occur, especially during high winds. Recommend that a qualified tree service contractor or certified arborist remove trees as necessary to prevent damage to the building exterior.

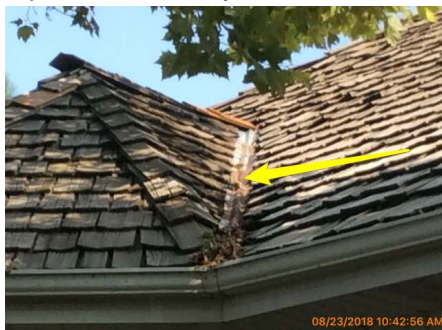
**RR 51:** - One or more roof flashings were rusted. Leaks can occur as a result. Recommend that a qualified person repair as necessary.

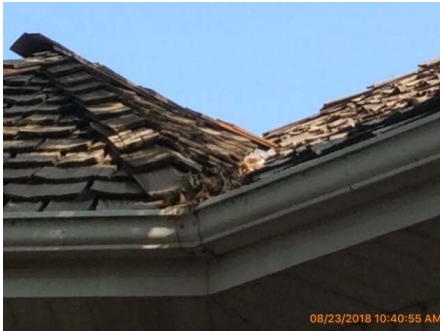
**RM 52:** - Debris had accumulated in one or more gutters or downspouts. Gutters can overflow and cause water to come in contact with the building exterior, or water can accumulate around the foundation. This is a conducive condition for wood-destroying organisms. Recommend cleaning gutters and downspouts now and as necessary in the future.

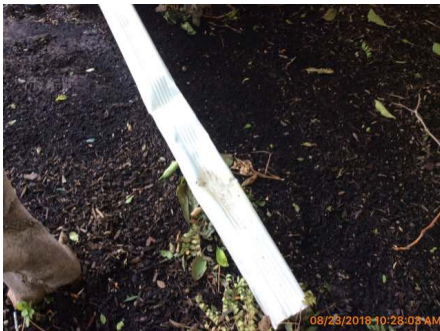
**RR 53:** - One or more downspouts and down spout extensions were damaged. Rainwater can come in contact with the building exterior or accumulate in and around the building as a result. Recommend that a qualified person repair as necessary.

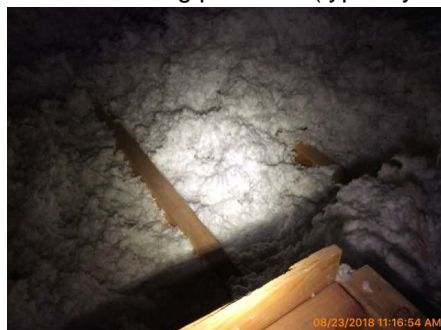
**61:** - The ceiling insulation in one or more areas of the attic was compacted or uneven and missing. Heating and cooling costs may be higher due to reduced energy efficiency. Recommend that a qualified person repair, replace or install insulation as necessary and per standard building practices (typically R-38).

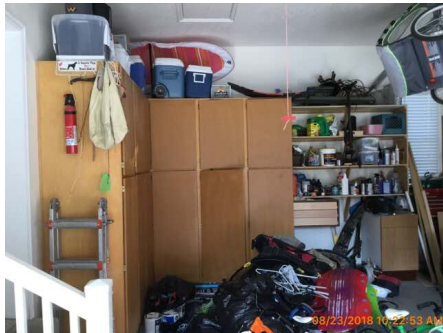
**E 76:** - The attic access hatch in the garage was blocked by a vehicle or stored items. The inspector was unable to enter, view or traverse the attic space over the garage. This area is excluded from this inspection.

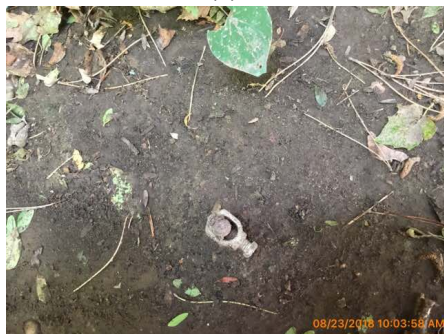
85: - Ground rod(s) in soil.

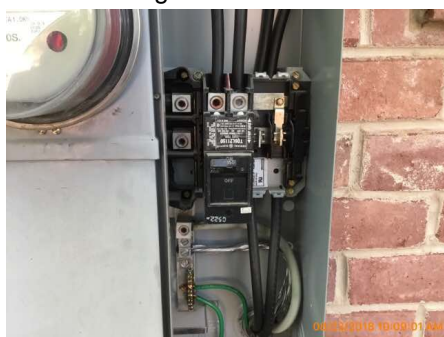
86: - Building exterior.

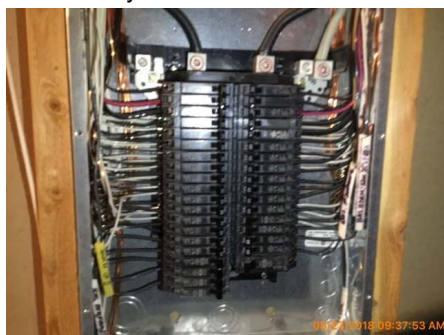
87: - Utility room.

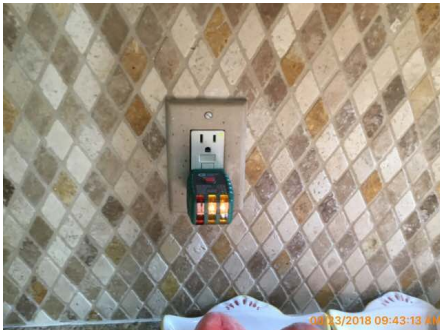
Kitchen

**Safe** **RR** 92: - One or more receptacles (outlets) were worn. Worn receptacles can work intermittently or when the plug is wiggled. They can overheat or arc and spark due to loose connections. Recommend that a qualified electrician replace such receptacles as necessary.

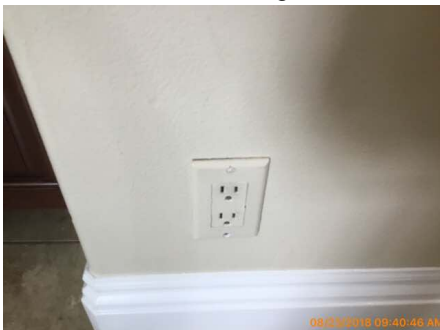
Kitchen

**Safe** **RM** 93: - Some electric receptacles (outlets) and/or the boxes in which they were installed were loose and/or not securely anchored. Wire conductors can be damaged due to repeated movement and/or tension on wires, or insulation can be damaged. Recommend that a qualified electrician repair as necessary.

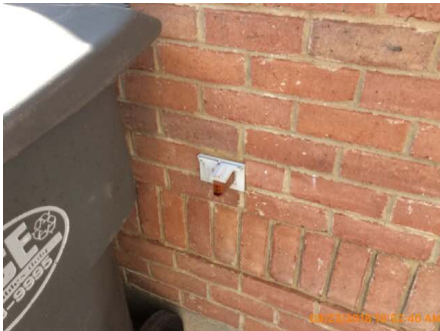
Outside the garage

**RM E 94:** - One or more electric receptacles (outlets) appeared to have no power. Switches may need to be operated to make some receptacles energized. If necessary, recommend that a qualified electrician evaluate and repair.

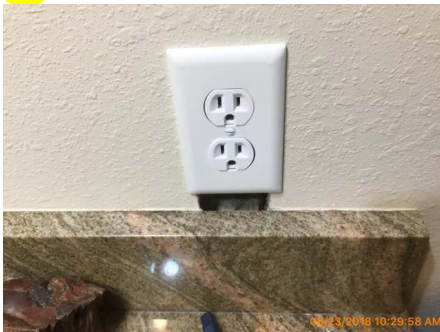
Basement bedroom

**RR 96:** - Recommend installing oversized coverplates where gaps are visible.

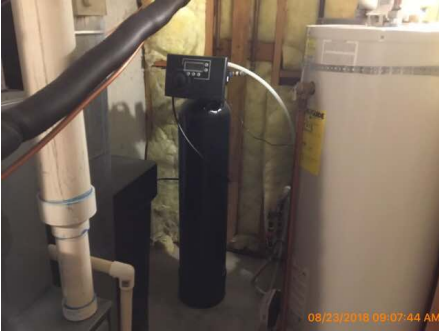
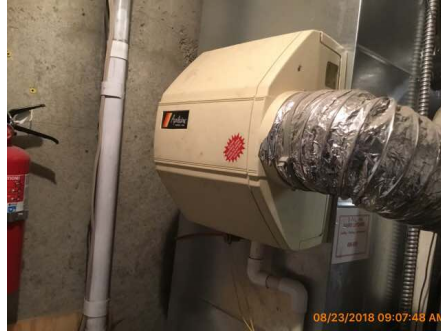
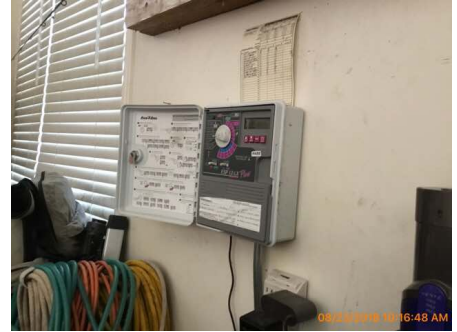
**98:** - Based on visible equipment a water softener, humidifier and sprinkler system were installed at the property. These are specialty systems and are excluded from this inspection. Comments in this report related to these systems are made as a courtesy only and are not meant to be a substitute for a full evaluation by a qualified specialist. Recommend that a qualified specialist evaluate the these systems for defects and repair if necessary.

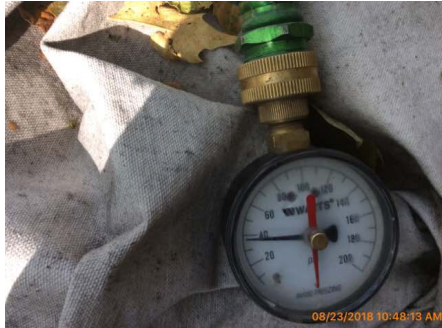
**100:** - 38 PSI.

**102:** - Water pressure was below 40 pounds per square inch (PSI), but the flow appeared to be adequate. 40-80 PSI is considered the normal range for water pressure in a home. The inspector performed a "functional flow test" during the inspection, where multiple fixtures were run simultaneously and checked for significantly decreased flow. For example, the shower flow did not decrease significantly when the toilet was flushed. However, this is not a guarantee that the client will find the pressure and flow to be adequate. If the client does find the flow to be inadequate, they should have a qualified plumber evaluate and repair as necessary. A pressure-boosting system was installed. For information on these systems, visit:

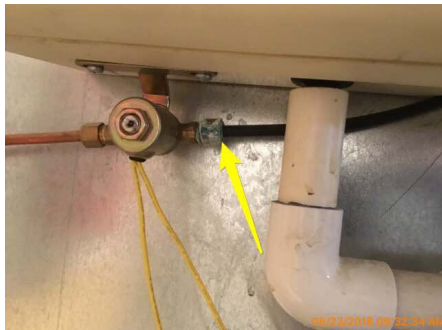
**104:** - Corrosion was found in some water supply pipes or fittings. Leaks can occur as a result. Recommend that a qualified plumber evaluate and replace components as necessary.

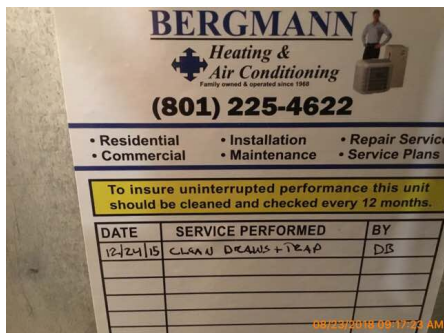
126: - 12/24/15

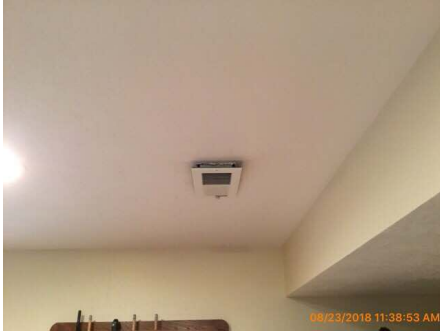
**RM 138:** - Some air supply registers were loose or installed in a substandard way. Recommend that a qualified person repair as necessary so registers are securely attached and are flush with the surface on which they are installed.

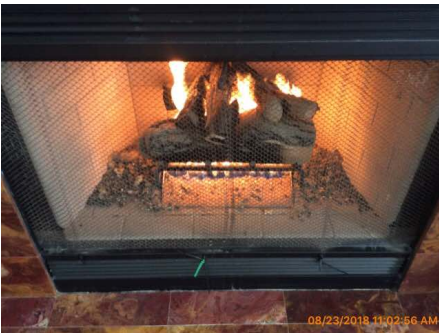
**149:** - Converted wood-burning fireplace.

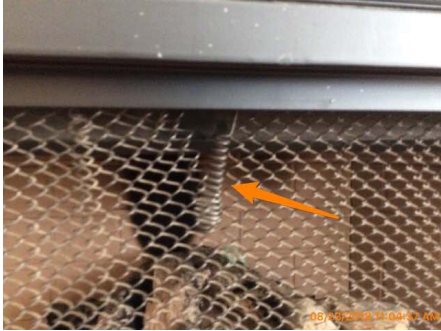
**Safe** **RR** **150:** - The fireplace was equipped with a gas burner and the chimney damper could close. This is a safety hazard due to the possibility of burner or pilot light exhaust gases entering living spaces. Modifications should be made to prevent the damper from ever closing to prevent this. A qualified contractor should repair per standard building practices so the damper cannot close.

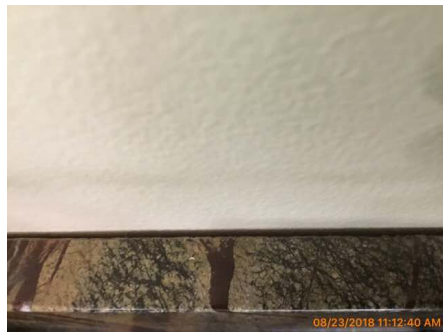
Master bathroom

**155:** - Gaps, no caulk, or substandard caulking were found between the backsplash and the wall in the master bathroom. Water can penetrate these areas and cause damage. Recommend that a qualified person repair as necessary. For example, by installing or replacing caulk.

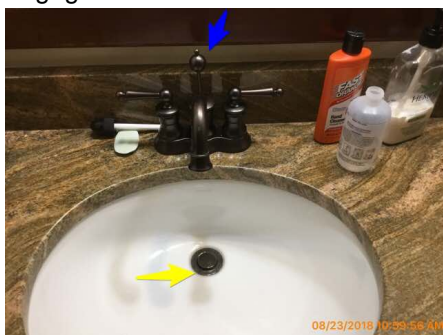
Basement bathroom

**RM 157:** - The sink drain stopper(s) in the basement bathroom and master bathroom allowed water to pass when engaged.

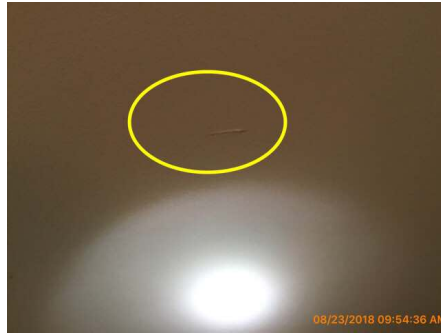
North bedroom

**RR 174:** - One or more doorstops were missing. Wall damage had occurred as a result.

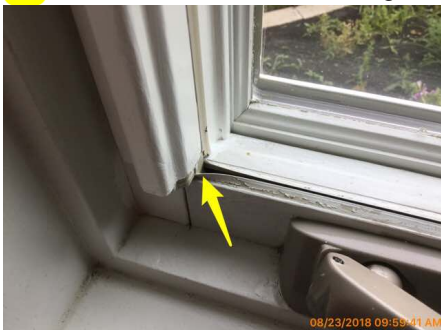
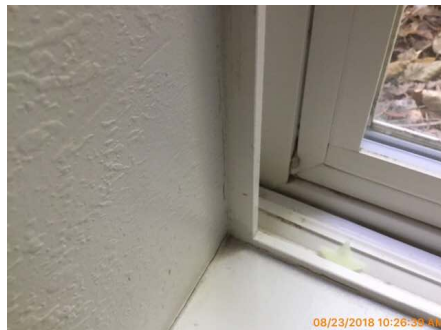
Basement bedroom

**Ma 176:** - Recommend caulking around the insides of windows where cracks are visible.

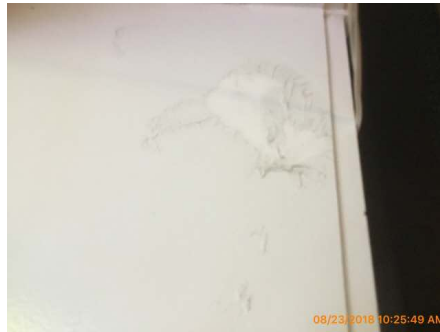
Basement bedroom

**178:** - Evidence of past water intrusion was found in one or more window sills. No elevated levels of moisture were found at the time of the inspection. The inspector is unable to determine the condition of underlying materials. Recommend monitoring these areas in the future especially during times of heavy and/or prolonged rain. If moisture is found in the future recommend a qualified person make repairs.

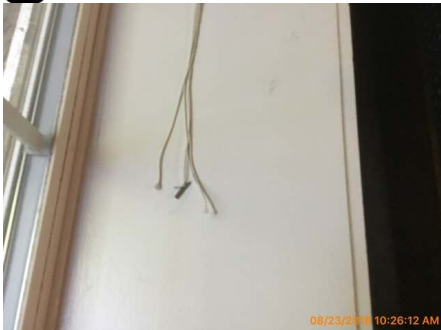
Basement bedroom

**C 179:** - Some window blinds were damaged.

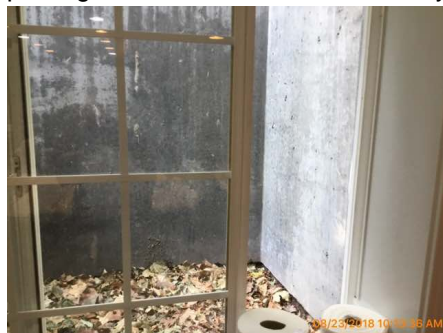
Basement south window.

**RR 181:** - One or more window screens were missing. These window(s) may not provide ventilation during months when insects are active. Recommend replacing window screens as necessary.

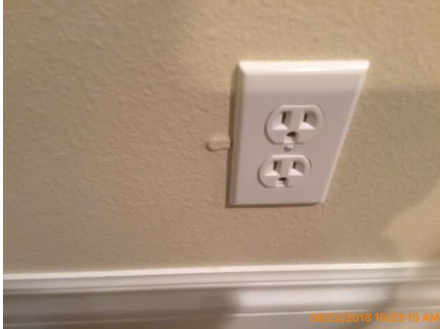
Basement Southwest wall

**RM 185:** - Minor cracks, nail pops and/or blemishes were found in walls and/or ceilings in one or more areas. Cracks and nail pops are common, are often caused by lumber shrinkage or minor settlement, and can be more or less noticeable depending on changes in humidity. They did not appear to be a structural concern, but the client may wish to repair these for aesthetic reasons. For recurring cracks, consider using an elastic crack covering product:

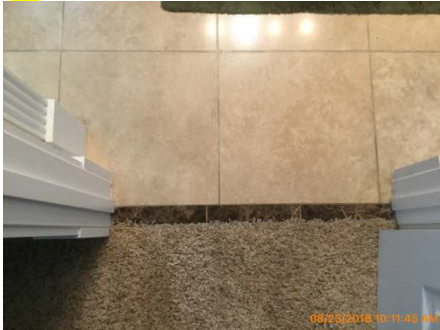
**RR 187:** - Recommend installing transition strips where two different types of flooring meet.

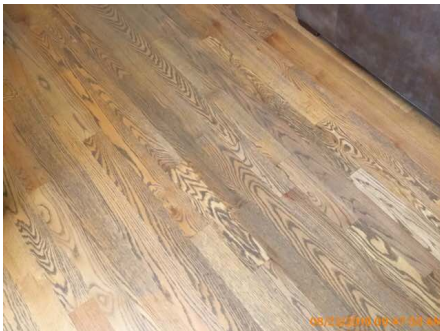
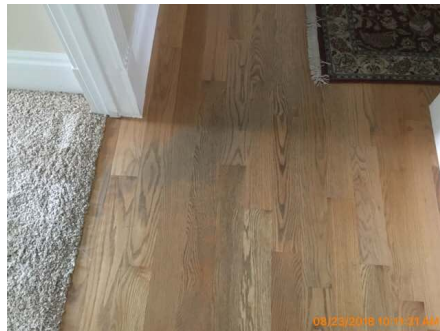
**Ma 188:** - Wood flooring in one or more areas was worn, deteriorated or damaged. Recommend that a qualified contractor refinish wood flooring as necessary.
