Home Inspection Report

Sample , Greenwich , CT 06830

Sunday, August 16, 2020

1st Selection Home Inspection

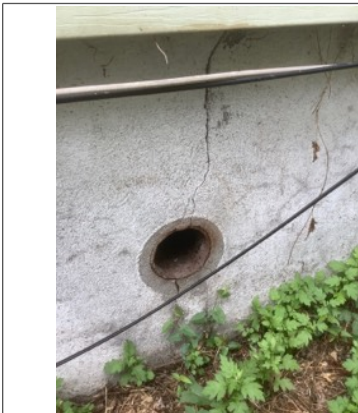
Foundations Repair/Monitor: Minor surface deterioration (spalling, crumbling material) was observed on foundation walls. This condition is common in many old homes and does not usually represent a serious structural concern unless there is substantial loss of material. In an effort to prevent long term deterioration, it would be wise to consider parging (a concrete stucco-like coating) over deteriorated areas. Lot drainage improvements and elimination of water or roof runoff splashing against foundation walls as outlined in the Exterior section of this report are also recommended.

Typical cracks observed

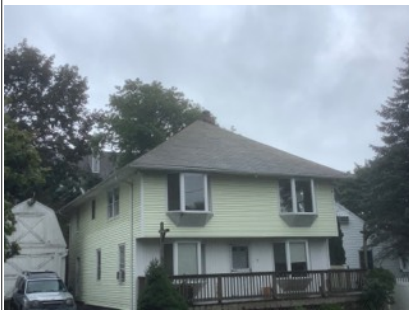
Monitor/Deferred Cost Item: The roofing is near the end of its life. Minor repairs might be possible to extend the roof life and to defer leaks. Damaged or missing roofing material should be repaired. All roof penetrations should be examined and sealed as necessary. Expect to replace the roof soon. It is recommended that the present layers of roofing materials be removed prior to re-roofing. This adds cost of demolition and debris removal to the re-roof cost. Replace the roof flashing materials when re-roofing to avoid leaks in these areas.

3 tab asphalt shingle observed/
aging roofing surface

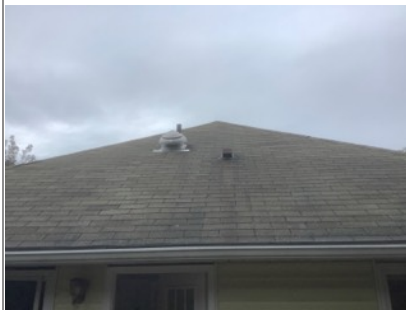
Loss of granular/ discoloration

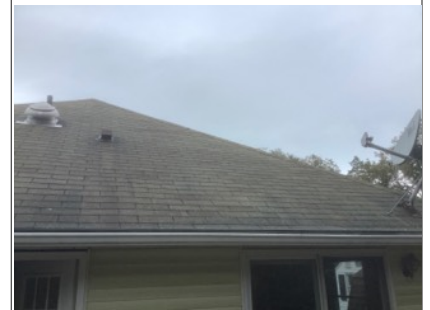
Loss of granular/ discoloration

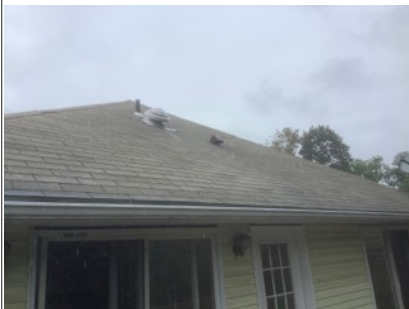
3 tab asphalt roof is aging/ budget
for replacement!

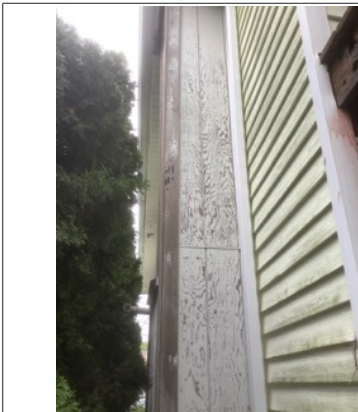
Remove plywood makeshift chimney

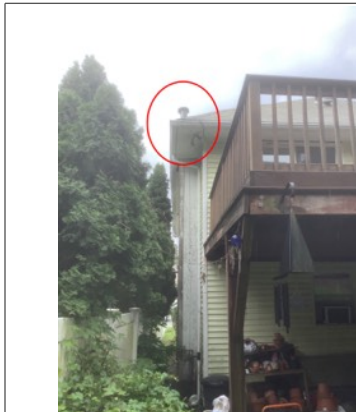
Abandoned chimney / removal recommended

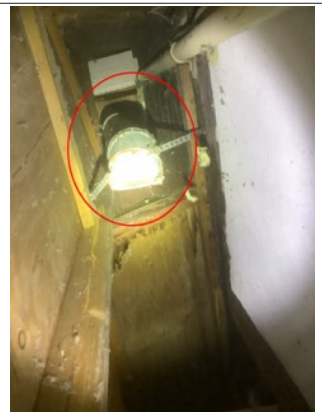
Remove the abandoned chimney and the plywood housing around it

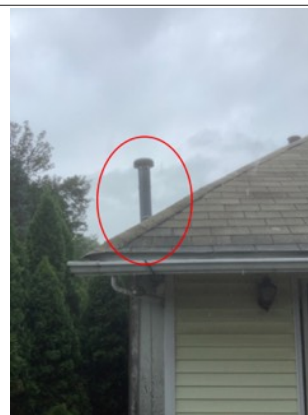
Repair, Safety Issue: The metal chimney should be braced in order to ensure its stability in heavy winds. Repair: The masonry chimney should be cleaned and it's interior flue inspected to ensure safe and proper function.

Metal chimney better secure

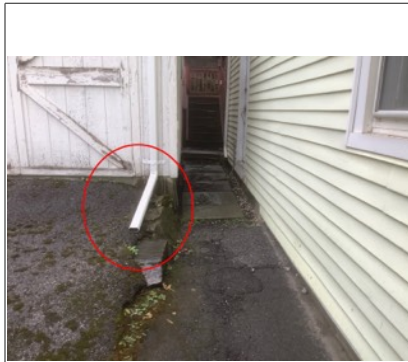
Repair: The downspout(s) should discharge water at least five (5) feet from the house. Storm water should be encouraged to flow away from the building at the point of discharge.

Downspouts discharging onto walkway

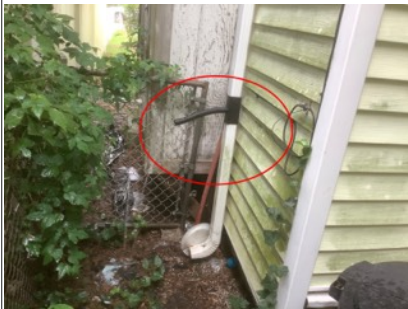
Missing rain barrels

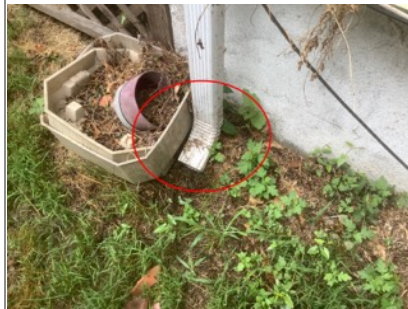
Downspouts discharging in close proximity to foundation

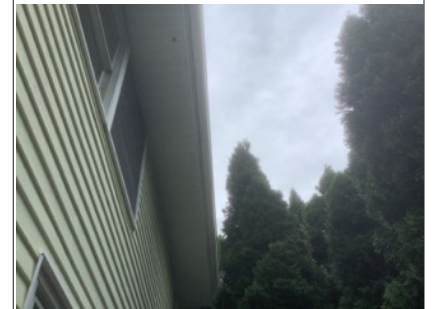
Repair: Minor leaks in the gutters should be repaired.

Leaks in gutters

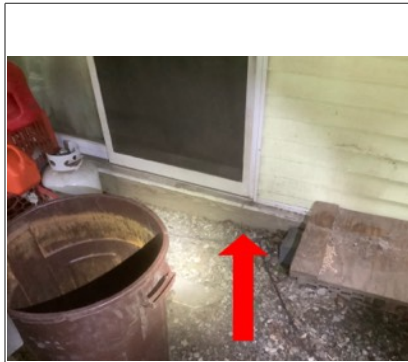
Wood to soil contact should be avoided

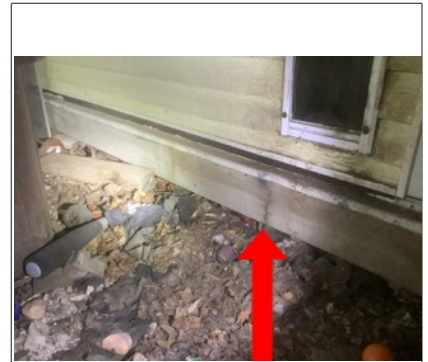
Wood to soil contact

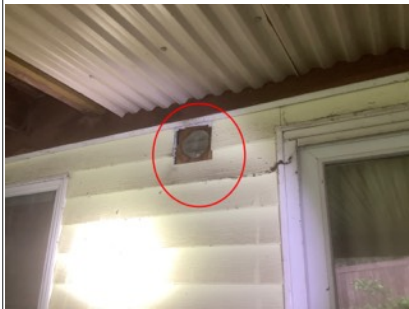
Ext. walls Repair: Damaged and missing vinyl siding was observed at the homes exterior. Repairs should be made to prevent moisture penetration.
 Improve: Power washing the vinyl siding would be a logical and cheap improvement.
 Repair: Wood to soil contact was observed at the rear exterior of the home.
 This condition should be improved. Localized rot should be replaced.
 Improve: Replacement of the vinyl siding and windows would be a logical improvement.

Missing vinyl siding/ patching

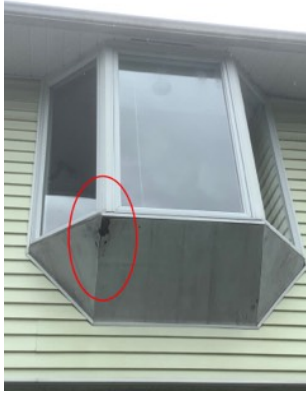
Localized rot damage observed

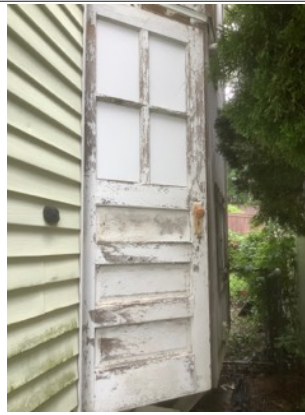
Door requires replacement

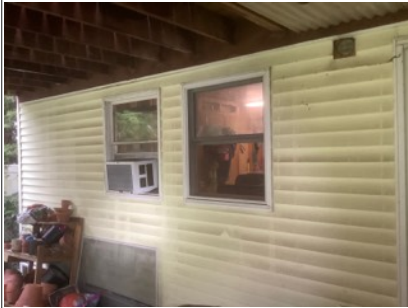
Missing window screens

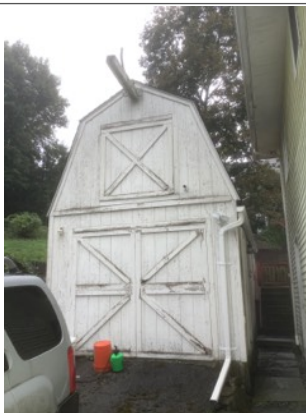
Repair: The detached garage has noticeably deteriorated. Significant repairs will be required to bring it to an acceptable standard.

Detached garage/ significant rot observed

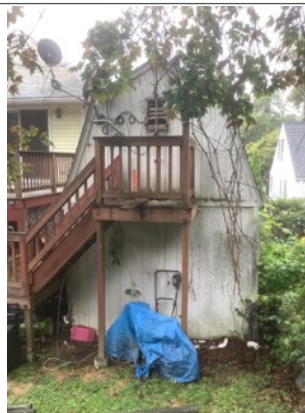
Significant rot and deterioration observed at the detached garage

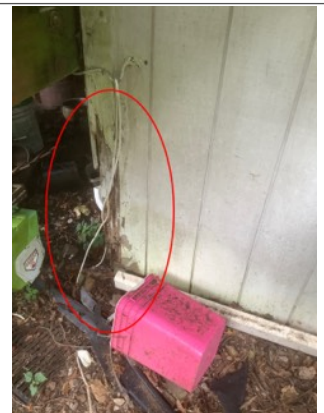
Repair: Major rot damage was observed at the wood siding.

Rot damage to siding and structure

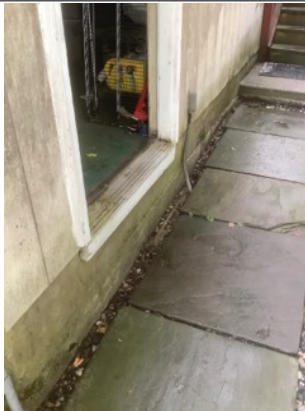
Repair: A staircase should be provided for the garage man door access.

Missing staircase to garage

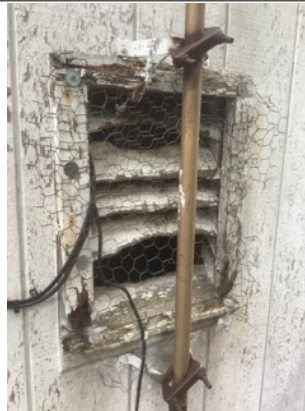
Significant rot damage observed

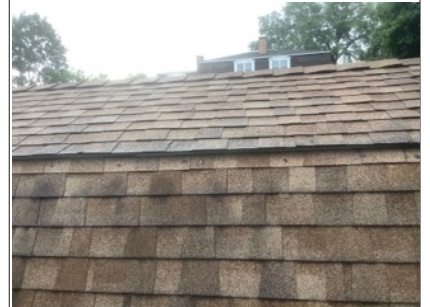
Exposed nail heads at garage roof

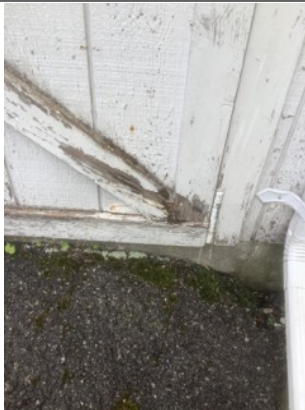
Localized rot damage

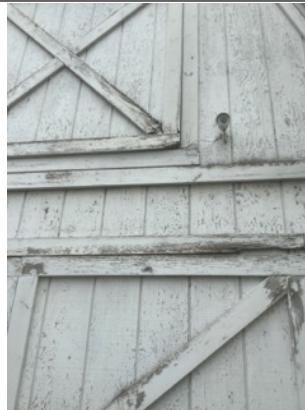
Localized rot damage observed

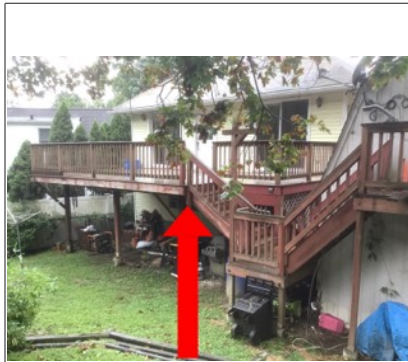
Repair/ Safety Issue: The deck staircase requires reinforcement or rebuilding.

No support column / staircase is not safe

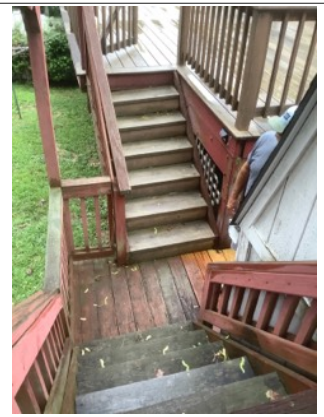
Significant settlement of staircase

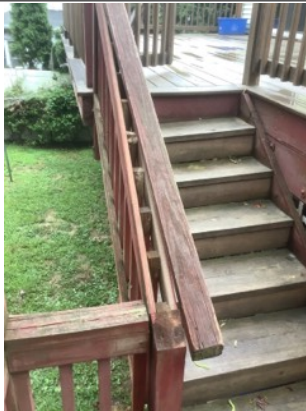
Railings are loose/ significant rot was observed

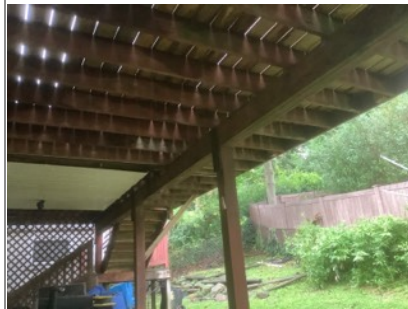
Deck Repair/Safety Issue: The deck is not built to today's standards, shows evidence of rot damage and is in need of reinforcement. Complete replacement may eventually be desired. In the interim, localized repairs should be undertaken.

Deck requires reinforcement

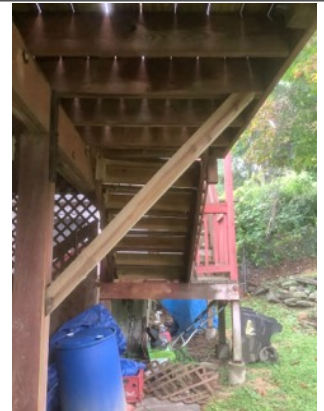
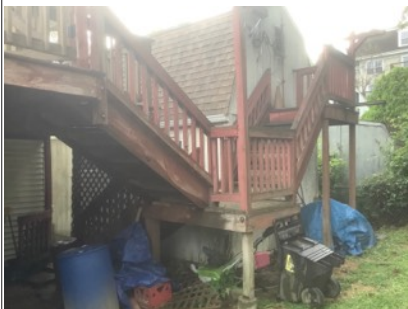
Deck staircase requires rebuilding

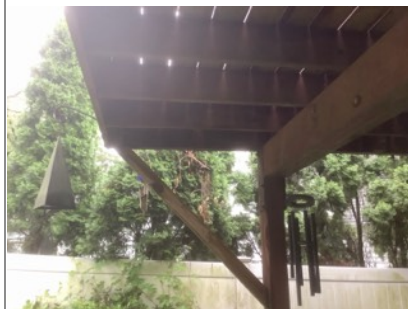
Deck structure requires reinforcement

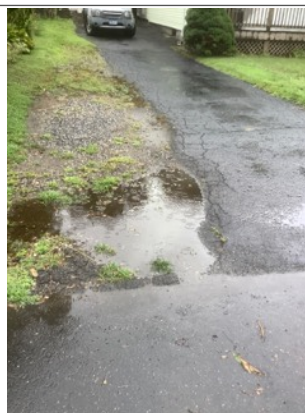
Ponding observed

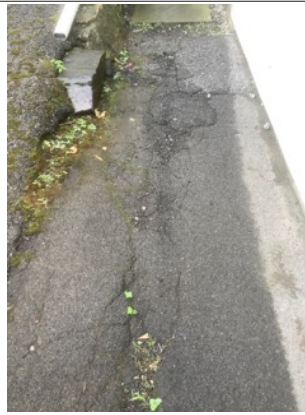
Repair/Monitor: Typical cracks and deterioration was observed at the driveway. The best long-term approach is resurfacing the driveway. The driveway should be sealed annually to prevent further deterioration.

Typical cracks and deterioration observed

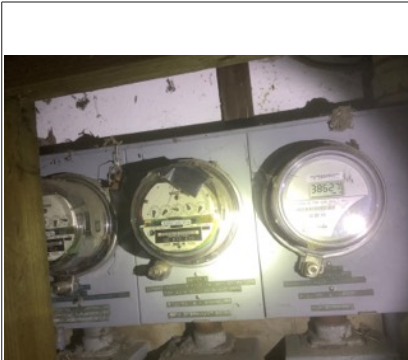
Electric Meters/ limited access

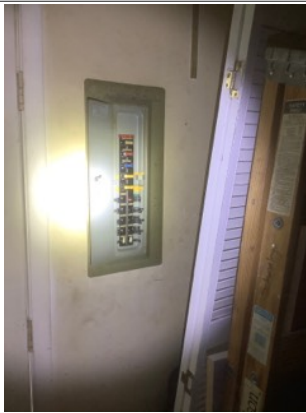
Panel/ garage

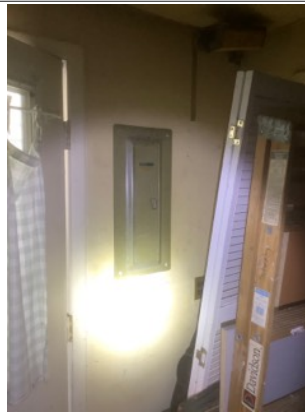
Panel/ garage

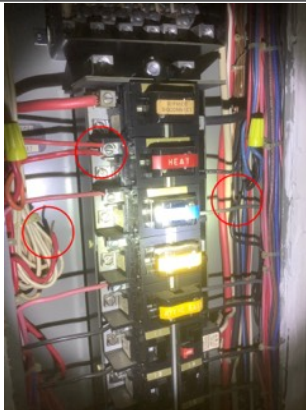
Repair/Safety Issue: Circuits within the main distribution panel that are doubled up (referred to as "double taps") should be separated. Each circuit should be served by a separate fuse or breaker. Consult a licensed electrician for further evaluation and repairs.
 Repair/ Safety Issue : It is now required that electrical panels are grounded in 3 locations. Consult a licensed electrician for further evaluation and repairs.

Double tap observed/ open wires

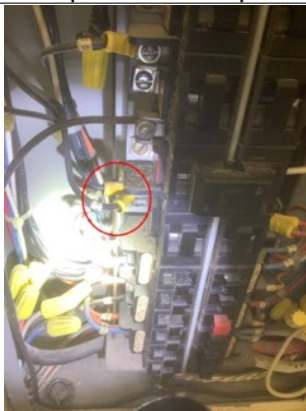
Panel cover removed

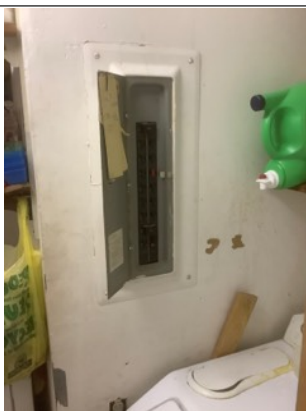
Paint covered/ panel not removed

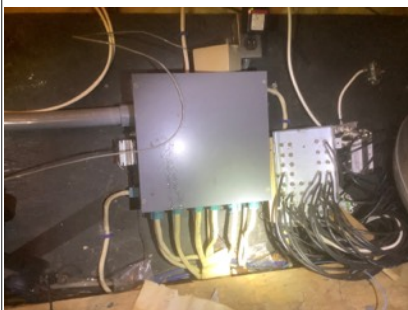
Distribution wires Repair: Abandoned wiring should be removed or appropriately terminated with a box and cover.
 Safety Issue: All junction boxes should be fitted with cover plates, in order to protect the wire connections.

Consult a licensed electrician for further evaluation

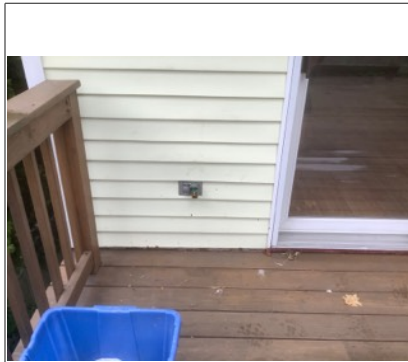
Repair/Safety Issue: The installation of a ground fault circuit interrupter (GFCI) is recommended. A GFCI offers increased protection from shock or electrocution.
 Repair: An outlet is damaged. It should be replaced.

Not Gfci protected

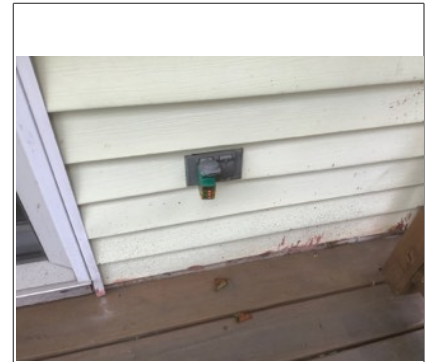
Not Gfci protected

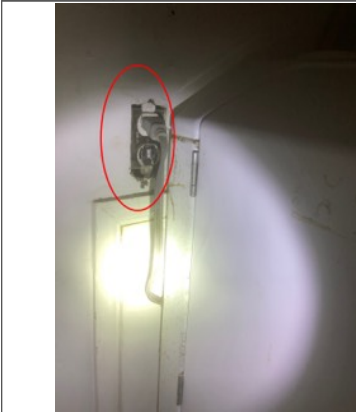
Outlet damaged

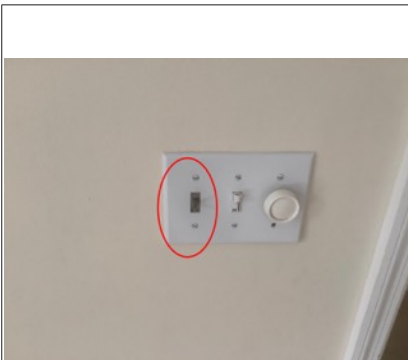
Repair: Damaged light switches require repairs or replacement.

Damaged light switch

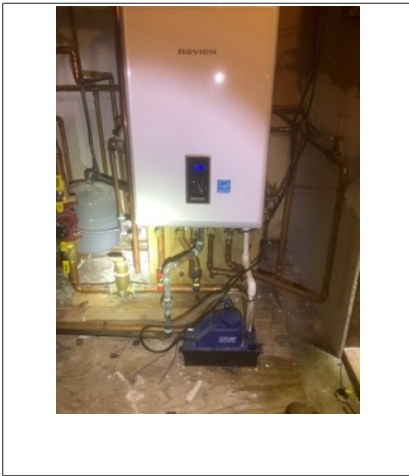
Condensate drip in plumbing system

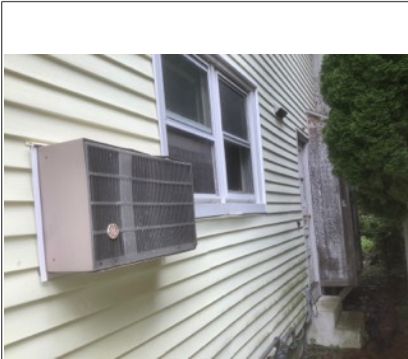
Old

Air conditioning Improve: The installation of a ductless AC system is recommended for this home. Consult a licensed HVAC technician for further evaluation and quote for installation.

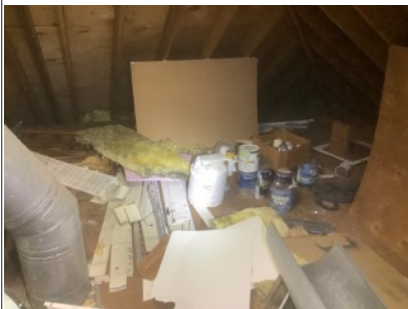
Remove all storage and debris

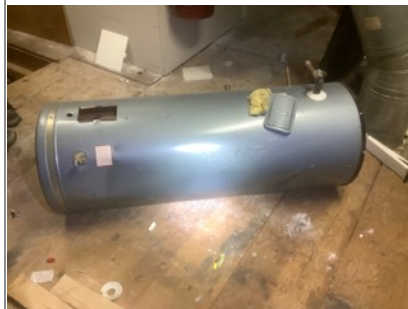
Remove old tank

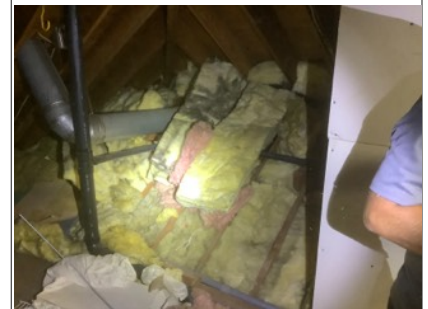
Fiberglass insulation observed

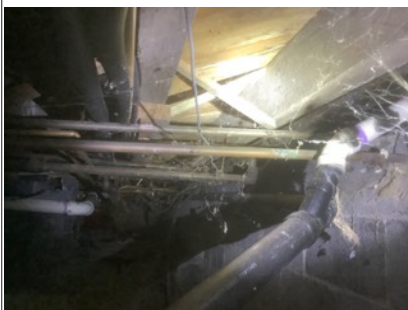
Plumbing in crawl space has freezing potential

Discretionary improvements cont. During the process of plumbing fixture renovation, it would be wise to replace old piping that is exposed. Supply piping may be susceptible to freezing during extremely cold weather. Heating or insulating this pipe would be wise.

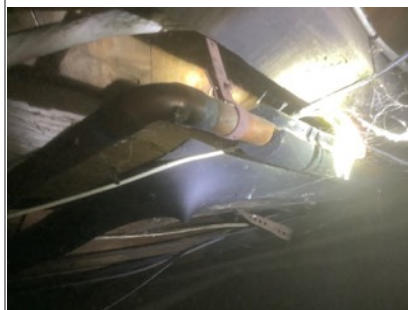
Loose and missing insulation

- Crawl space improvement** Insulation improvements to the floor above the crawl space may be desirable, depending on the anticipated term of ownership.
 Repair: Loose or damaged insulation in the floor above the crawl space should be improved.
 Repair: Plumbing pipes within the crawl space should be insulated to protect them from freezing.
 Repair: Ventilation of the crawl space is insufficient. One (1) square foot of free vent area should be provided for every five hundred (500) square feet of crawl space. Proper ventilation will help to control humidity and reduce the potential for rot. Crawl spaces can be vented to the building interior or exterior, depending on the configuration of the crawl space.
 Improve: The moisture (vapor) barrier in the crawl space floor should be adjusted to cover all areas of exposed soil.
 Repair: Evidence of mildew was observed in the crawl space. This

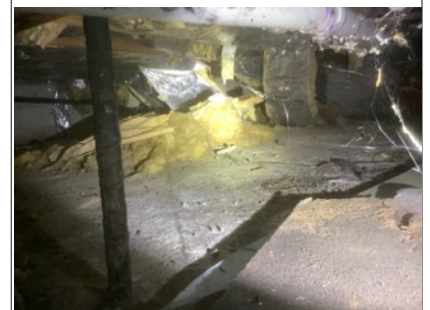
Loose and damaged insulation

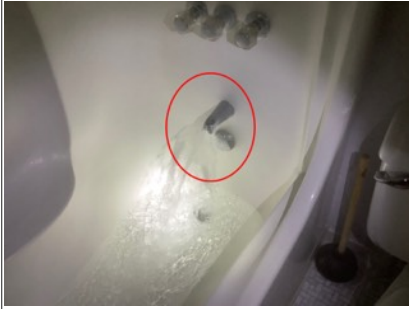
Damaged plumbing fixtures

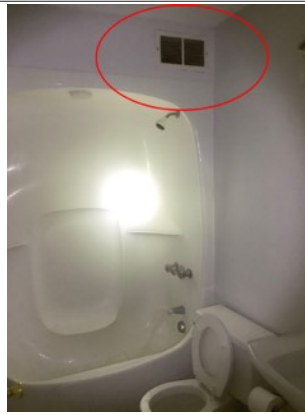
Bathroom exhaust fans are inoperative

Repair:The bathroom exhaust fans require replacement. Bathroom exhaust fans should vent directly to the homes exterior.

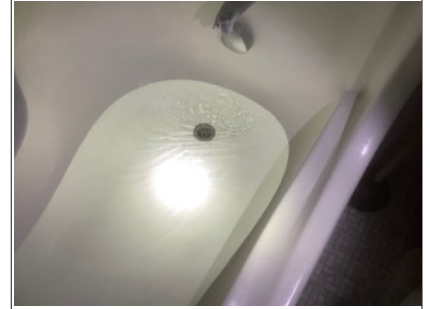
Bathtub drains slow

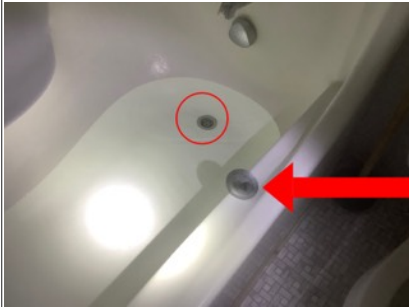
Missing drain cap

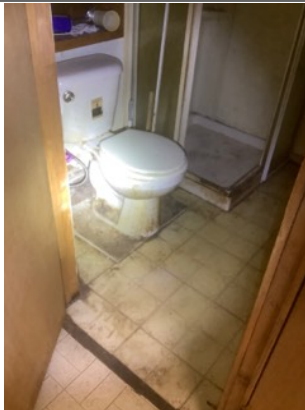
Bathroom / 1st floor / gut renovation

Repair:Monitor: Some of the fixtures in the 1st level unit were not operated at the time of inspection. All fixtures should be fully functional at the final walkthrough. This bathroom requires gut renovations.

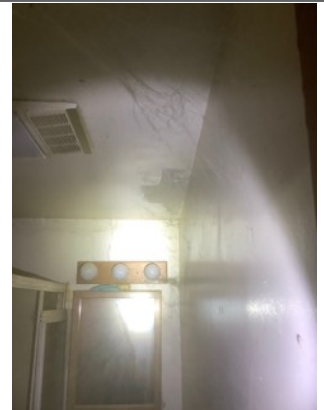
Bathroom requires renovation / 1st floor

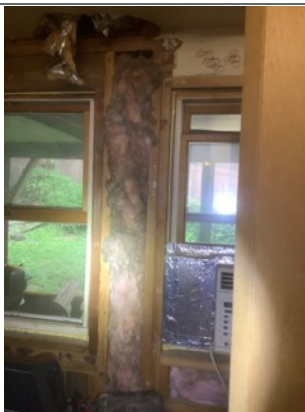
Exposed wires and insulation

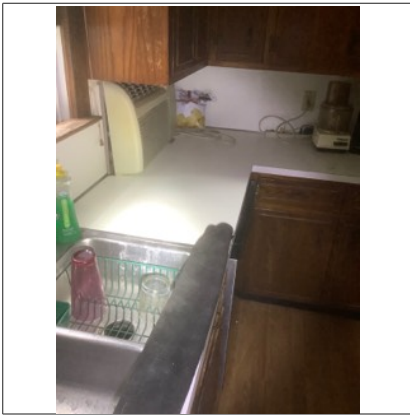
Kitchen cabinets Repair: Damaged kitchen cabinets should be repaired.
 Monitor: The kitchen cabinets are old. Improvement may ultimately be desirable.

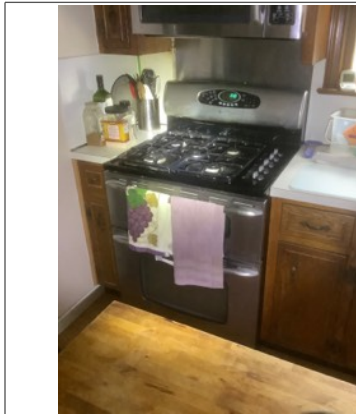
Gas range unit Monitor: The gas range is an old unit. While replacement is not needed right away, it would be wise to budget for a new range. In the interim, a higher level of maintenance can be expected.

Gas range/ middle age

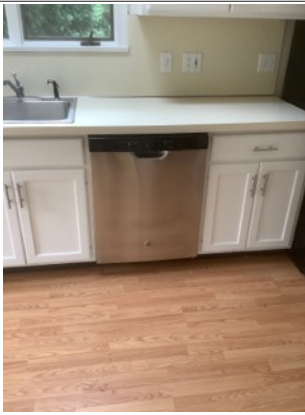
Dishwasher unit Repair: The dishwasher airgap device does not appear to be properly configured. Air gaps are now standard equipment to assure a separation between supply and waste water. It is advised that this condition be investigated.

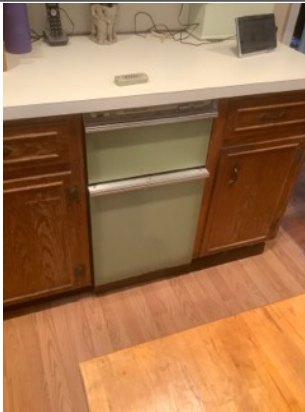
Old dishwasher

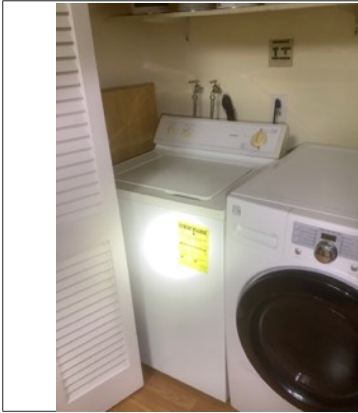
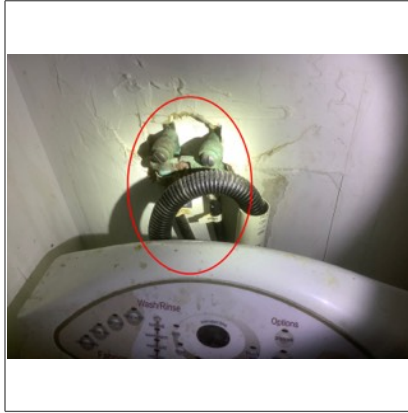
Clothes washer unit Improve: Update the supply hoses to braided metal.

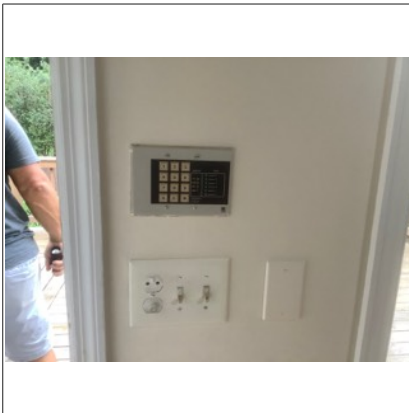
Intercom system Monitor: The intercom system is an old system. Reliability and performance may not be ideal.
