Inspection Report

Robbins Services, Inc.

Property Address

1007 USA Drive, Shield City, FL 34685

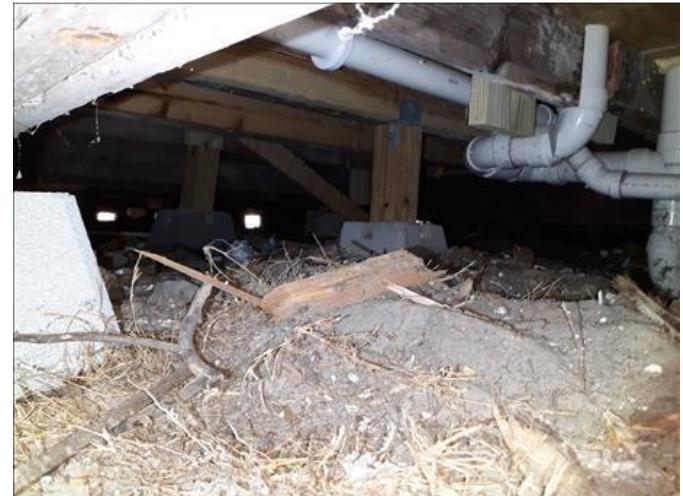
Re-inspection 10/2/19 - Deck Support, Kitchen

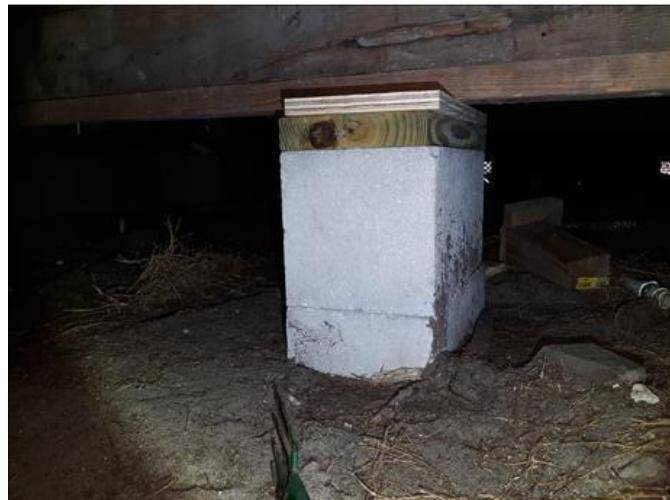
Re-inspection 10/2/19 - Concrete blocks, Center Beam

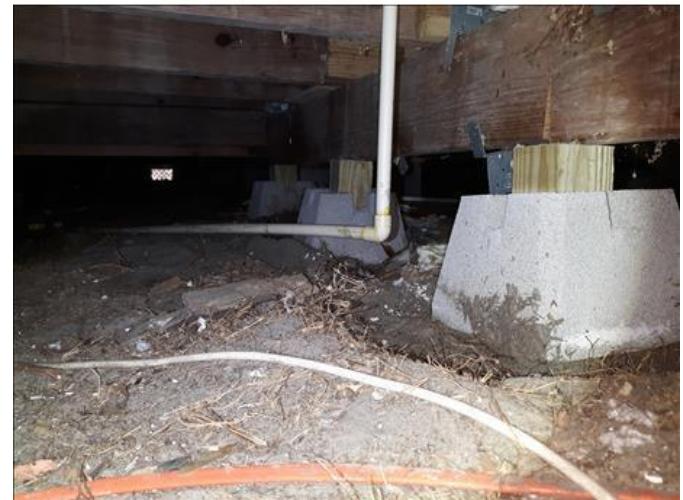
Re-inspection 10/2/19 - New supports have been added at the center beam and kitchen. Loose concrete blocks have been added for added support and are still in use at the rear bedroom, these piers generally require proper footers to support the excessive weight of the home. Deck post supports and loose blocks are generally not considered structurally sound for use in home foundations. The ground did not appear to have been disturbed as expected for footers to have been added, however the inspector is unable to comment on whether pier footers were added or repaired since they are underground and generally concealed from view. Generally, the contractor would add a vapor barrier once foundation work is completed to help avoid future issues. If the work was performed by a contractor familiar with crawlspace foundations and conditions; I recommend you obtain a warranty from the contractor in writing guaranteeing the work and that the improvements were made per approved construction standards.

Re-inspection 10/2/19 - Deck Supports, Center beam/Kitchen

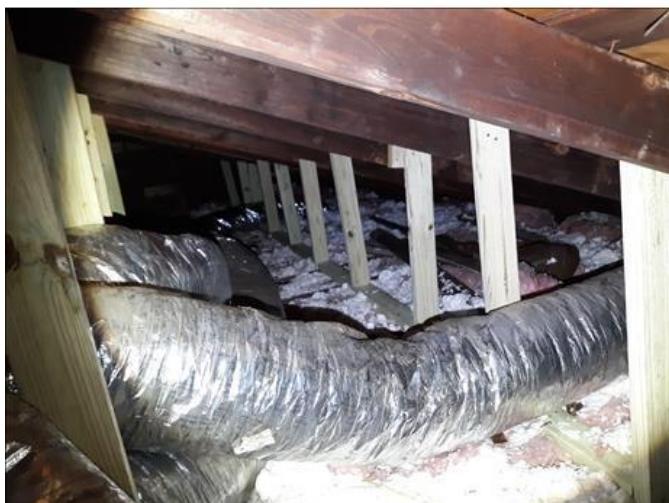
Re-inspection 10/2/19 - Improved supports

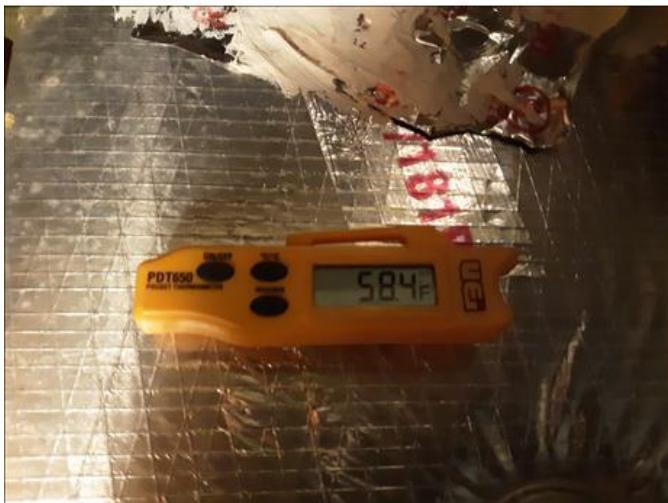
Re-inspection 10/2/19 - Supply

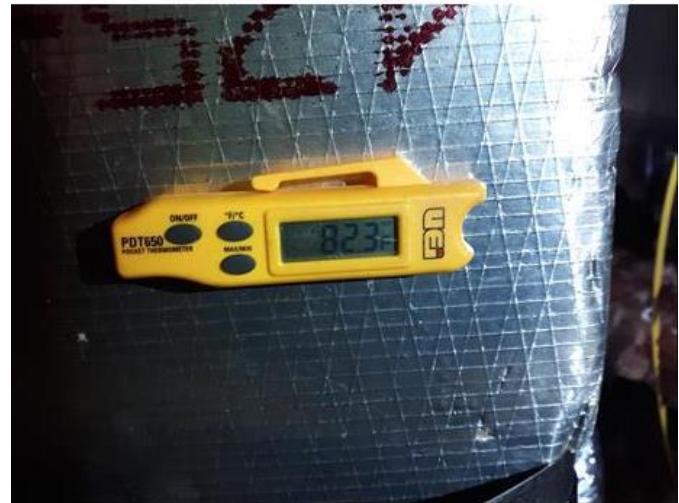
Re-inspection 10/2/19 - Return

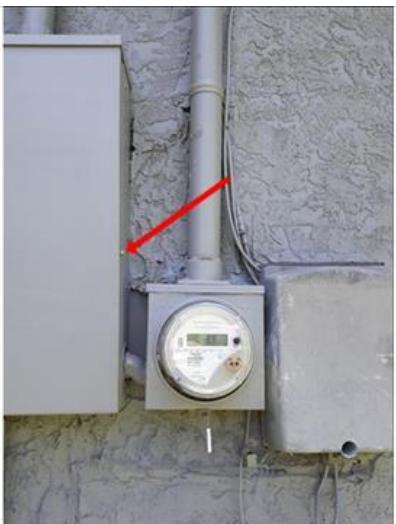
Re-inspection 10/2/19 - #2 Bolt securing dead front plate

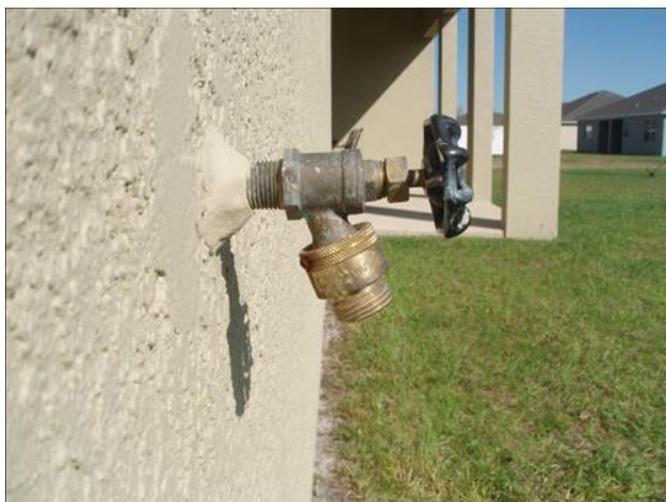
Re-inspection 10/2/19 - Not improved

Example of Back-Flow Device

Back-flow prevention devices are now required on exterior hose bibs under current plumbing standards to prevent cross contamination of the domestic water supply. These devices are inexpensive and available at most hardware stores. Consider upgrading the hose bibs by installing back-flow devices.

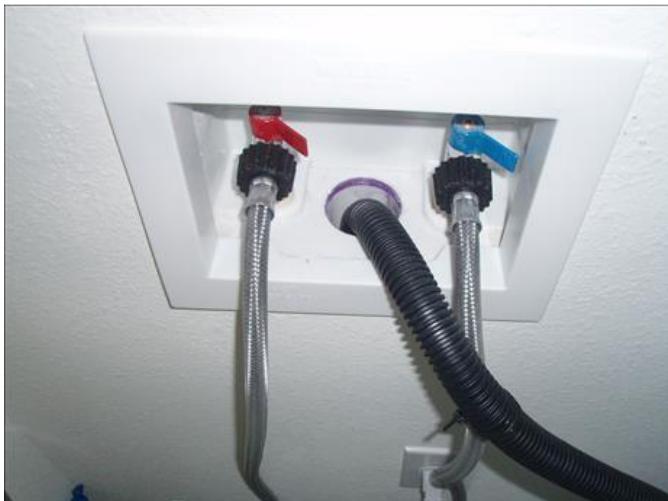
Example of Anti-Burst Hoses

Install braided metal, anti-burst, water supply hoses to the clothes washing machine in place of the rubber water supply lines that exist now as these rubber lines have been known to fail and burst and could cause significant water damage.

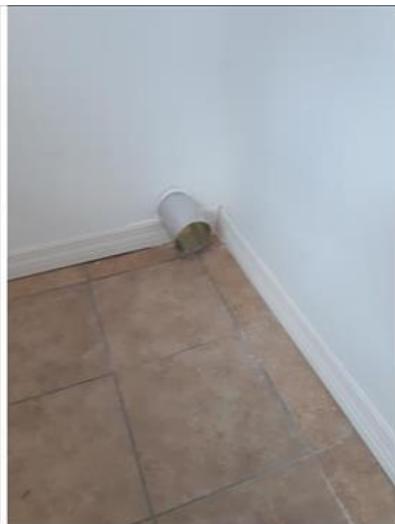
There is no dryer vent present. Recommend routing dryer vent to outdoors to avoid indoor moisture issues. It is suggested that a "Licensed General Contractor" be contacted for further evaluation and repair.

Re-inspection 10/2/19 - Completed satisfactory.

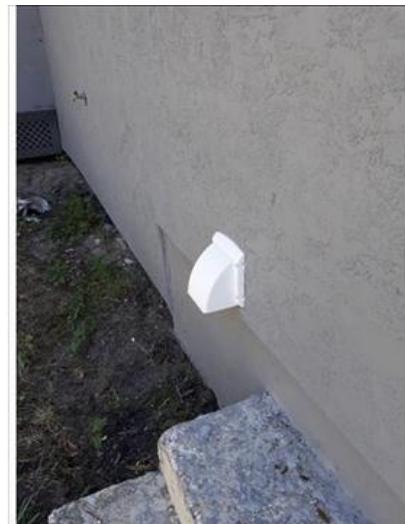
Re-inspection 10/2/19 - Completed satisfactory.
